Failmore

Desktop Assessment

Western Region

(AFA0076)

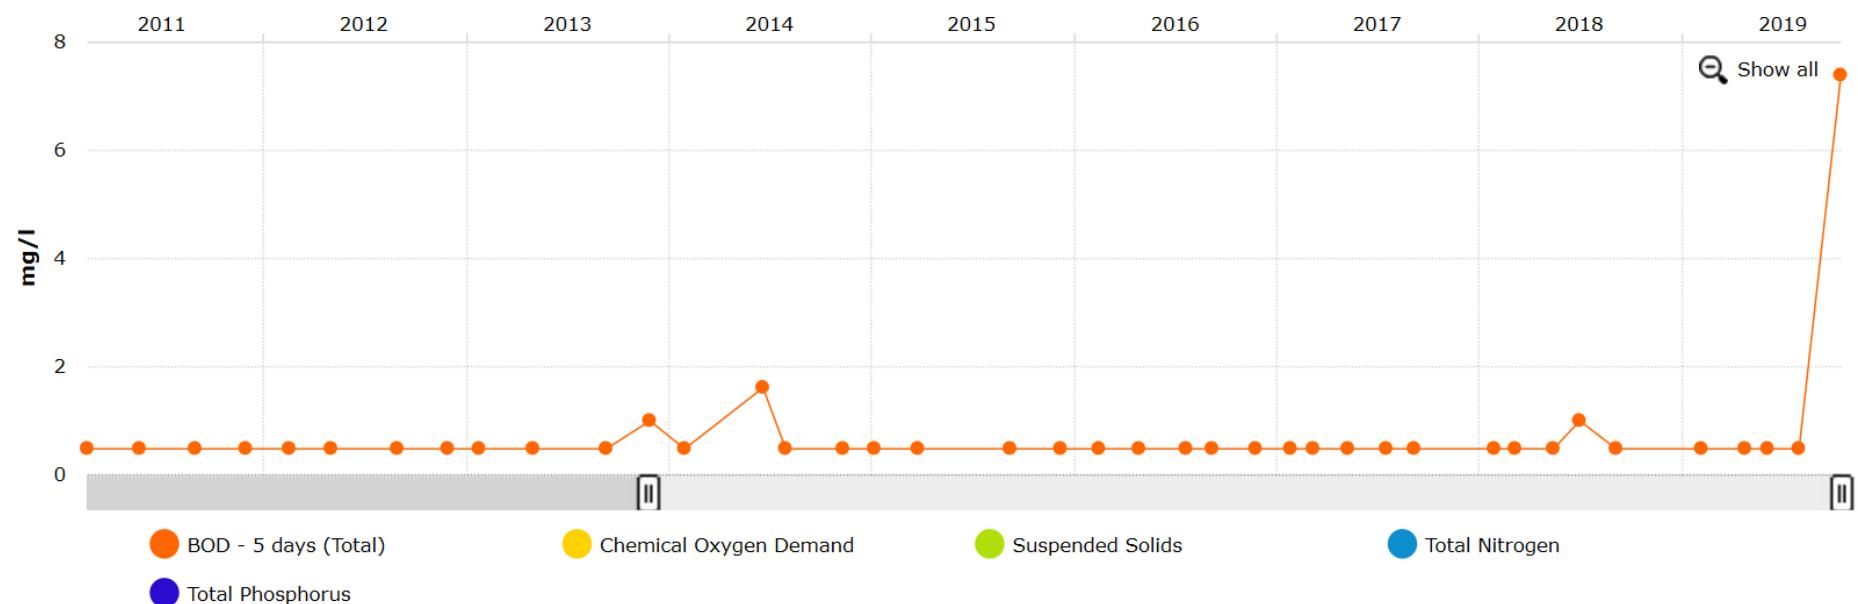
Figure 4: BOD graph for the Failmore_010

EPA Biologists Comments	The Failmore river improved to High ecological quality in August 2018.	
Significant issue: monitoring point	Unknown. Potentially BOD given spike in 2019, plus sediment, given land drainage of peat soils.	No issues at the monitoring point.

- All the chemistry is below the EQS, except for BOD, where there was a spike in 2019.
- Since 1982 up until 2012, the Q - value at this monitoring point was at Q4 – 5.

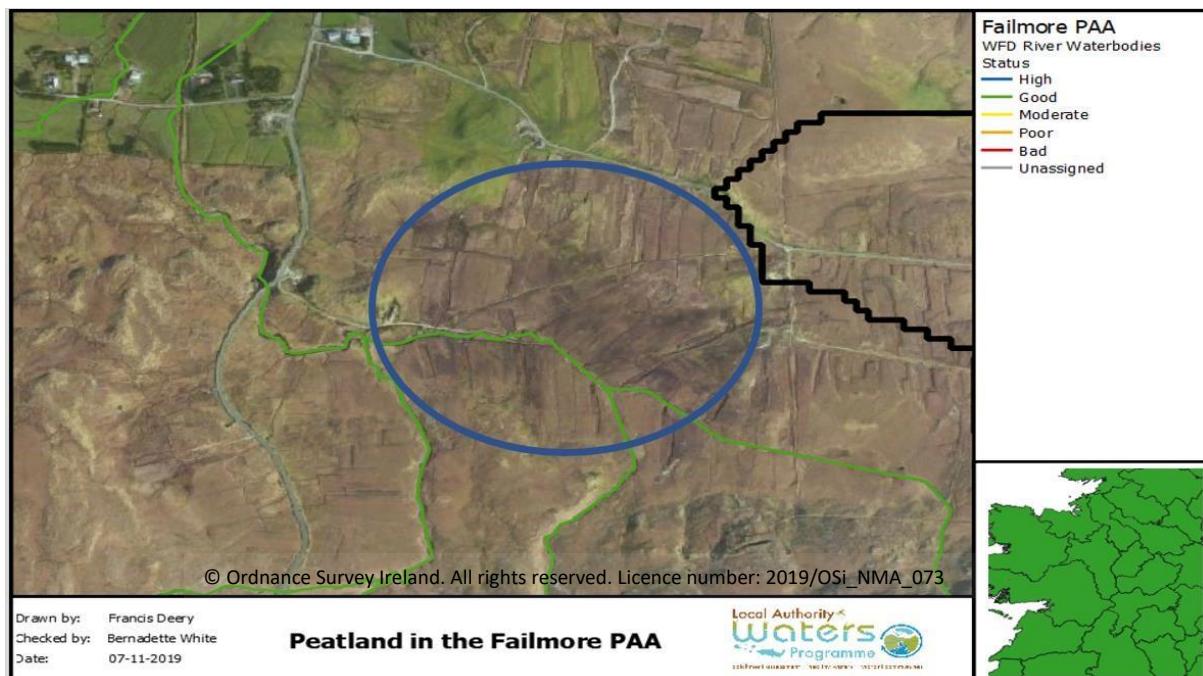
Figure 5: Peat Cutting in the Failmore_010

The extractive industry in the form of peat cutting has been identified as a pressure in the Failmore_010, with altered morphology as the impact. There is peat cutting being carried out in the vicinity of the Failmore_010. With these peat cutting areas there are peatland drains, to drain the peatland, therefore the sediment from the peatland is being transported from the peatland to the river via these drains, as can be seen in **Figure 5** and **Figure 6**.

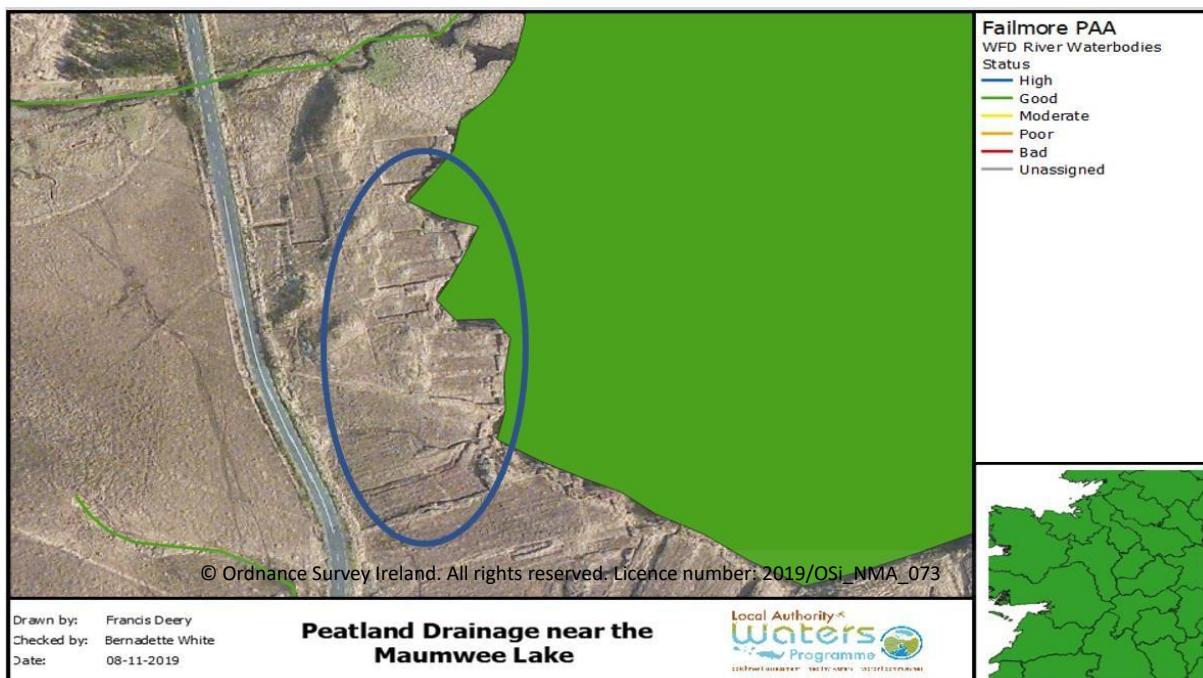
Figure 7: Peatland Drains near the Maumwee Lake

Hydromorphology in the form of land drainage is seen to be impacting the Maumwee lake by impacting upon the morphological processes of the lake. There are number of areas around the Maumwee lake, where peat cutting appears to have taken place in the past, with these areas there are peatland drains with some leading into the Maumwee lake itself (**Figure 7**). From viewing the Geohive historical maps from 1800s, the Owenwee (Corrib)_010 has been modified, straightened and channelised to drain the adjacent land as seen in **Figure 8**. There is moderate sediment accumulations around the southern shore of the lake. If sediment cover is found in the channel during field survey, then this means that human activities have potentially caused this locally, and this will probably be the case of the levels of sediment found are excessive (>50% cover). In reviewing the morphological quality index, the natural river flowing into the lake have a high morphological quality.

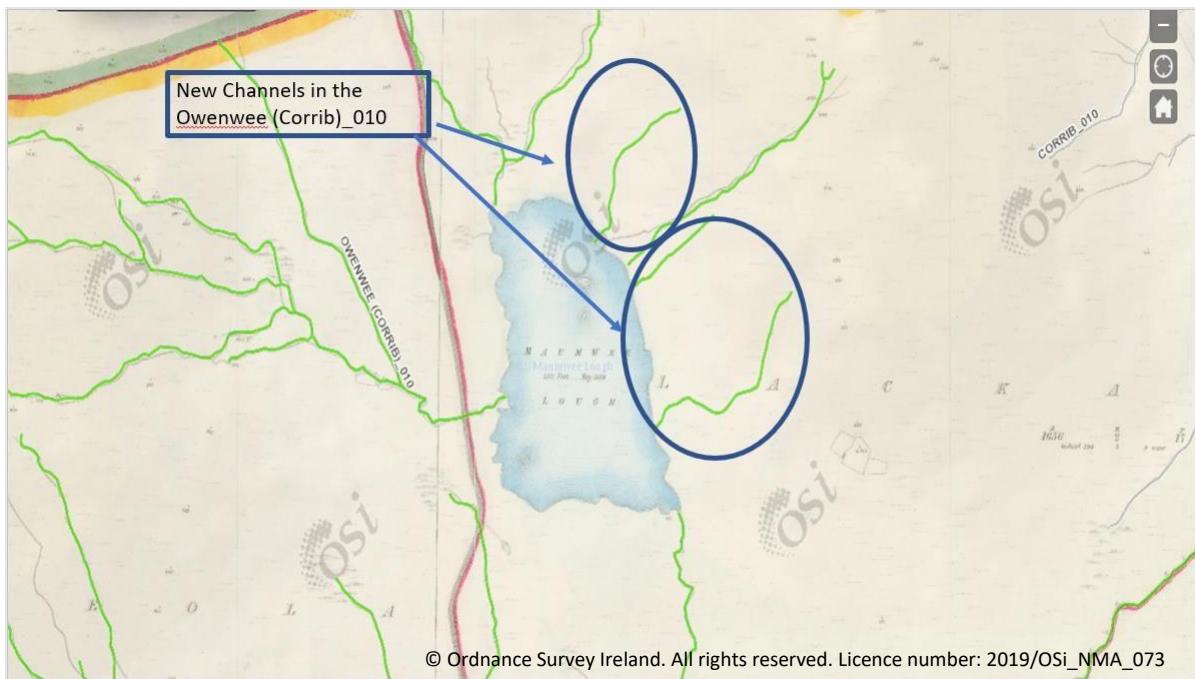
Figure 8: New River Channels in the Owenwee (Corrib)_010

- The significant pressure impacting upon the Maumwee lake is hydromorphology in the land drainage. The inputting river, Owenwee (Corrib)_010 has been straightened and channelized over the years, there are also new river channels opened and there is a drain leading into the lake.

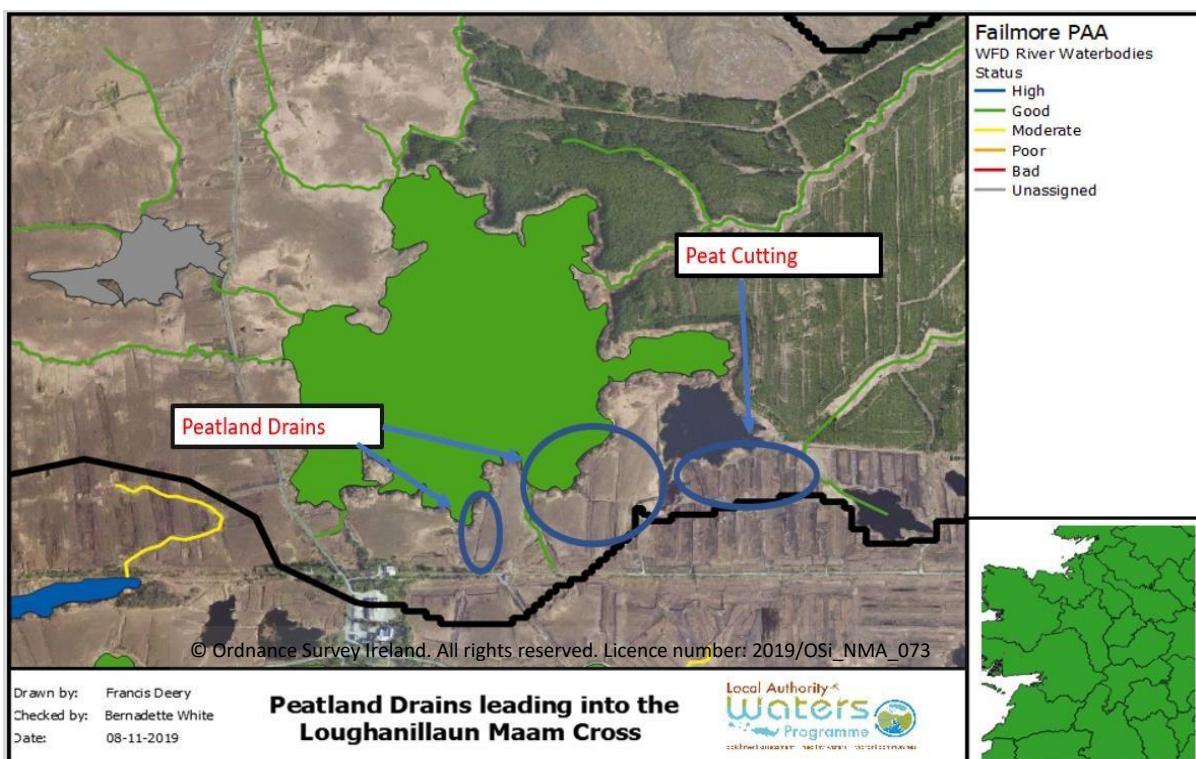
Figure 9: Peatland Drains leading into the Lake

Hydromorphology in the form of channelisation is impacting upon the Loughanillaun Maam Cross lake, the habitat is being altered due to morphological changes in the surrounding area of this waterbody. The WFD App also states that the lake may be under pressure from accelerated erosion processes. There are several peatland drains (**Figure 9**) leading into the lake itself which would be transporting sediment and mobilised nutrients, such as ammonium. Naturally, moderate levels of sediment accumulation are expected around the southern and eastern shores of the lake. In reviewing the morphological quality index, there is no morphological alterations to the inflowing rivers. On the outflowing part of the Owenwee (Corrib)_010, no alterations have occurred in this waterbody.

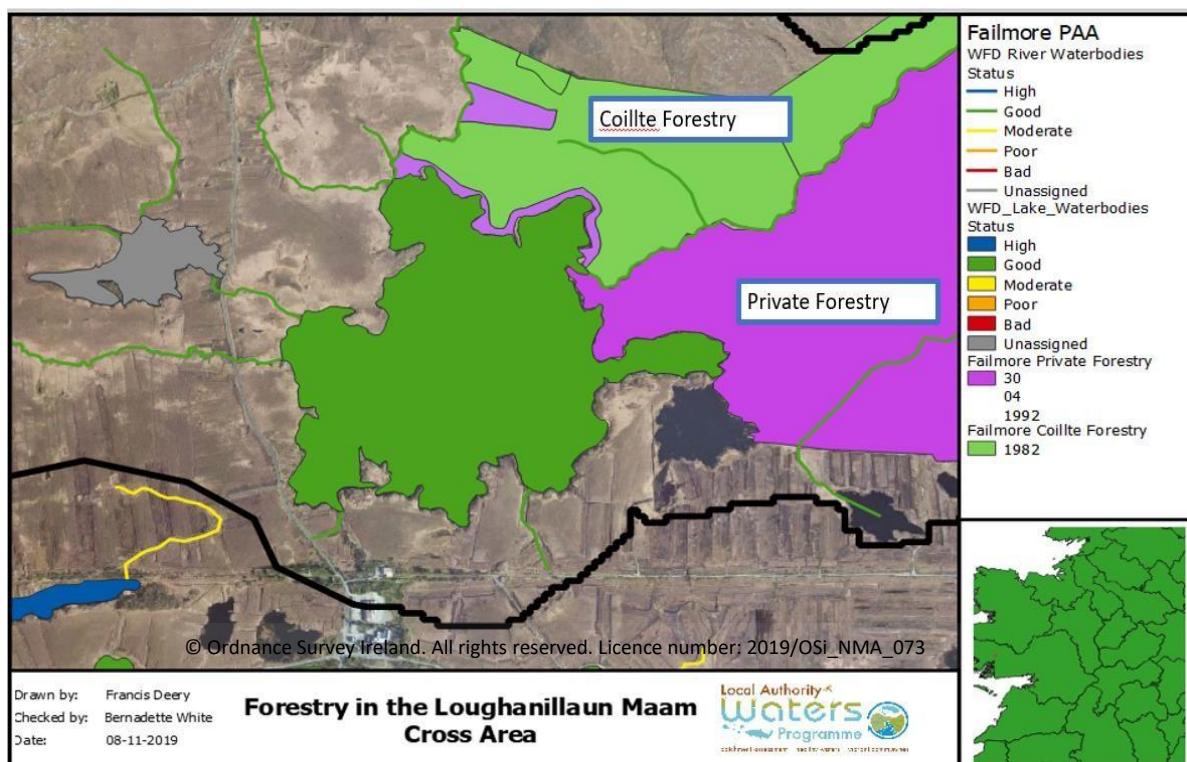
Figure 10: Forestry near Loughanillaun Lake

Forestry was not identified as a significant pressure during initial characterisation. There are number of forestry plantations located around the Loughanillaun Maam Cross both Coillte and Private forestry (**Figure 10**). The Coillte forestry was planted in 1982, there would appear to be a buffer zone between the lake and the plantations, and dominant species of this plantation is Sitka Spruce. The private forestry was planted in 1992, again there would appear to be a buffer zone between the forest and the lake. The main species are Sitka Spruce and Lodge pole pine.

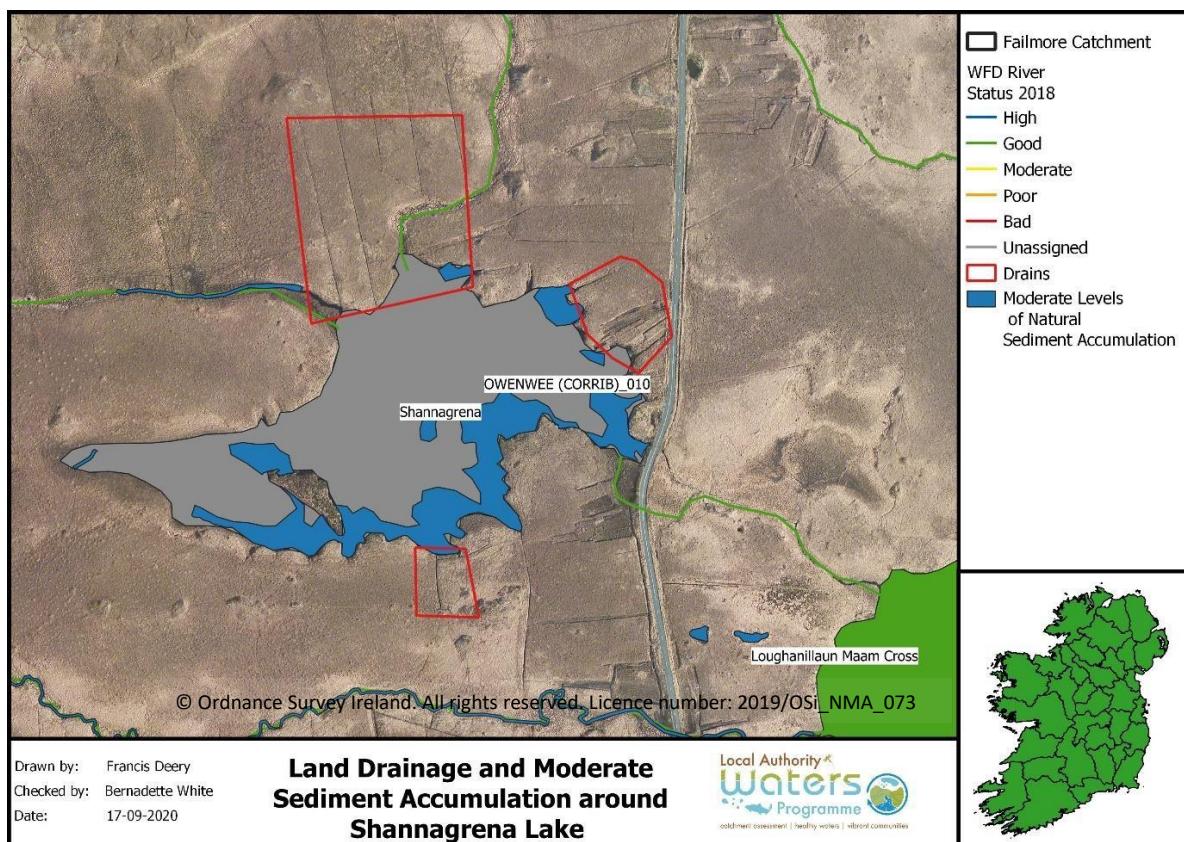
Figure 11: Land Drainage in the Shannagrena Lake

Hydromorphology in the form of land drainage was identified as a significant pressure with impact to habitats caused by morphological changes to Shannagrena lake. The WFD App also states that there is an issue with accelerated erosion and could be impacting upon the status of the lake, which is yet to be determined as this waterbody is unassigned. There are several land drains leading from the peatland into the lake, as seen in **Figure 11**. There is a significant amount of moderate sediment accumulation on the southern and eastern shores of the lake. If sediment cover is found in the channel during field survey, then this means that human activities have potentially caused this locally, and this will probably be the case of the levels of sediment found are excessive (>50% cover).

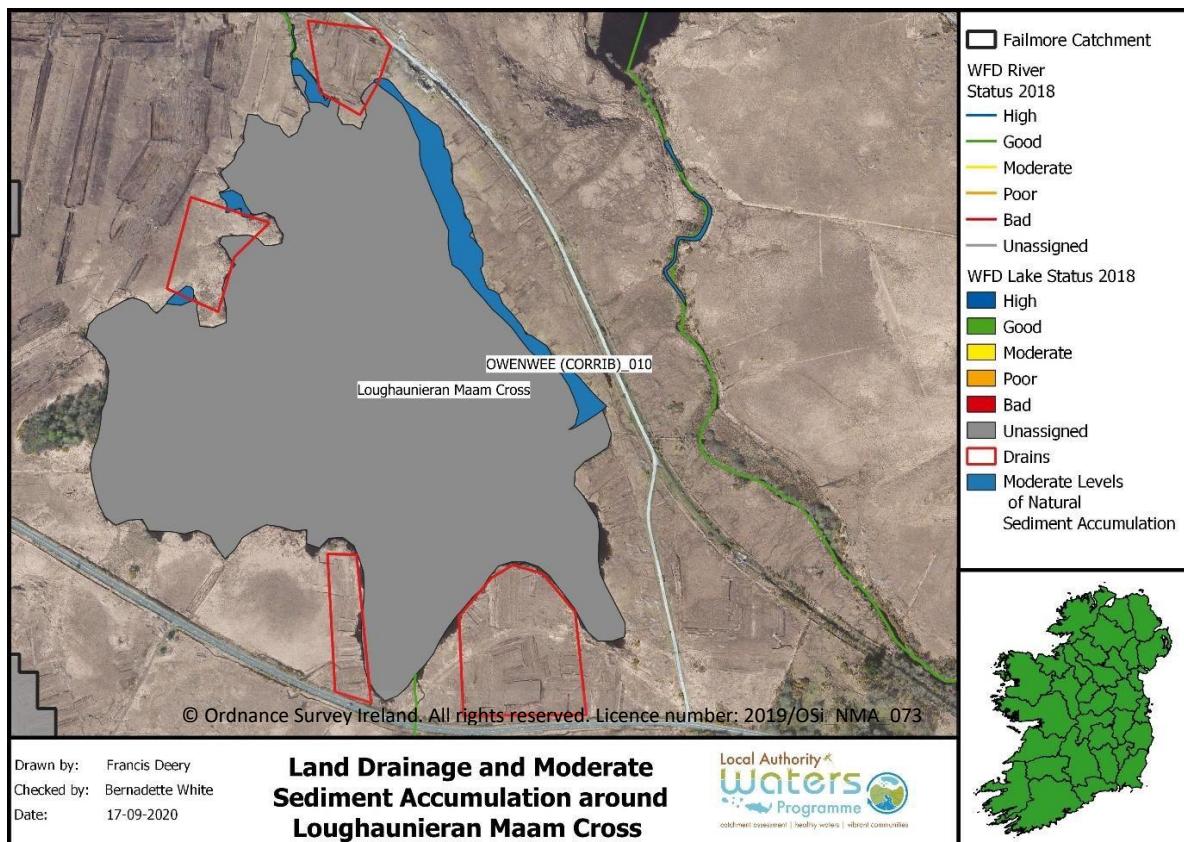
Figure 12: Peatland Drainage in the Loughaunieran Maam Cross Area

Hydromorphology in the form of land drainage was identified as a significant pressure with impact to habitats caused by morphological changes to Loughaunieran Maam Cross lake. The WFD App also states that there is an issue with accelerated erosion and could be impacting upon the status of the lake, which is yet to be determined as this waterbody is unassigned. There are several land drains leading from the peatland into the lake, as seen in **Figure 12**. Natural sediment accumulation mapping indicates that there is an area located along the eastern shores of the lake where moderate levels of sediment accumulation would be expected.

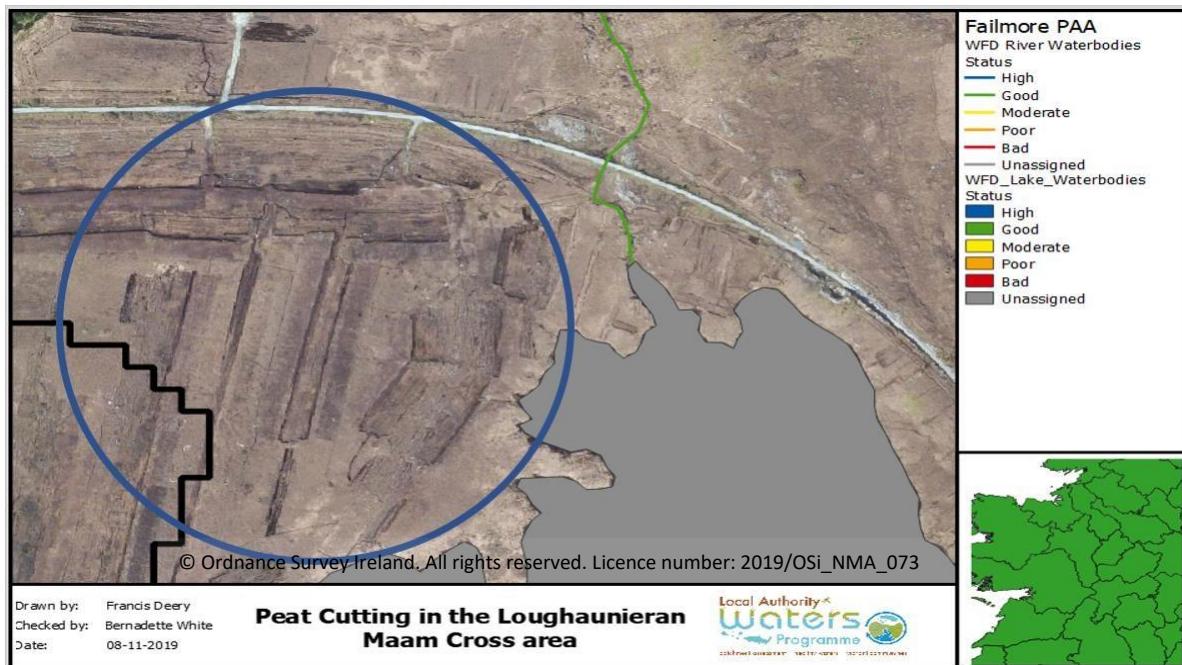
Figure 13: Peat Cutting in the area of the Lake

Peat cutting was not indicated as a significant pressure on this lake during initial characterisation. There are number of areas around the lake where there is peat cutting being carried out, as seen in the **Figure 13**.
