Boycetown Priority Area for Action

Desktop Assessment Report

Version 8

09/10/2019

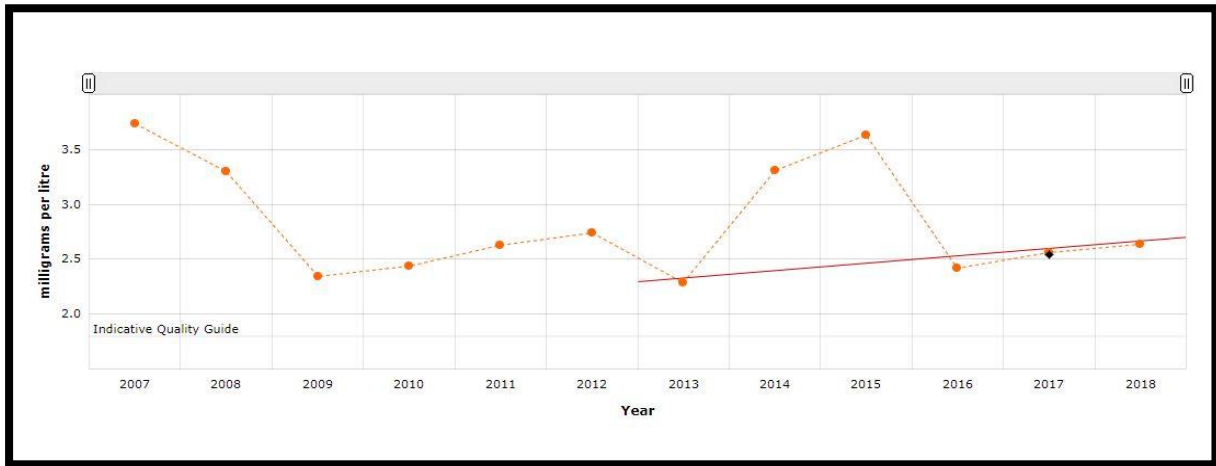
Figure 3: TON at monitoring station at Scurlockstown Bridge

Boycetown_020 chemistry data show that Total Oxidised Nitrogen (Figure 3) had been increasing (not significantly) since 2013 and was above the EQS standard for good nutrient conditions for TON (3.5 mg/l) in 2015. It subsequently dropped in 2016 to 2.420 mg/l and in 2018 it was 2.61 mg/l. It is still on an upward trend but not considered environmental significant. Phosphate levels have remained below the EQS. Boycetown_020 was classed as moderate status in 2007-2009, it had failing nitrogen conditions and the biology was indicative of moderate quality. In 2010-2012, the status was classed as moderate again due to its biology. In 2010-2015 the status decreased to poor because of the poor biology and failing Dissolved Oxygen. The Q-Value for Boycetown_020 has been recorded every 3

However, the chemistry data has gradually improving over the years 2009-2015. TON is still on an upward trend but not considered environmentally significant (Figure 3). Therefore, chemistry might not be significantly impacting on the macro-invertebrates. Sediment has been observed in the waterbody and this has the potential to impact on the macro-invertebrates. The Q-value (figure 4) was assessed in 2018 and the status has improved to moderate status (3-4) again.

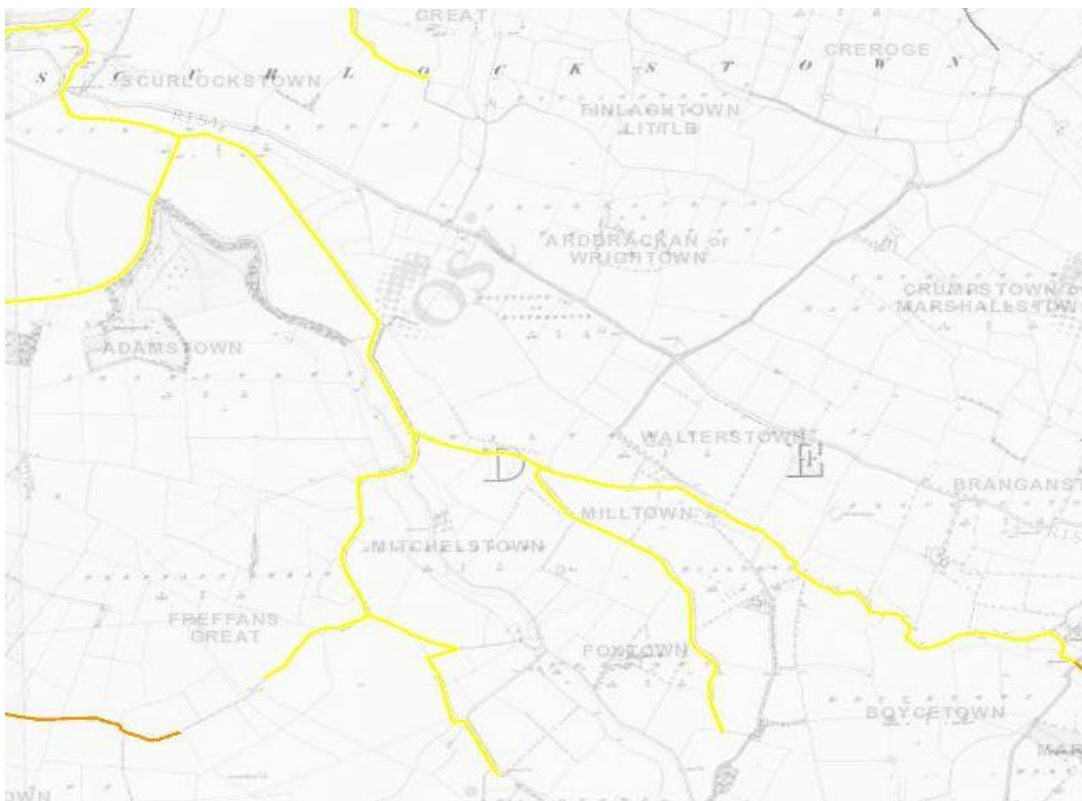
Figure 8 : Main channel of Boycetown_020 showing channelisation (1829-1842).

Channelisation is identified as a significant pressure in both waterbodies in the Boycetown PAA. The OSI historical 6" maps (1829-1842) show that the main channel of the river in Boycetown_010 (Figure 7) and Boycetown_020 (Figure 8) have been straightened over 150 years ago. This modification of the natural course of the waterbodies coupled with the agricultural practice of cleaning rivers and drains could accelerate the natural sediment loss in a river resulting in excess sediment loss issues. The over straightening and deepening of a stream, which can result in slower flows and the loss of riffle/run habitats. This has a negative impact on the macro invertebrates which can be exacerbated by the sediment losses. In order to improve grassland production areas of poorly drained soil within the PAA will have a high field/land drain density. The field drains are also a source of nutrients and sediment to the river.

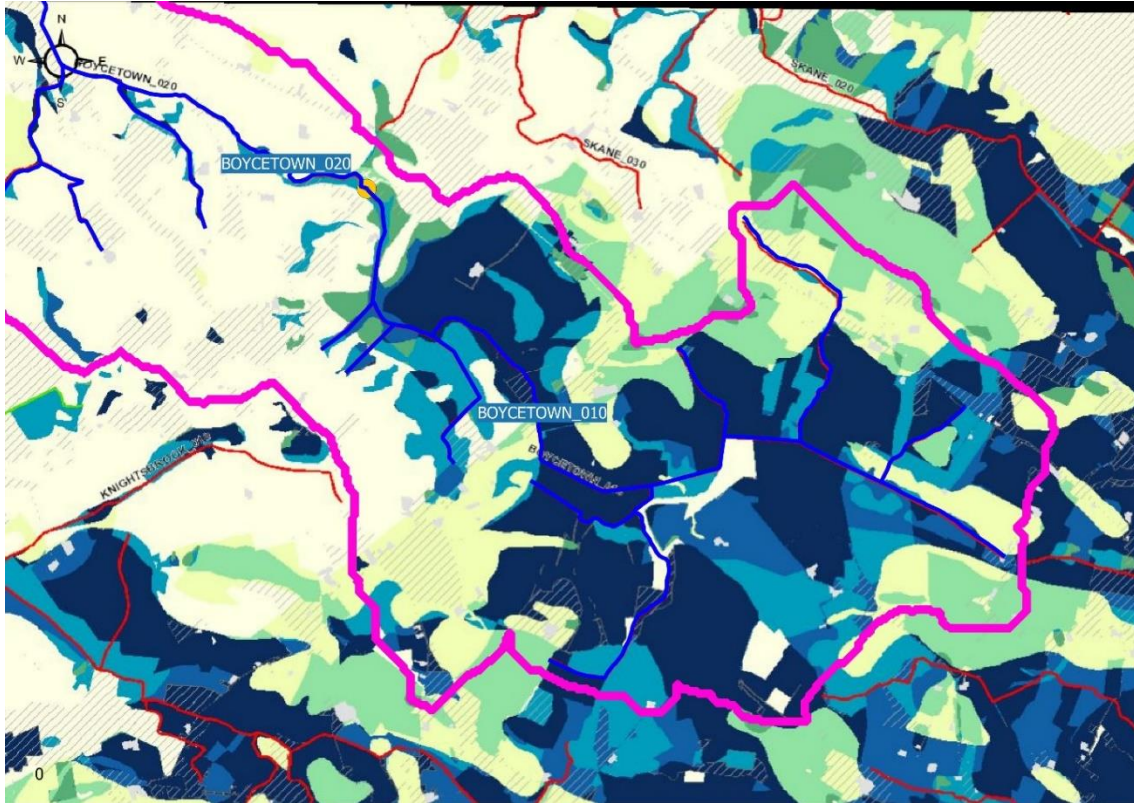
Figure 10: Pollution Impact Potential (PIP) phosphate map for Boyce town_010.

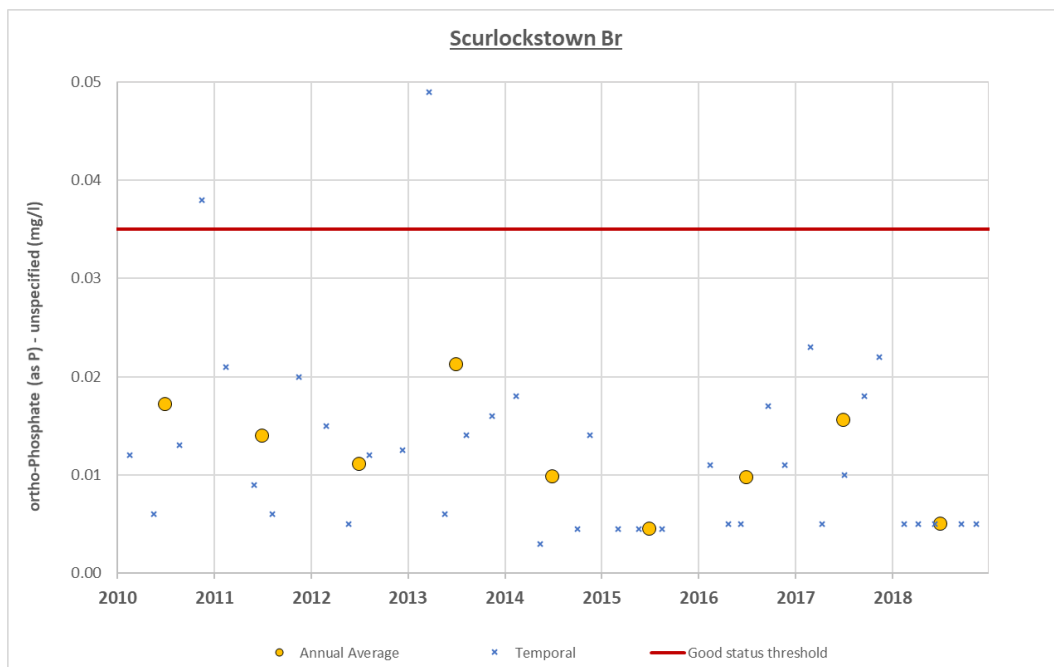
Figure 16 : ortho-phosphate at monitoring station for Boycetown_020

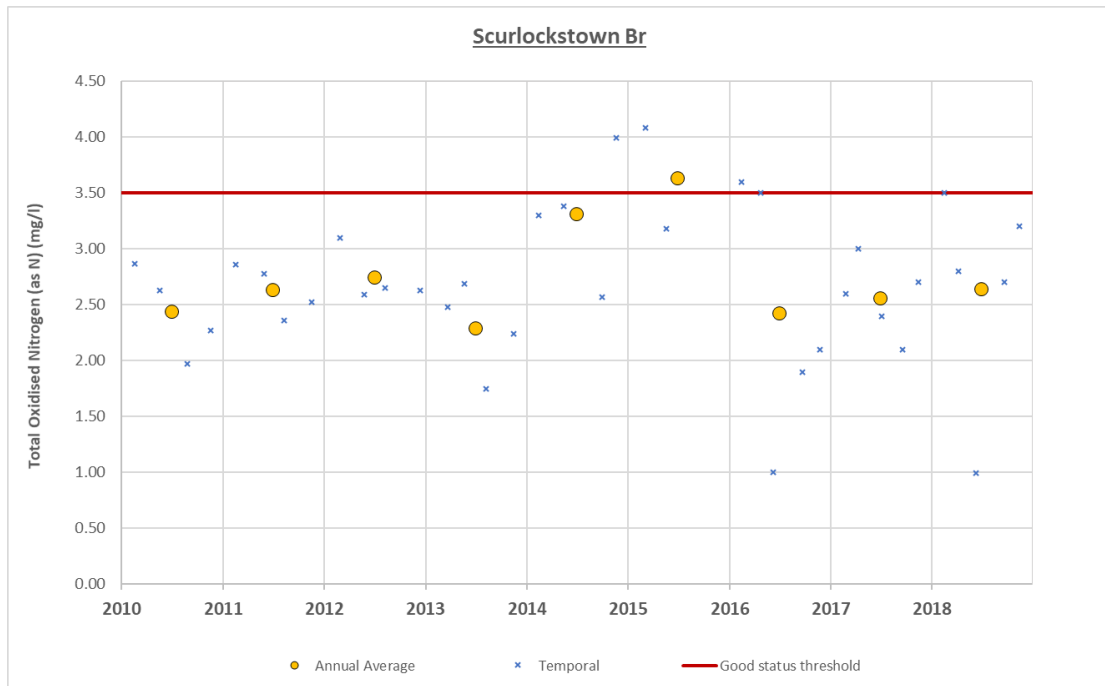
Figure 17 : TON at monitoring station for Boycetown_020
