Lower Nanny Priority Area for Action

Desk Study Assessment

AFA0125

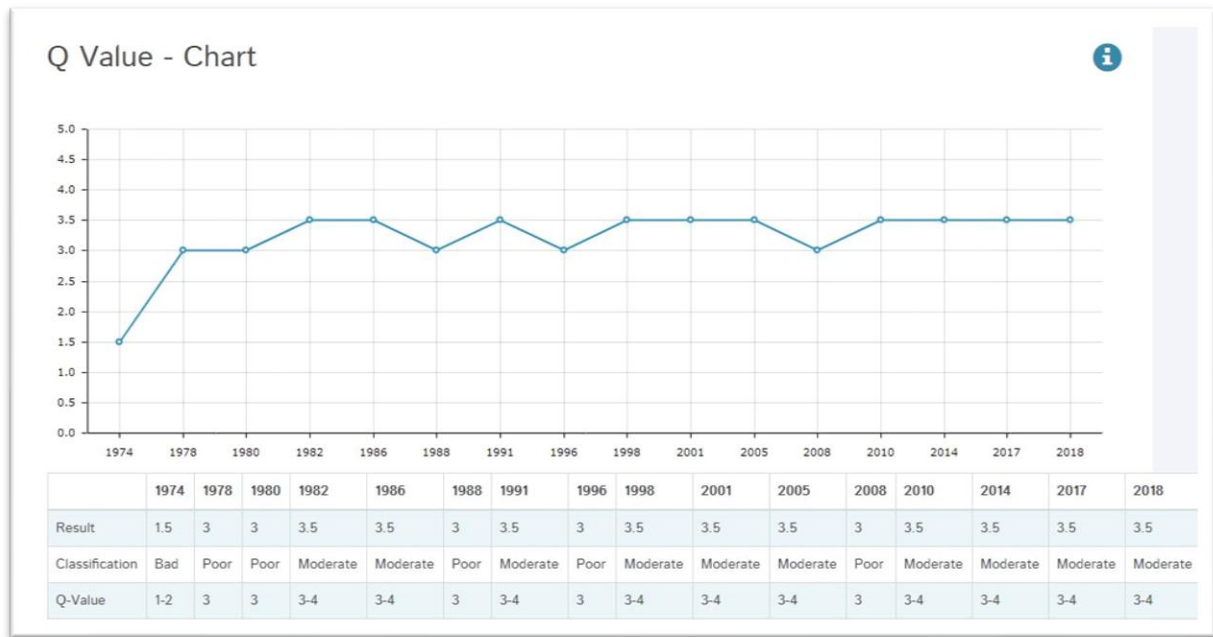
Nanny_040 (Figure 5) water quality has improved from bad (Q-value 1-2) in 1974 to fluctuating between poor and moderate q-values until 2010 where it has remained moderate (Q-value 3-4). Its

Figure 5 : Q-values in the Nanny_040.

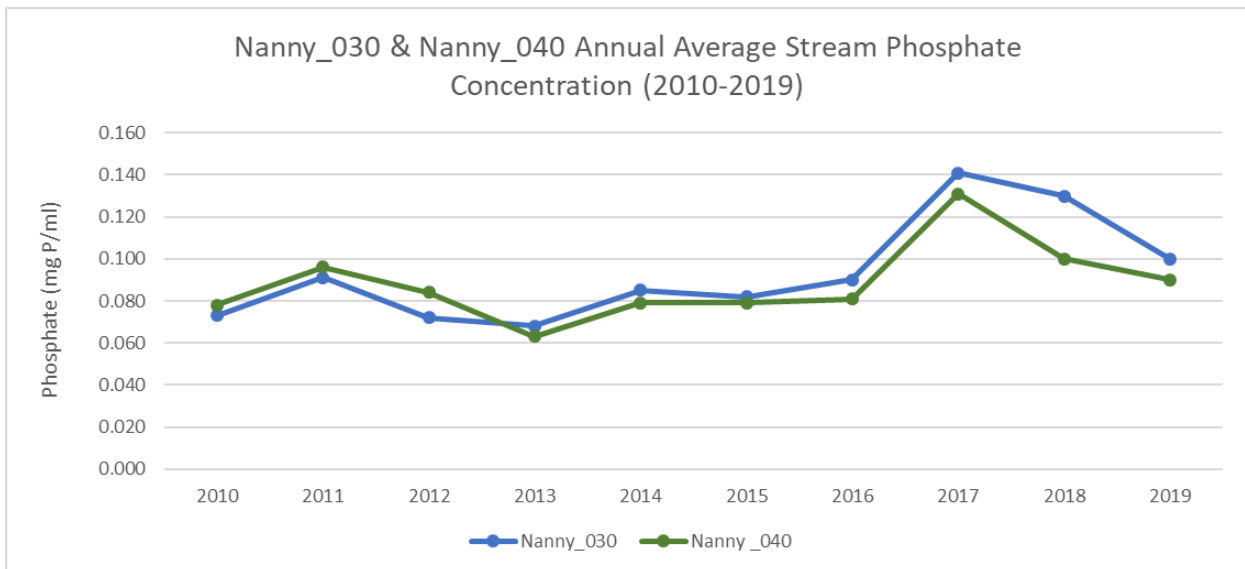
Figure 8 : Annual average phosphate concentrations in the Nanny_030 and Nanny_040 (2010-2019)

- Since 2013, the Nanny_040 phosphate concentrations have been lower than the Nanny_030 and the Nanny_040 is diluting the phosphate concentrations in the river. The average phosphate concentrations in the Nanny_050 have consistently been lower than the concentrations in the Nanny_040 (Figure 9). Therefore, there are none or low phosphate contributions occurring the Nanny_050 and the waterbody is having a diluting effect on the phosphate concentrations.

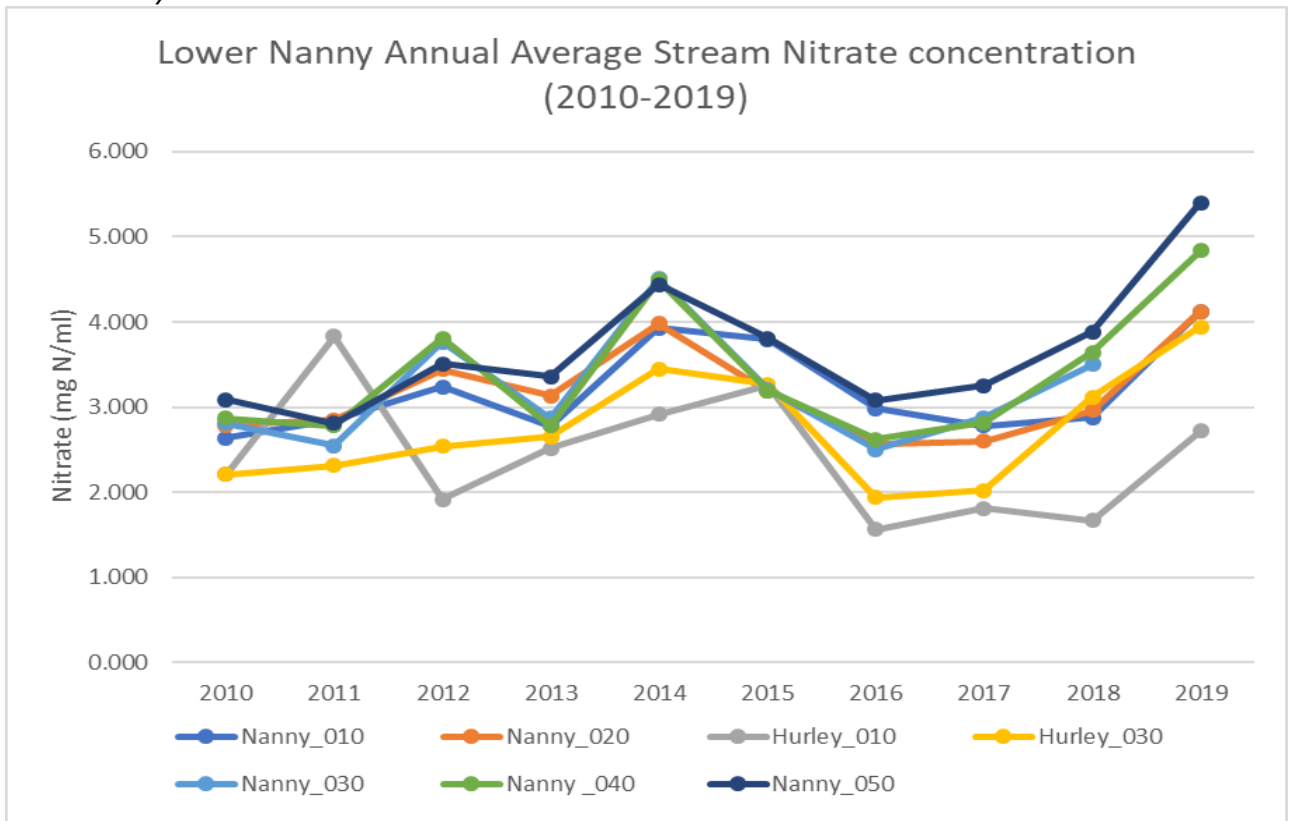
- The temporal patterns in the nitrate concentrations in the different waterbodies are similar (Figure 10). Overall, the Hurley_10 and Hurley_30 have the lowest annual average nitrate concentrations and the Nanny_040 and Nanny_050 have the highest.
- The temporal pattern in the Nanny_030 and Nanny_040 is very similar which indicates that the nitrate in the Nanny_040 is coming from upstream.
- In the Nanny_050 the nitrate concentrations are the highest in the river Nanny. This suggests that while there is nitrate entering the waterbody from the upstream waterbodies, there is also nitrate entering the river in this waterbody as well.

Figure 10 : Annual average nitrate concentrations in the river Nanny (2010-2019)

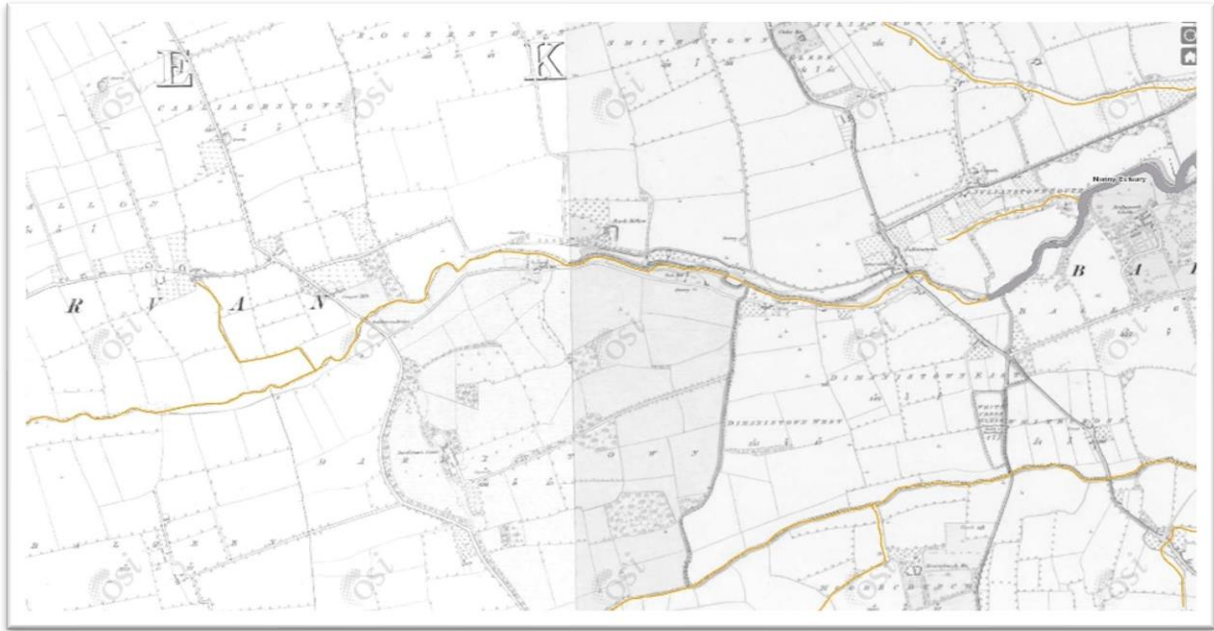
Figure 22 : Nanny_050 overlaid on OSI 6" map (1837-1842) (source Geohive)

Channelisation is identified as a significant pressure in both waterbodies in the Lower Nanny PAA. The historic maps show that the river's natural course has been altered nearly 200 years ago. The over straightening and deepening of a river can have a negative effect on the macro invertebrates, flow, and habitats. It can also accelerate sediment losses which can also impact on water quality. During the LCA an assessment will be made to establish if hydromorphology (channelisation) is a significant pressure in this PAA.
