AFA0113 Lough Ennell/Dysart Stream

Lough Ennell/Dysart Stream Area for Action

Desktop Assessment

AFA0113

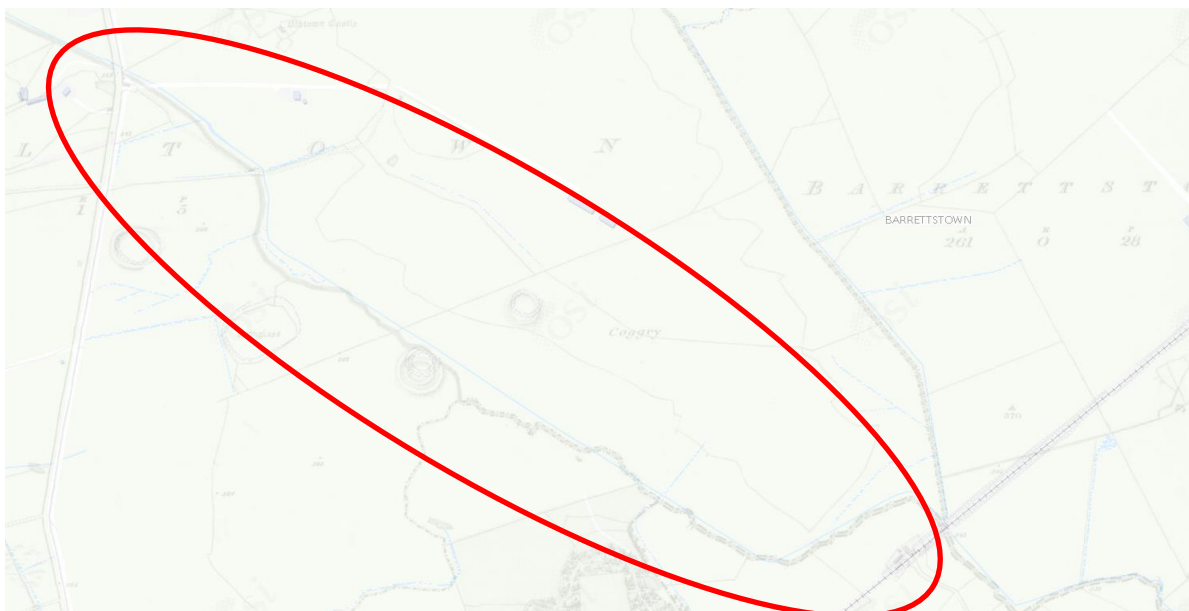
Figure 5 An example of historic drainage alterations in the Dysart_010 – channalisation.

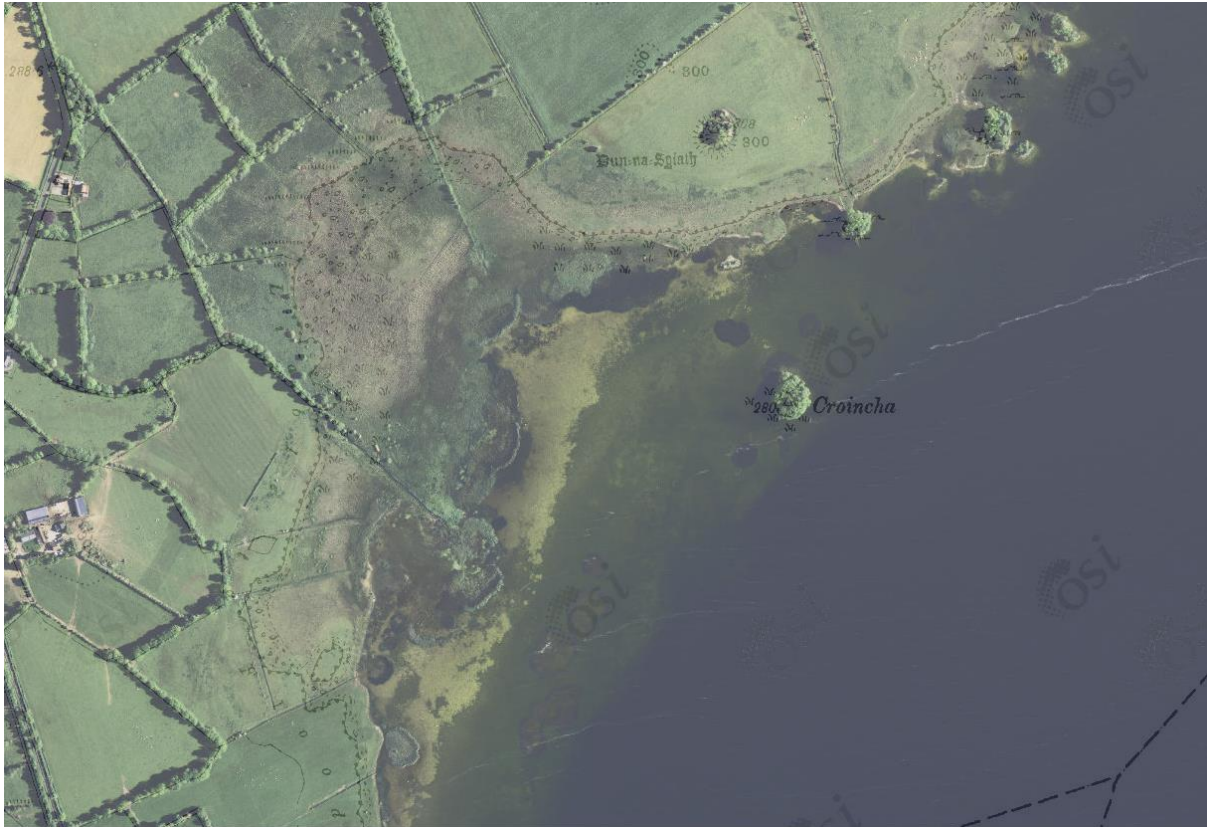
Figure 7 The changing shoreline of Lough Ennell
