Portarlinton Priority Area for Action

AFA0153

Desktop Assessment

29th January 2021

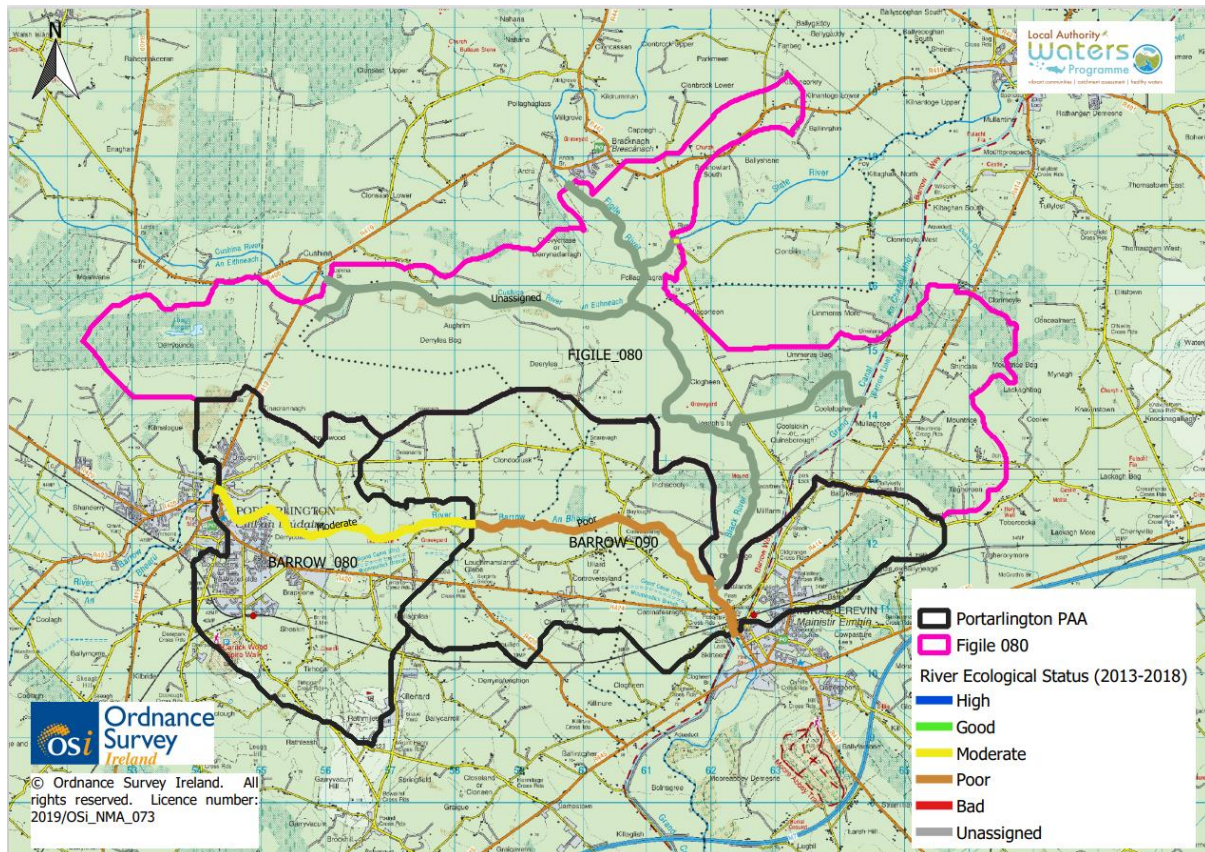
Figure 1: Location of the waterbodies within the Portarlinton PAA and their assigned Ecological Status (Inc. Figile_080).

Barrow_080 begins at Spa bridge in Portarlinton, it is 4.65km long, running through the town (**Figure 1**). A large section (approx. 70%) of this waterbody’s route is through land dominated by agriculture. This section of river then flows into the Barrow_090 at Lea, Co. Laois. The last EPA monitoring station on this waterbody is the Ford S of Trascaun. The Barrow_090 is 5.41km long, flowing mainly through agricultural land, until it reaches the monitoring point Pass Bridge on the outskirts of Monsterevin, Co. Kildare. There are two small pockets of privately-owned forestry adjacent to the waterbody along this stretch. There are additional Coillte and privately-owned forestry within the catchment, however, they are not located within close proximity of the waterbody. Peatlands are located within the catchment boundary although the waterbody does not flow directly through this land type. The land use/type is

shown in **Figure 2** below. The Figile_080 is an inputting waterbody into the Barrow_090, it is unassigned, and is not included within the PAA boundary. This waterbody enters just upstream of the EPA monitoring point Pass Bridge (**Figure 1**).

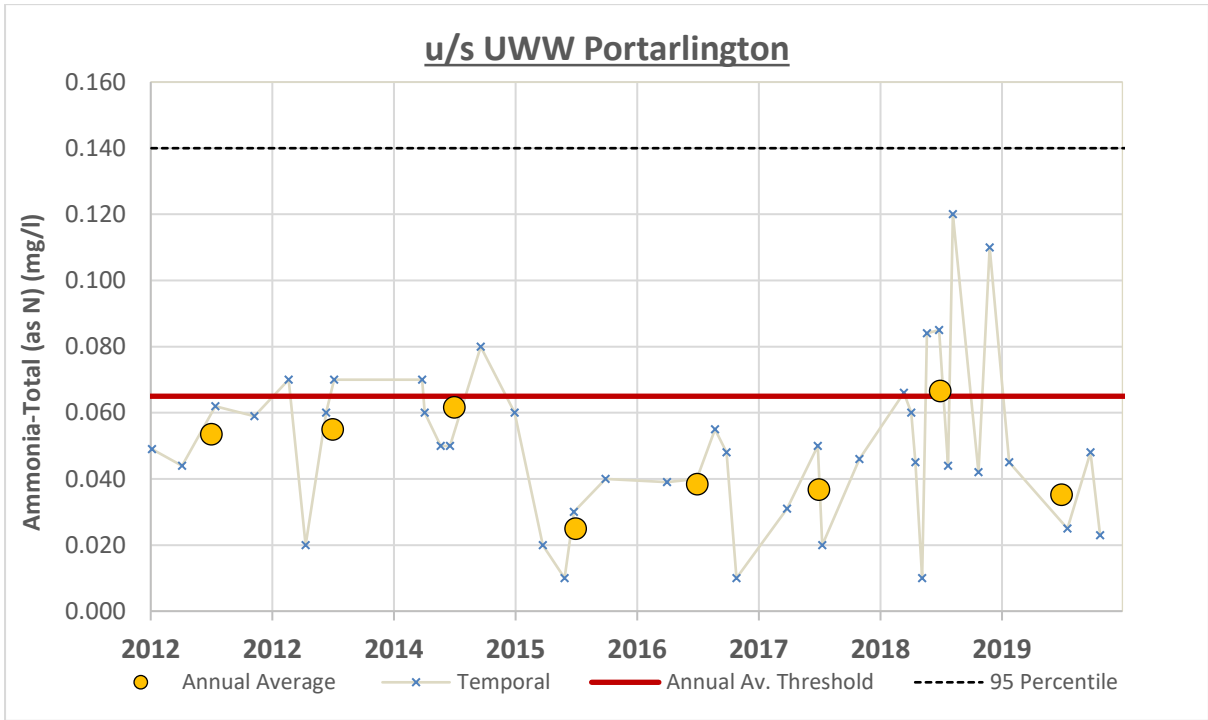
Figure 4: Ammonia concentrations between 2012 and 2019 at u/s UWW Portarlington

The ammonia levels at monitoring station u/s UWW Portarlinton showed 5 spikes above the mean EQS in 2018 as per **Figure 4** below. The exceedances varied between seasons, this suggests that the source may not be rain mobilised. Ammonia presence in the waterbody would indicate based upon the land use in the area a misconnection or an SWO. There were no exceedances in 2019.

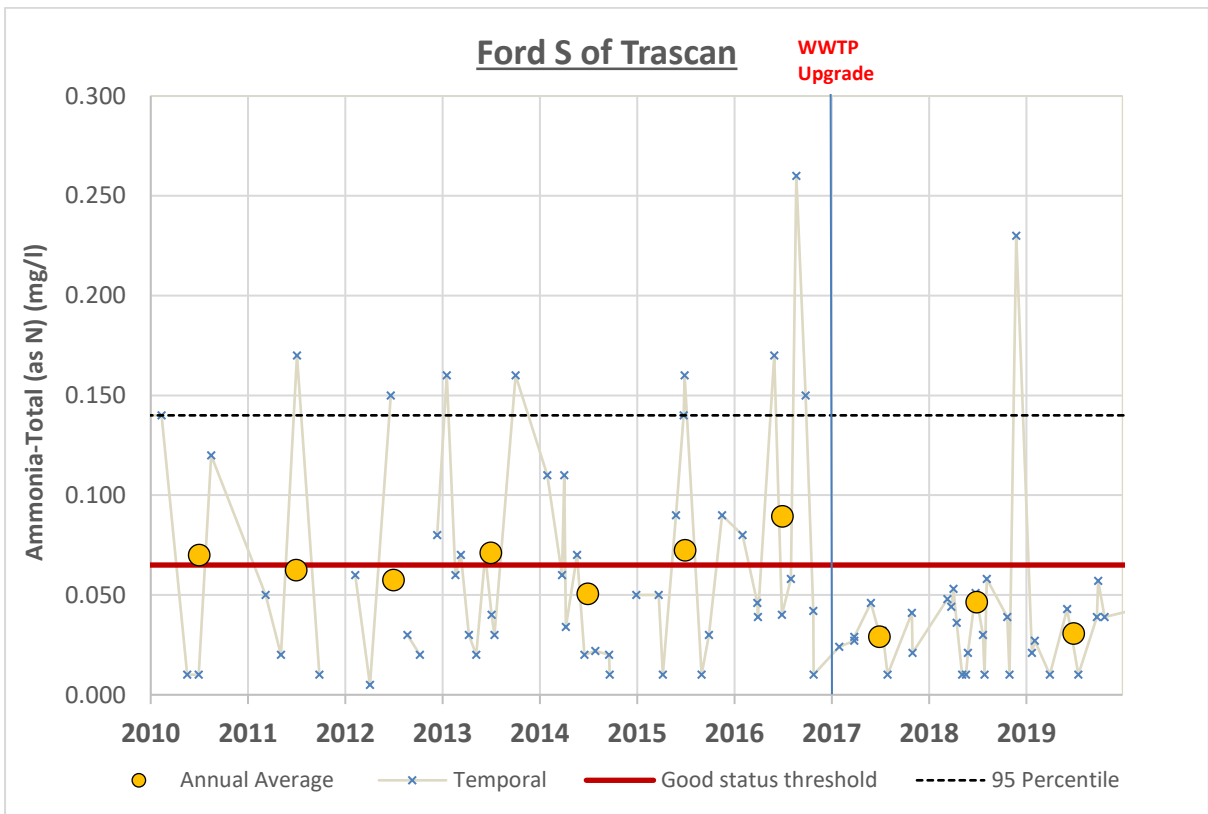
Figure 5: Ammonia concentrations between 2010 and 2019 at the Ford S of Trascan

The Ford S of Trascaan is the EPA monitoring station downstream of the Portarlinton WWTP. The raw data exceeded the mean EQS and 95%ile EQS on a regular basis up until 2017. There has been just one exceedance of the 95%ile in the raw data between 2017 and 2019 and this was recorded in November 2018. This represents a 2-fold exceedance of the 95%ile and a 3 and half fold exceedance of the annual average EQS. This can be seen as per **Figure 5** below. The Portarlinton WWTP underwent improvement works in 2017 and this reduction in exceedances may correlate with the upgrade works.

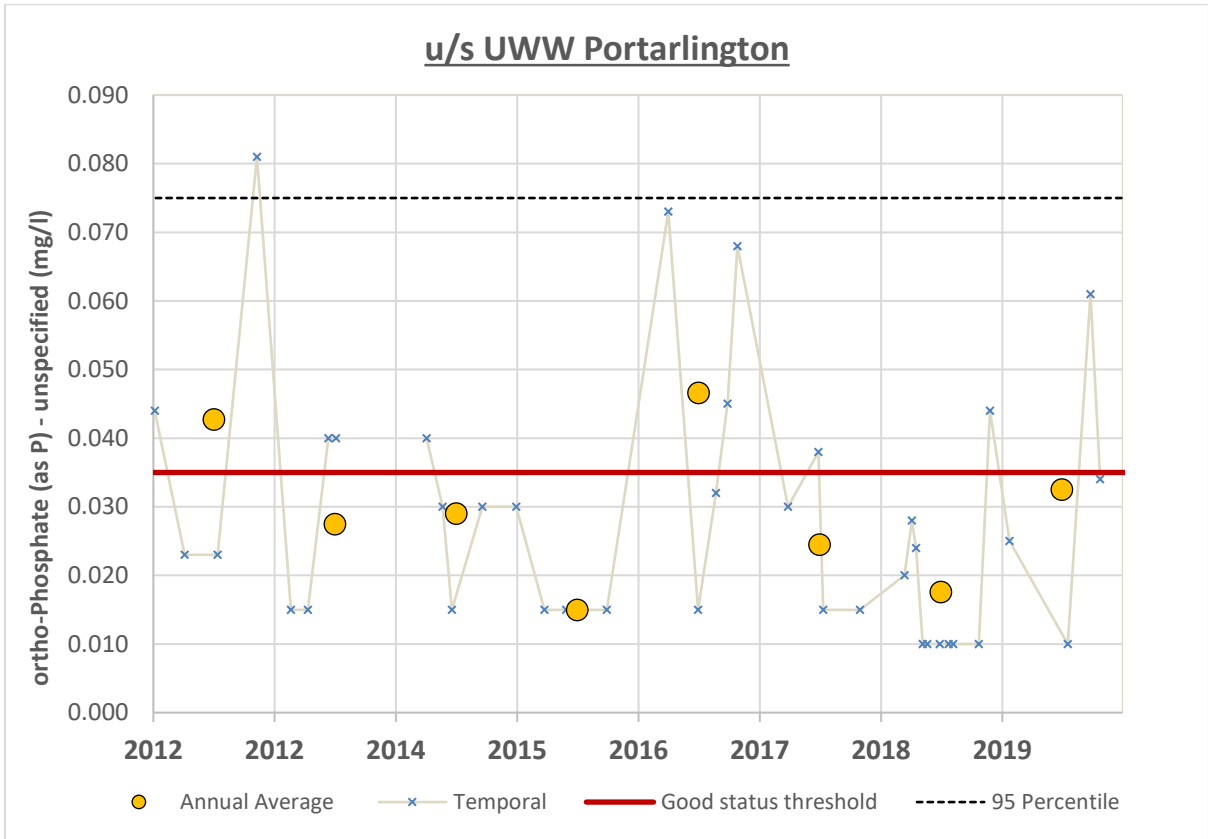
Figure 8: Ortho P concentrations u/s UWW Portarlington

Based on the annual averages Ortho P does not appear to be a significant issue u/s of the treatment plant as the mean EQS was exceeded just twice, in 2012 and 2016. However, although the annual averages are under the mean EQS (0.035mg/l), the raw data is showing an elevation above the mean EQS per year between 2017 and 2019. There is no correlation in the time of year in which exceedances occur. This would indicate there is a source of P entering the water column, however it may be coming from the Barrow_070 or alternatively there may be an additional source. The Barrow_070 cannot be compared with the Barrow_080 during this time period as the sampling dates do not correlate. However, the Barrow_070 raw data does show a number of exceedances of the mean EQS (0.035mg/l) between 2017 and 2019, the average ortho P concentration between this period on the Barrow_070 is 0.04mg/l. Therefore, it is evident the Barrow_070 is contributing a load of Ortho P to the Barrow_080.

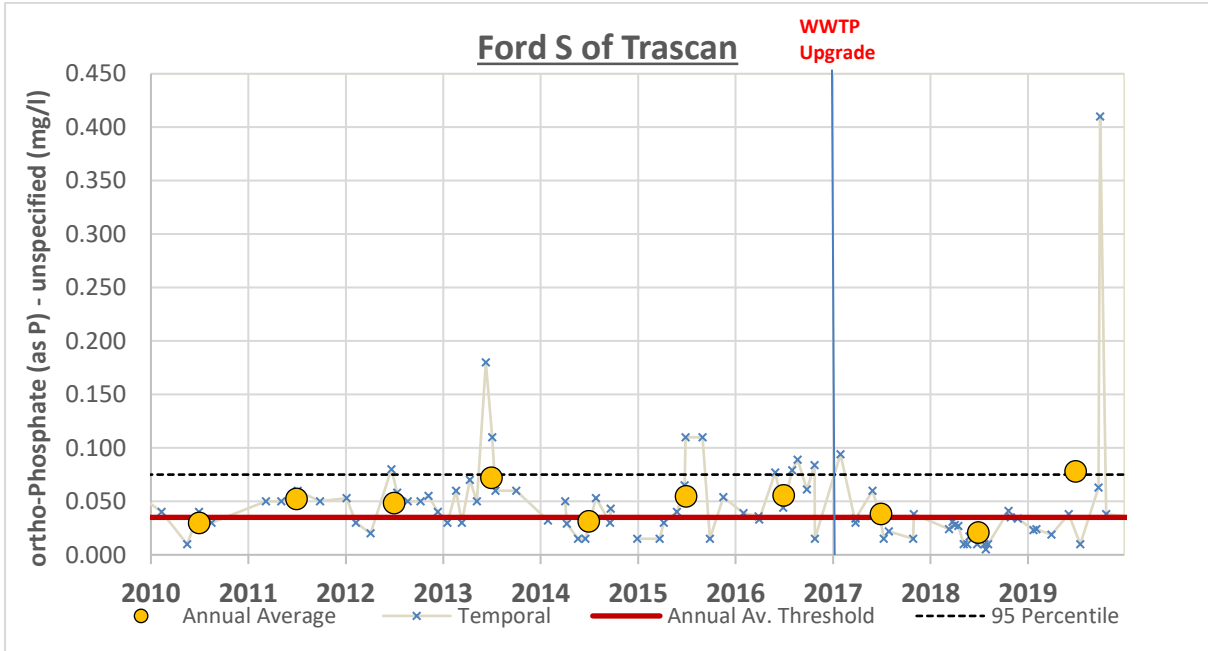
Figure 9: Ortho P concentrations at the Ford S of Trascan

Ortho P has been a consistent issue at the EPA monitoring station “Ford S of Trasca”, this station is located downstream of the Portarlinton WWTP’s discharge point. The Ortho P mean EQS of 0.035mg/l was exceeded regularly up until 2017. Between 2017 and 2019 the number of exceedances of the mean EQS did reduce, although there remained elevations in the raw data throughout the year. There were two exceedances of the 95%ile, one of which was in October 2019, the concentration recorded was over 5 times the 95%ile EQS. LAWPRO have made a request to IW for the WWTP discharge raw data.

The WWTP underwent upgrade works to the ferric dosing plant in 2017. Since the upgrades have been completed at the plant, there have been no exceedances of the annual averages of Ortho P. However, it was noted the raw data for this monitoring location between 2018 and 2019 did show 5 exceedances of Ortho P, indicating there is a source of ortho P present, whether it is from the plant or upstream is unknown as the sampling dates do not coincide between both locations.

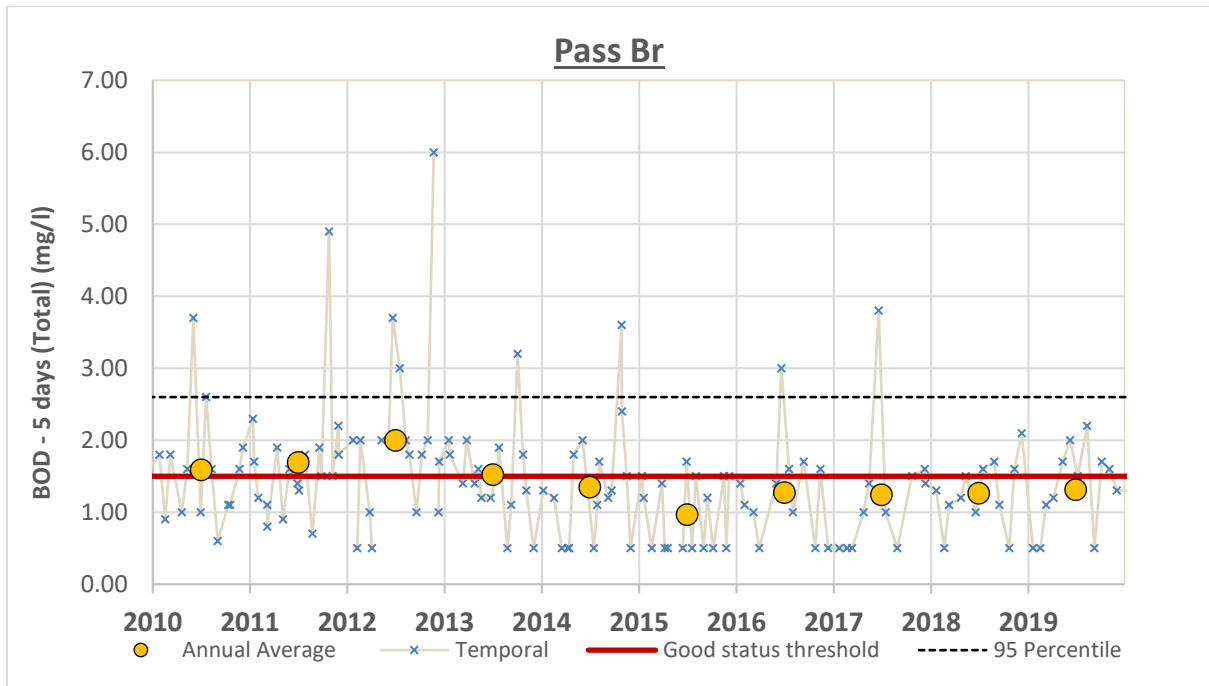
Figure 10: BOD concentrations at Pass bridge between 2010 and 2019

As per **Figure 10** the data states that although the annual averages are not exceeding the mean EQS in 2018 and 2019 there are a number of occurrences throughout these monitoring years when the individual events exceeded the EQS (1.5mg/l) on a regular basis. However, it has been noted there were no exceedances of the 95%ile in 2018 or 2019.

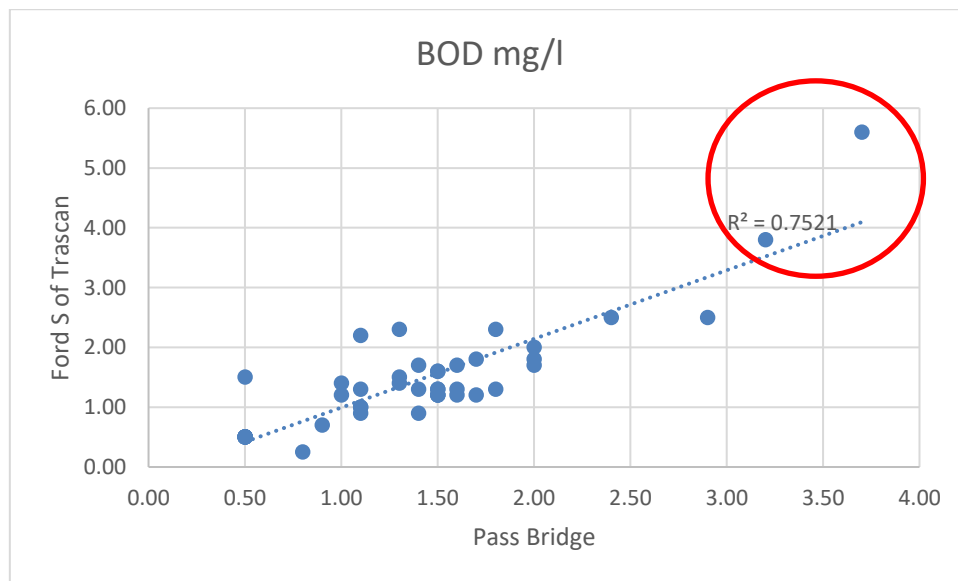
Figure 11: Ford S of Trascan & Pass bridge BOD concentrations (2007-2016 data)

There is a strong correlation in the BOD concentrations between EPA monitoring stations the Ford S of Trascaan and Pass Bridge as the R^2 value was 0.7572 (**Figure 10**). This correlation means when BOD is high at one monitoring point it is also high at the other. Based on the two highest correlations in **Figure 11** below highlighted in red shows the BOD peak upstream is causing a downstream peak. There is a reduction downstream on both sampling events, however, this is likely due to dilution.

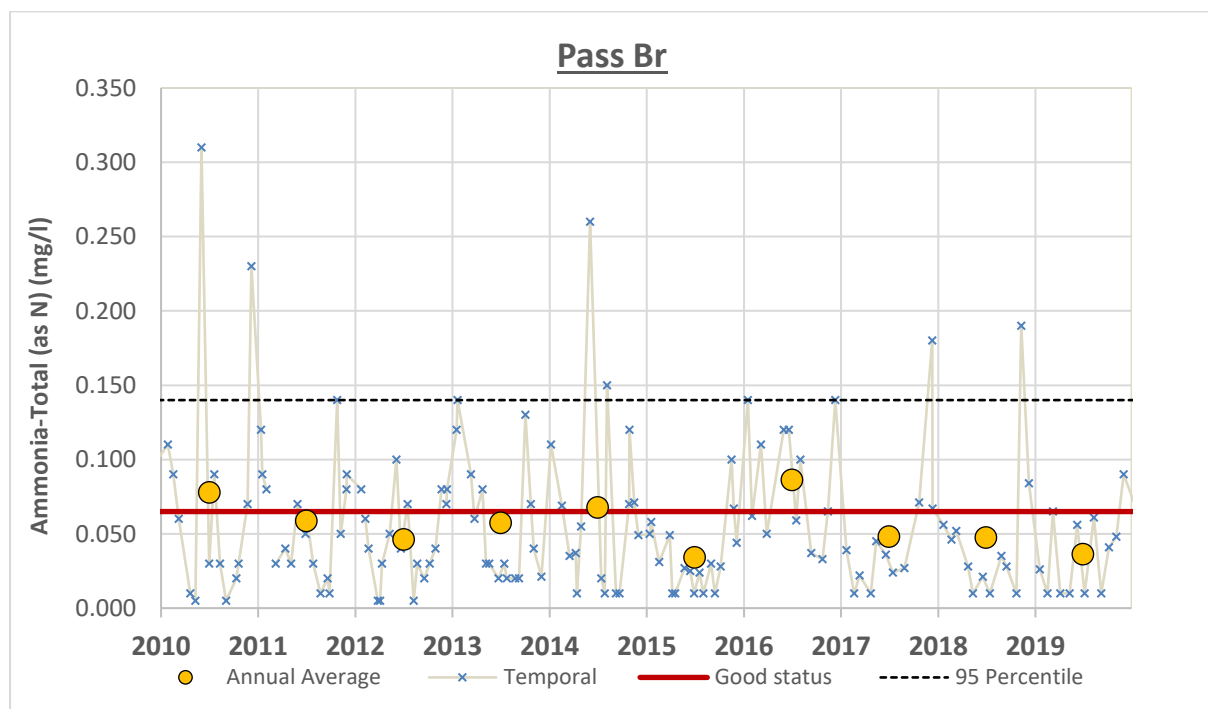
Figure 12: Ammonia concentrations at Pass bridge between 2010 and 2019

The ammonia temporal data for Pass bridge is largely compliant, with 4 exceedances of the mean EQS and 2 breaches of the 95th EQS between 2017 and 2019 (**Figure 12**). All exceedances occurred between October and December therefore suggesting there may be an association with heavy rainfall events. However, the rainfall data was assessed, and a strong correlation was not identified between ammonia concentrations and the rainfall data from Lullymore Nature Centre weather station, Co.

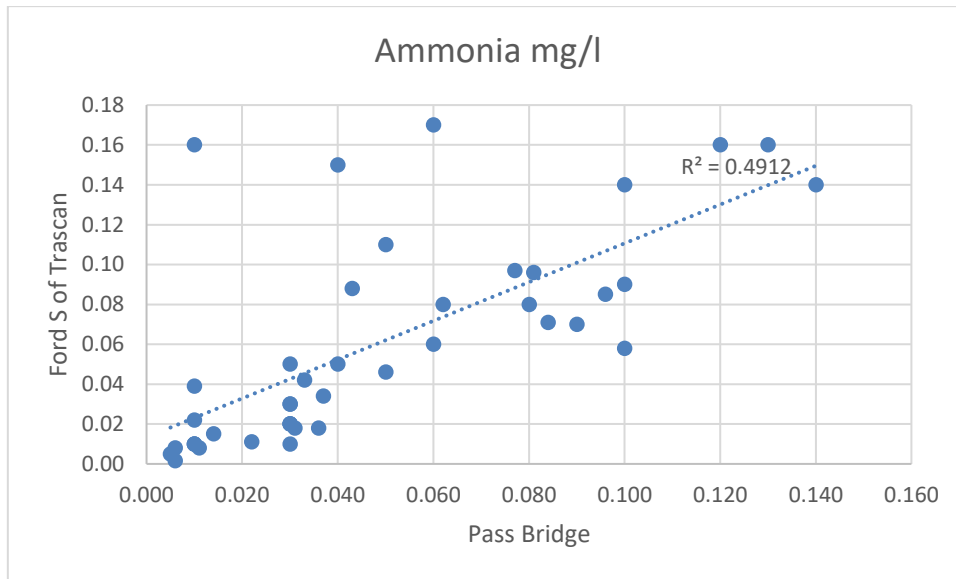
Figure 13: Ford S of Trascaan & Pass bridge Ammonia concentrations (2007-2016 data)

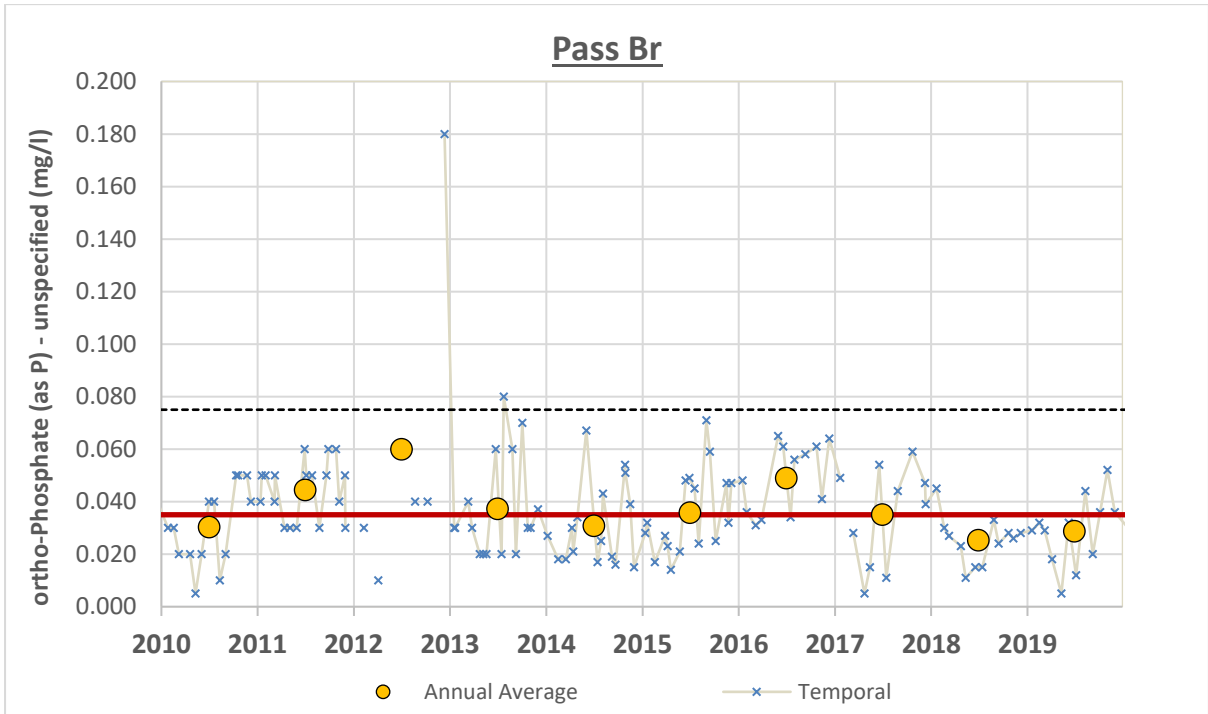
Figure 14: Ortho P concentrations at Pass bridge between 2010 and 2019

Ortho P shows elevations above the mean EQS in 2017, the individual sampling events were compliant throughout 2018, increasing above the mean EQS (0.035mg/l) again in the later part of 2019, as per **Figure 14** below. Again, it must be noted **Figure 15** displays data between Ford S of Trascaan and Pass bridge between 2007 and 2016 as the sampling days correlated, there was a change to the monitoring programmes in 2017 and onwards, therefore not allowing for comparison post 2016. There were two sampling events as per **Figure 15** which showed a correlation between both points. As this graph is based on data pre Portarlinton WWTP upgrade works, there may be a further decline in comparison between both sites in future. The increasing trend noted in 2019 will require field assessment, it may be linked to the Barrow_080 or potentially the Figile_080 which there is no data for.

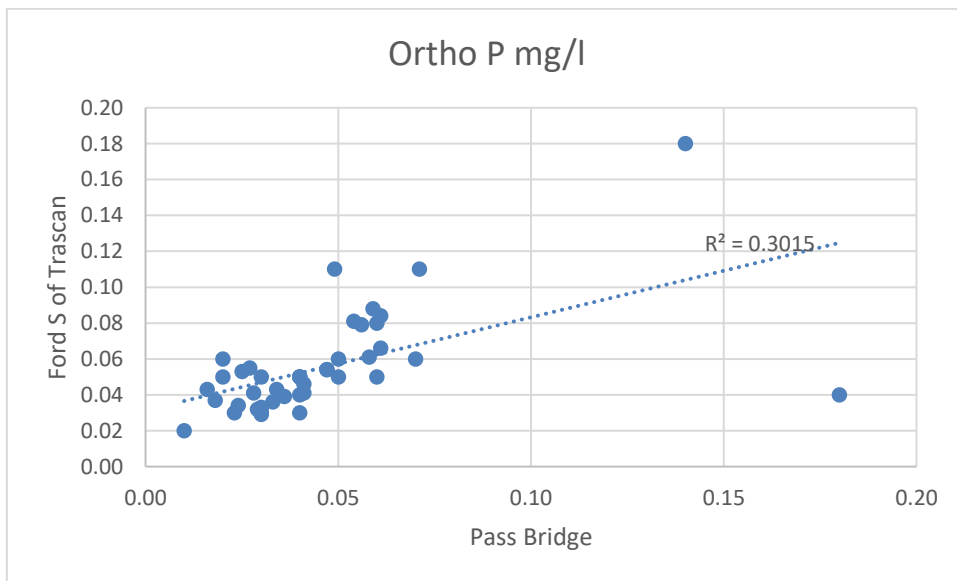
Figure 15: Ford S of Trascaan & Pass bridge Ortho P concentrations (2007-2016 data)

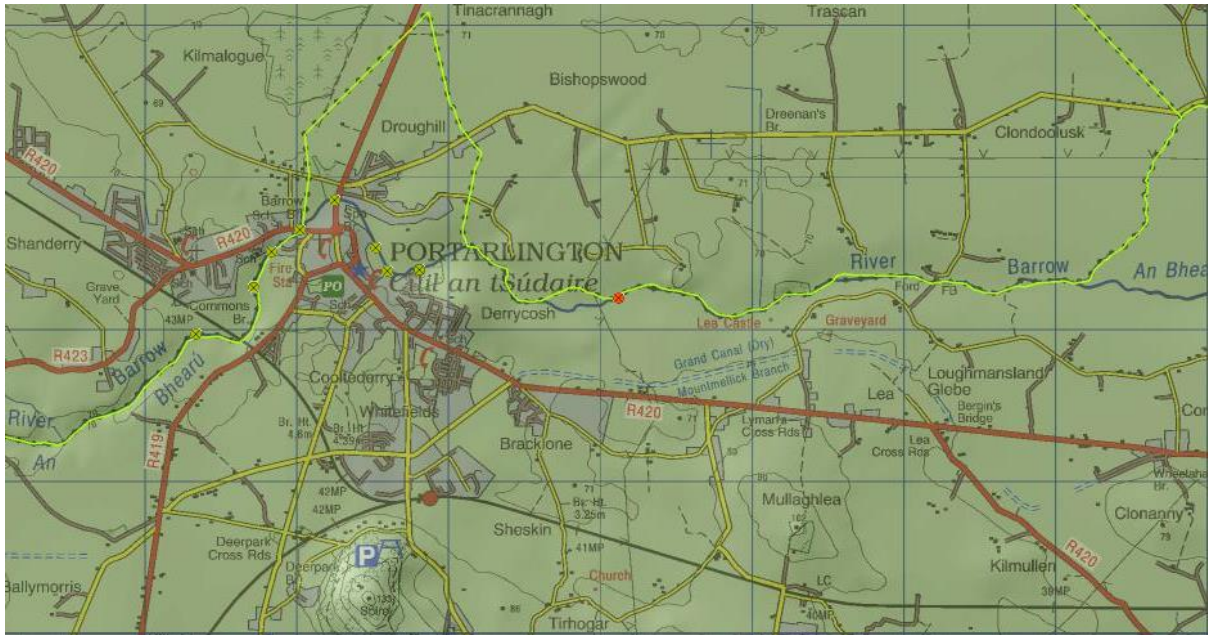
Figure 16: Map identifying the Storm Water Overflows (SWO's) throughout the Portarlington Urban area

There are eight storm water overflows throughout Portarlinton town, five are located along the Barrow_070 just before flowing into the Barrow_080. There are 6 SWO’s located above the upstream monitoring location u/s UWW Portarlinton and 2 downstream. These may be having a potential impact on the water quality during heavy rainfall events. There are 3 pumping stations within the town, one at Barrow bridge, one in the town square and the 3rd at Portarlinton Leisure Centre, all pumping stations are alarmed and have emergency overflows. The pumping stations have approximately 2-3 hours storage before the emergency overflow is activated. The storm water overflows (SWOs) are not alarmed or flow monitored, these discharge to the receiving waters in high rainfall events. These discharges will be assessed during the LCA in dry and wet conditions.

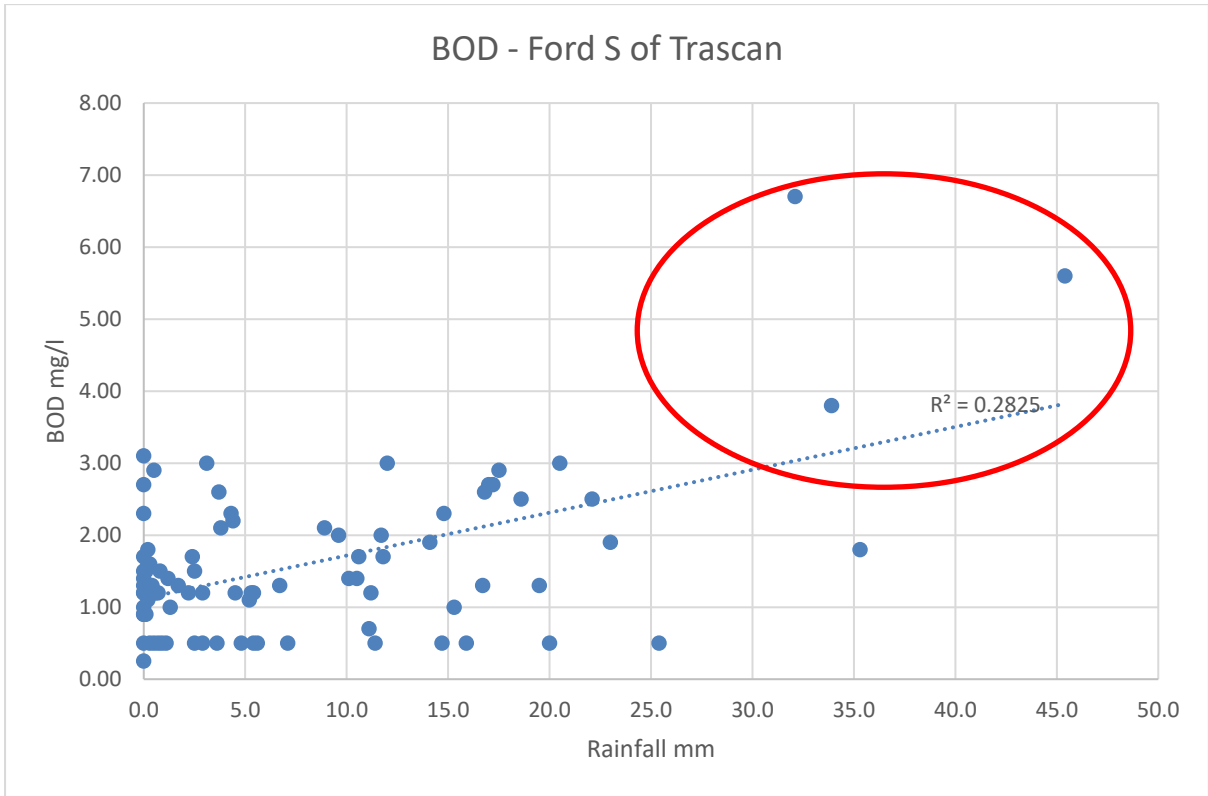
Figure 17: Correlation between rainfall data and BOD

The rainfall data was taken from the Met Eireann station in Clonslee. An accumulation of the rainfall data for two days prior to sampling was used. Rainfall data was compared to concentrations of BOD, ammonia and Ortho P to determine if a correlation was present. The R^2 value for all three parameters at both locations were below 0.5 and therefore there was not a strong correlation. However, there were a few sampling occasions at the Ford S of Trascaan where the elevation in BOD and Ammonia spiked at the same time as high rainfall. This would indicate that high rainfall events can result in impacts on water quality. As per **Figure 17** and **18** below there are three monitoring events in which the BOD and ammonia were elevated along with high rainfall. Samples were not taken u/s on these dates; therefore, it is unknown whether there was a spike u/s also. As there are a limited number of samples taken per year upstream approx. 4/5 there may be correlations, however, timing of sampling is not aligning or alternatively there may be an additional source for example misconnections.

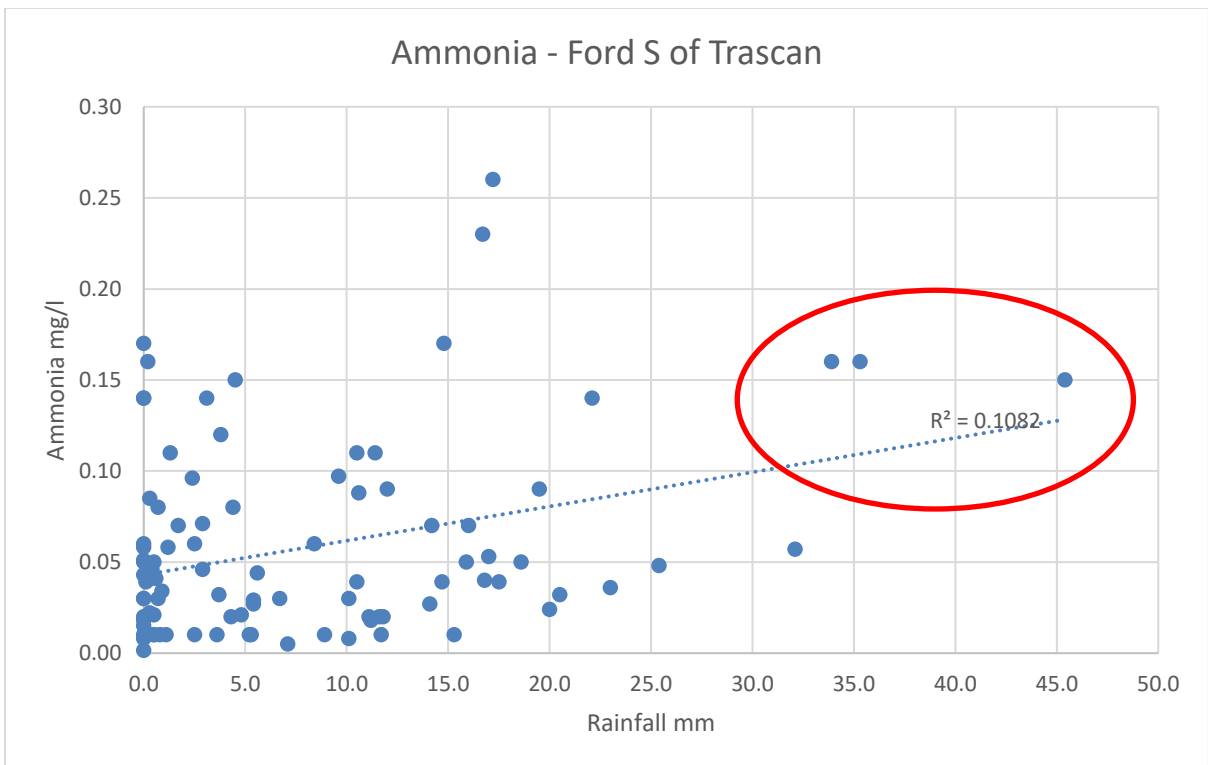
Figure 18: Correlation between rainfall data and ammonia

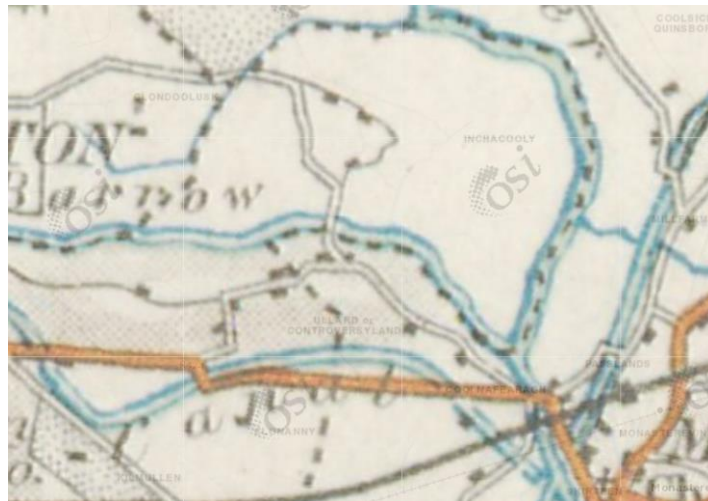
Figure 19: Historic 6 inch maps (1837-1842)

Hydromorphology (Channelisation) has been listed as the significant pressure along the Barrow_090. This waterbody was meeting Good ecological status between 2010 and 2012, this would indicate the deterioration or impacts on the waterbody arose between 2013 and 2015. As hydromorphology was selected as the main pressure it would be expected that some changes to the waterbody occurred during this timeframe (2013-2015). The historic maps below have identified that there have been no significant changes to the channel dating back to 1837 (**Figure 19, 20, 21**). This would therefore indicate channelisation may not be having a significant impact on the waterbody. The presence/absence of hydromorphological pressures will require verification in the field. However, based on review there seems to be no significant changes, this would indicate there may be an additional pressure, which will be considered during field assessment.

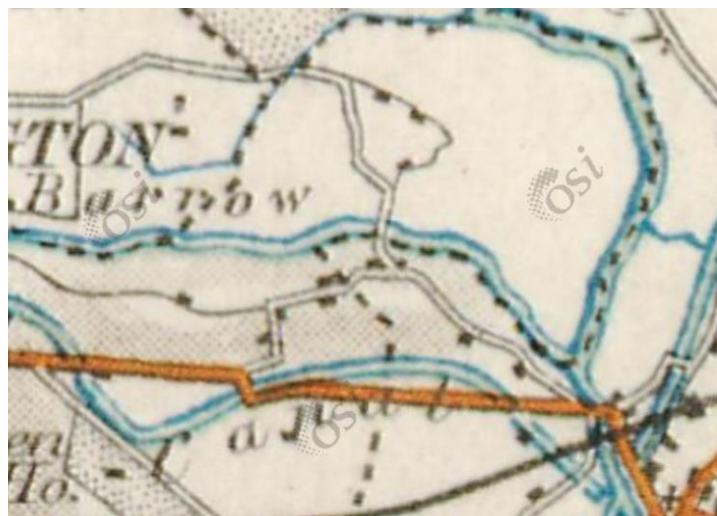
Figure 20: Historic 25 inch Map (1888-1913)
