# Adrigole Priority Area for Action Desk Study AFA001 South West Region

Adrigole Priority Area for Action Desk Study

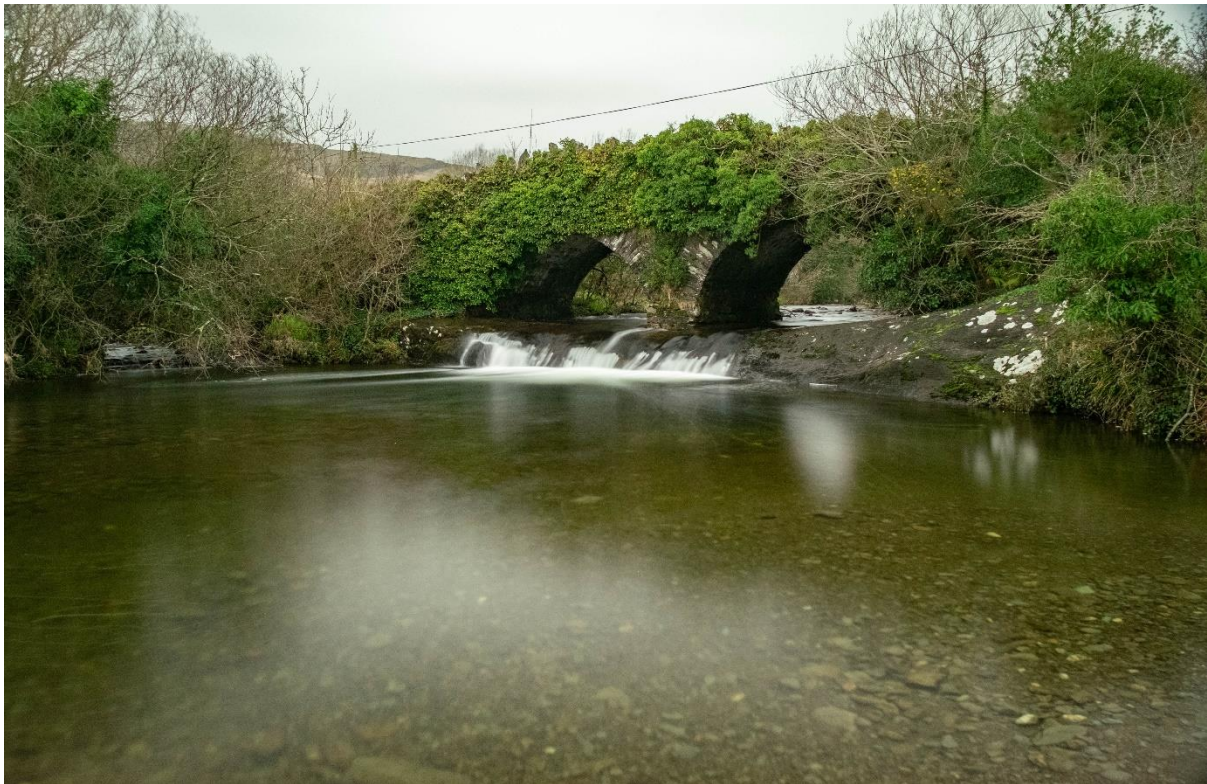
Inchintaglin Bridge Adrigole\_010 taken on 13/02/2019

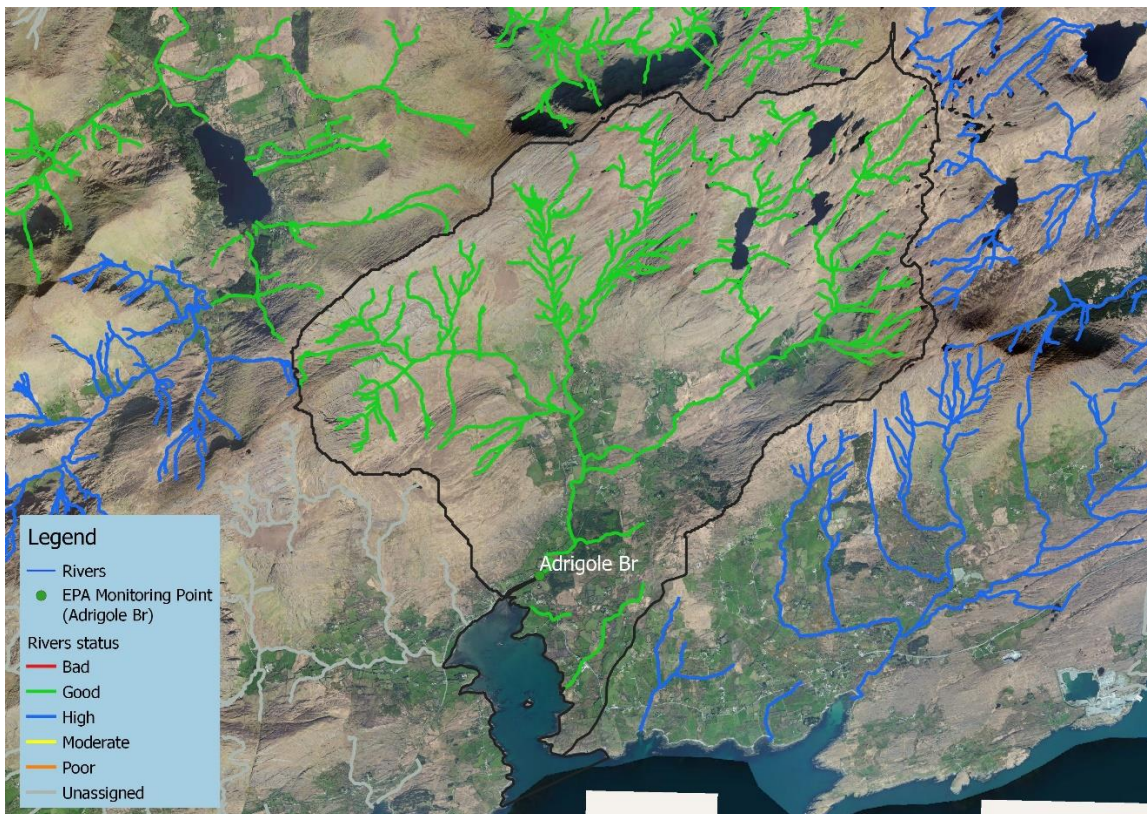
Fig. 1 Aerial image of Adrigole PAA showing EPA monitoring point and river status

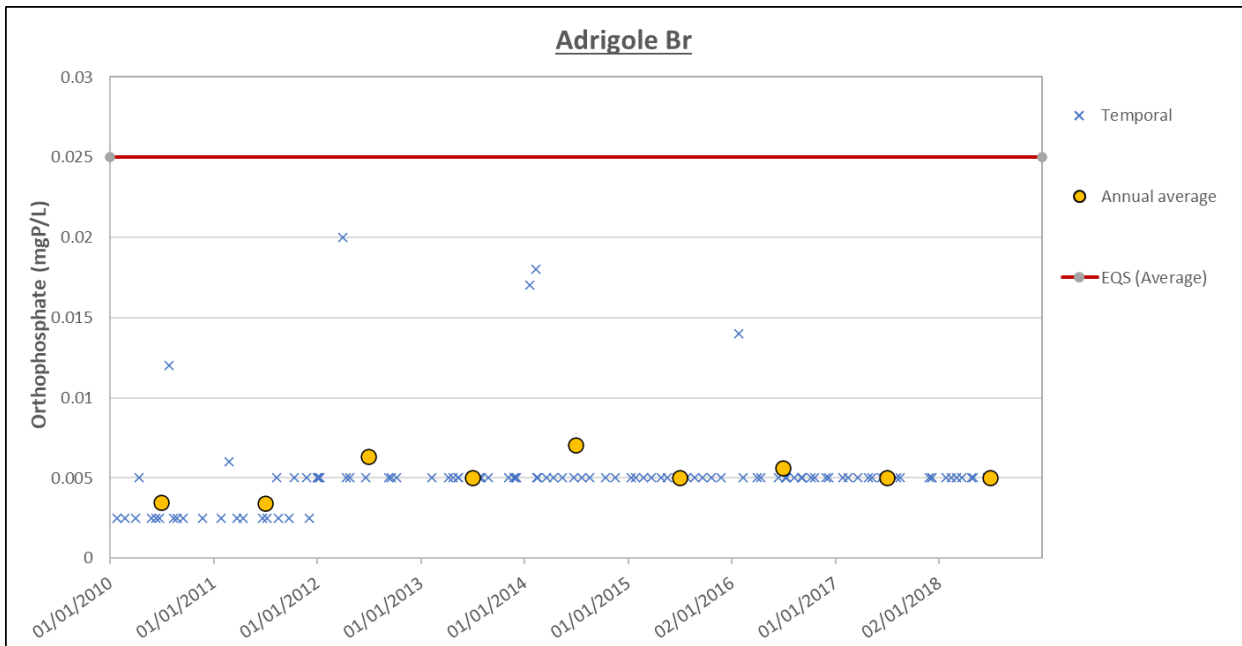
Fig. 3 Phosphate (mg/l-P) at Adrigole Br

Chemical monitoring results for phosphate (Fig. 3), Ammonium (Fig. 4), T.O.N. (Fig. 5) and B.O.D. (Fig. 6) are shown below. All nutrient parameters are generally well below EQS levels particularly in recent years. While average B.O.D. does not exceed the EQS there are some notable spikes which reflect organic impact potentially from agricultural activities.

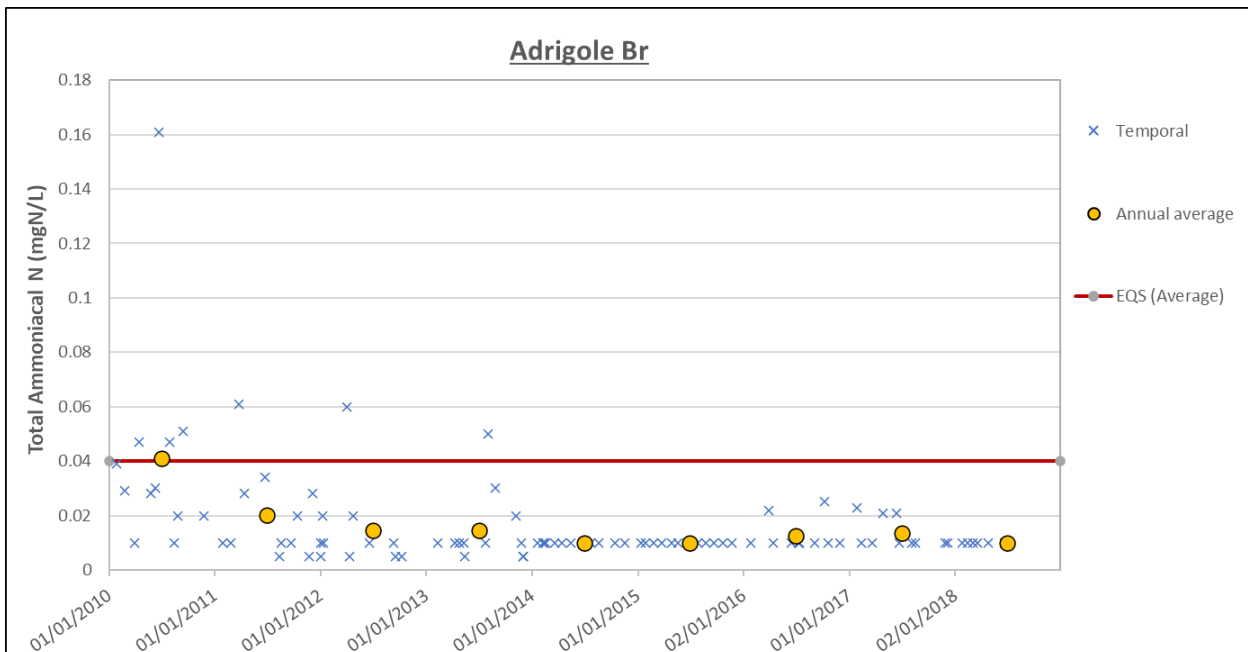
Fig. 4 Ammonium (mg/L-N) Adrigole Br

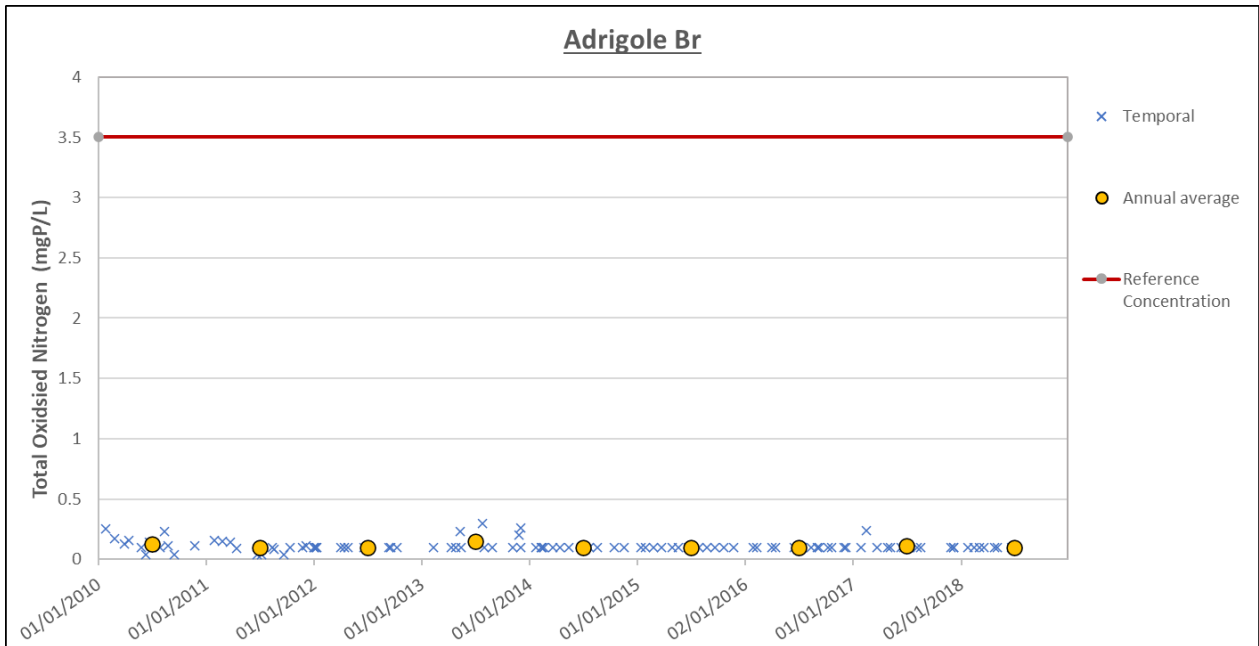
Fig. 5 TON (mg/l-N) at Adrigole Br

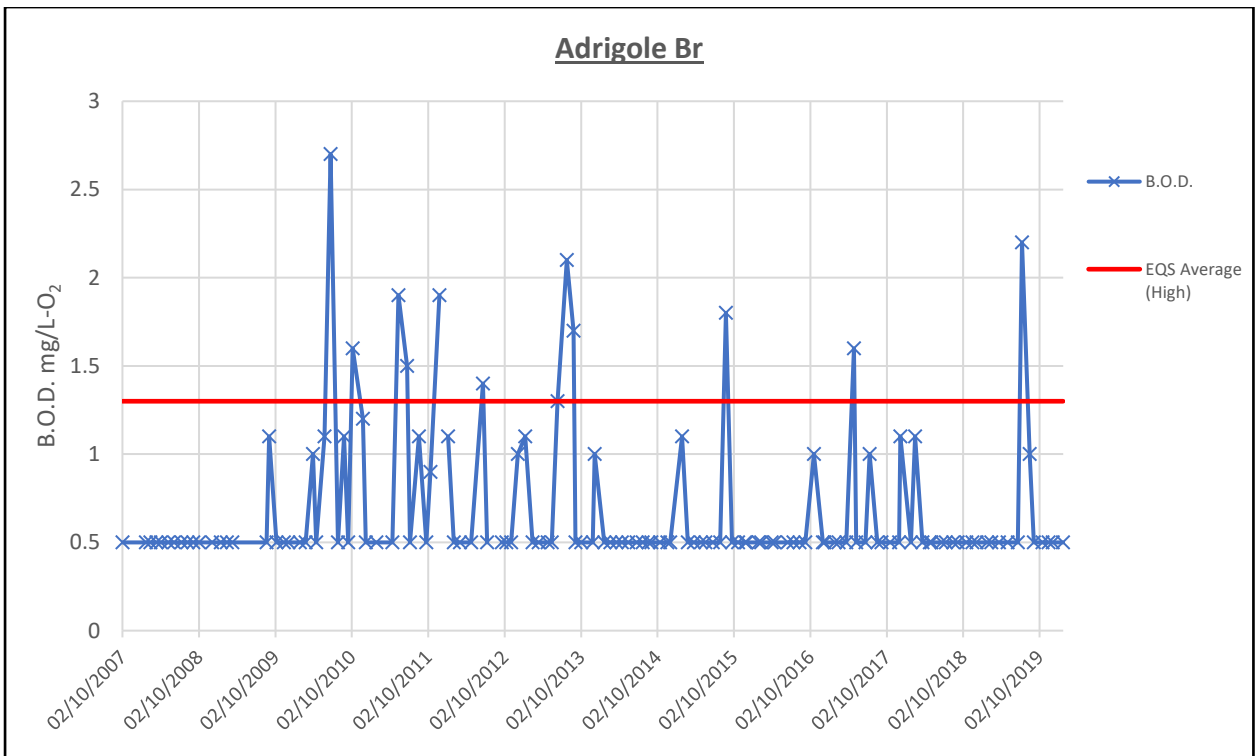
Fig. 6 Biological Oxygen Demand (mg/l-O2) at Adrigole Br

The biological status at Adrigole Br had remained high (Q4/5) since monitoring began in 1990 until it deteriorated to good between 2010 and 2012 and where it has remained since. This was initially driven by fish status with invertebrate status remaining high but falling to good between 2012 and 2015 where it has remained since. Clear felling of forestry is the only suspected significant pressure listed and while there is a relatively small amount of forestry within the catchment, the bulk of this is just upstream of the monitoring point (Fig. 7). All nutrient parameters appear to be relatively low although there are some minor spikes in B.O.D. (**Error! Reference source not found.**).
