Farahy  
Priority Area for Action Desk Study  
AFA 0077  
South-West Region

Farahy Priority Area for Action Desk Study

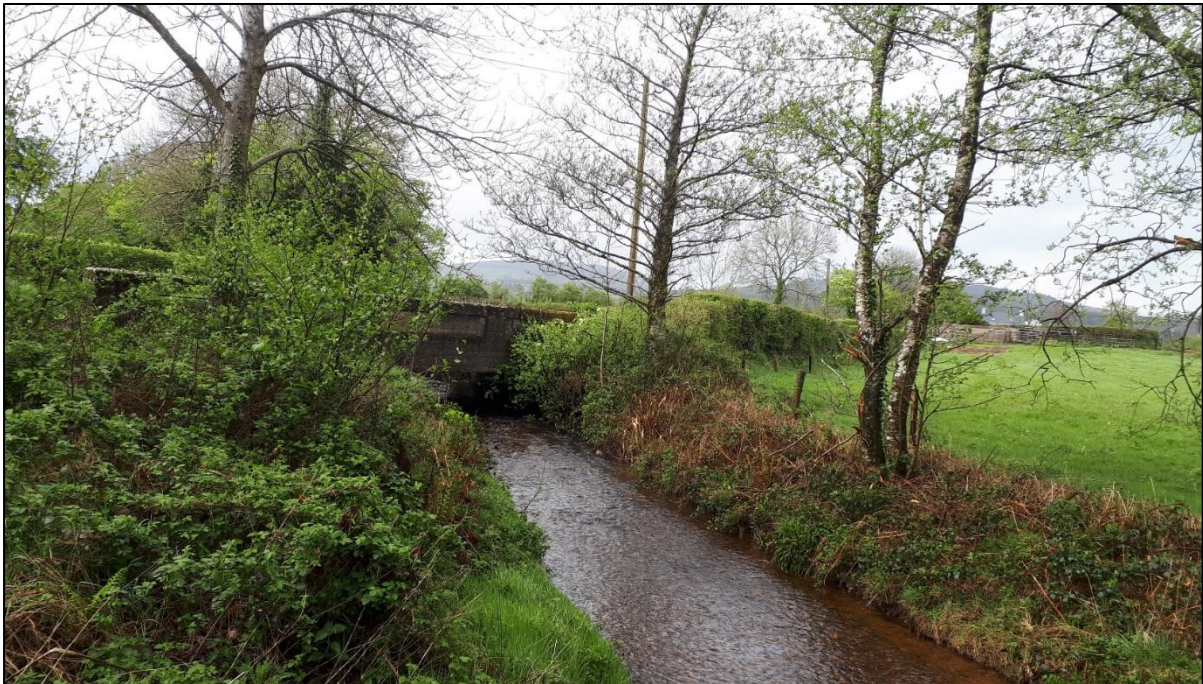
*Photograph of the WFD operational monitoring point at the Bridge Ballyshonock, taken on 26<sup>th</sup> of April 2019*

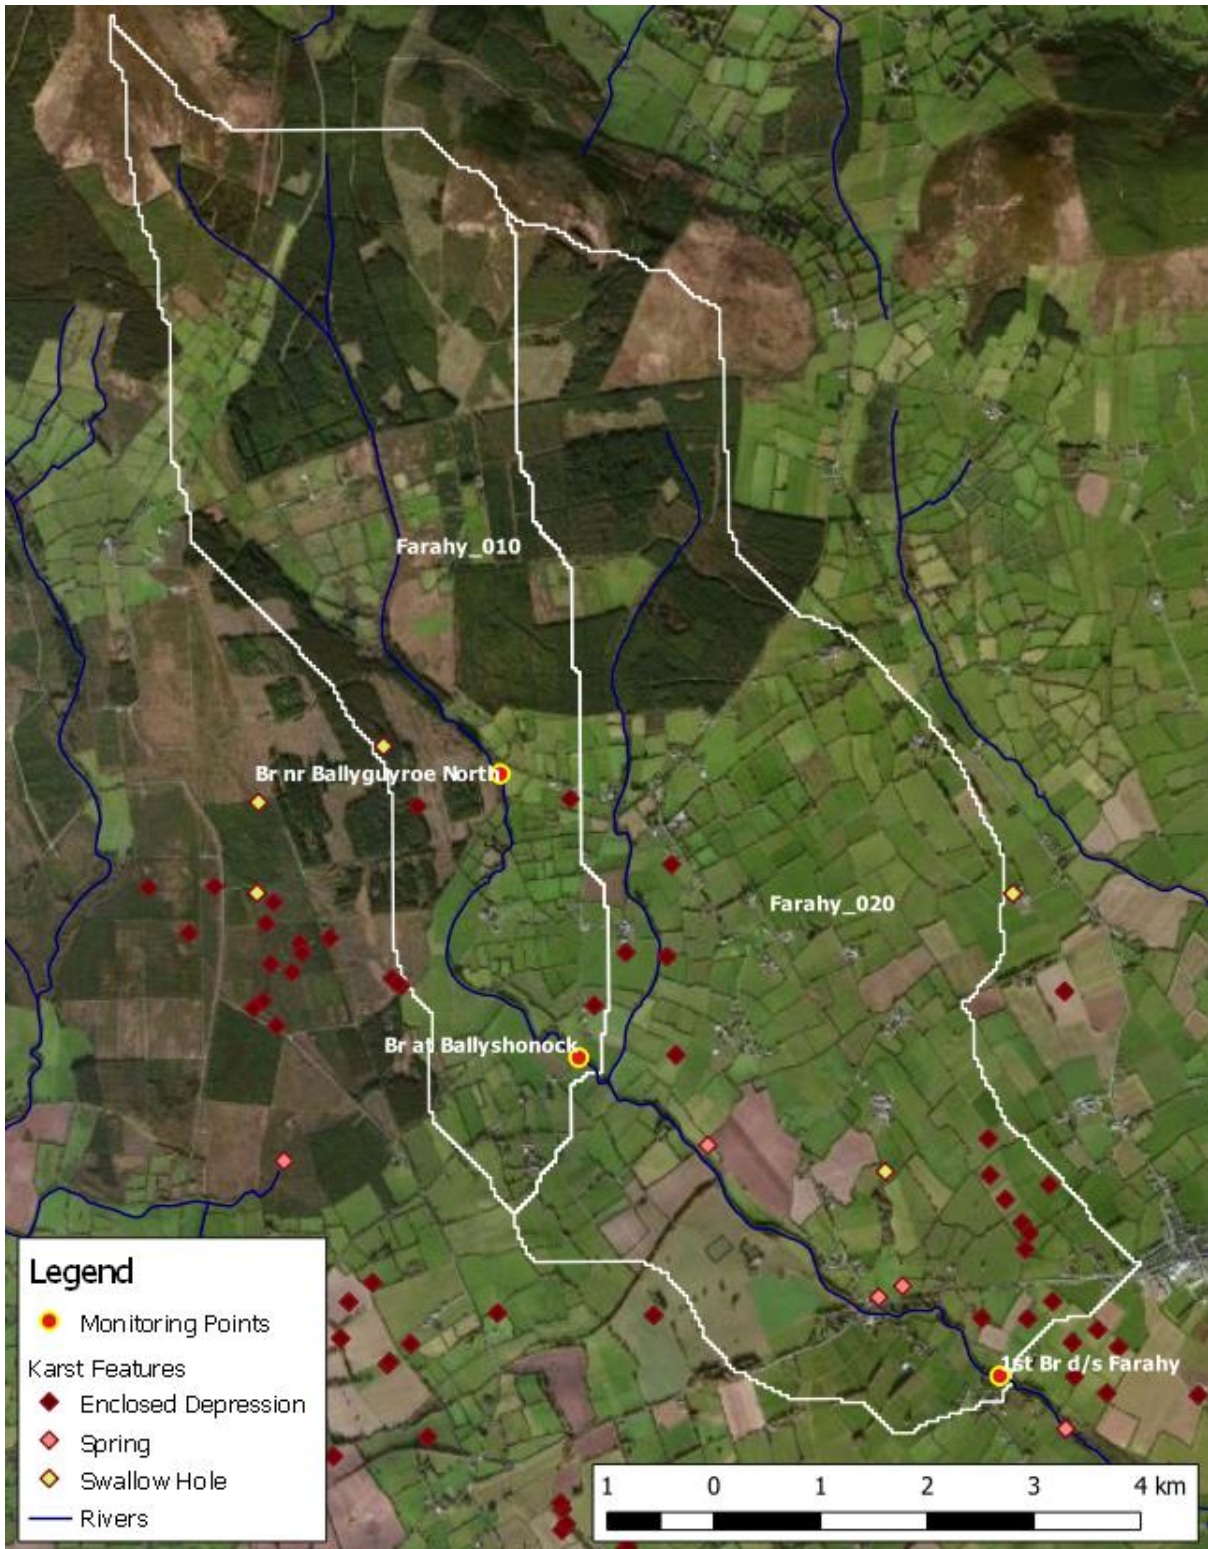
Figure 1-1: Farahy Waterbodies

A map of the Farahy waterbodies is presented in figure 1.1 below:

Table 1.2 outlines summary status and pressure information on each waterbody. Details of monitoring points on each waterbody are provided in table 1.3 and shown on the map in figure 1.1 above.

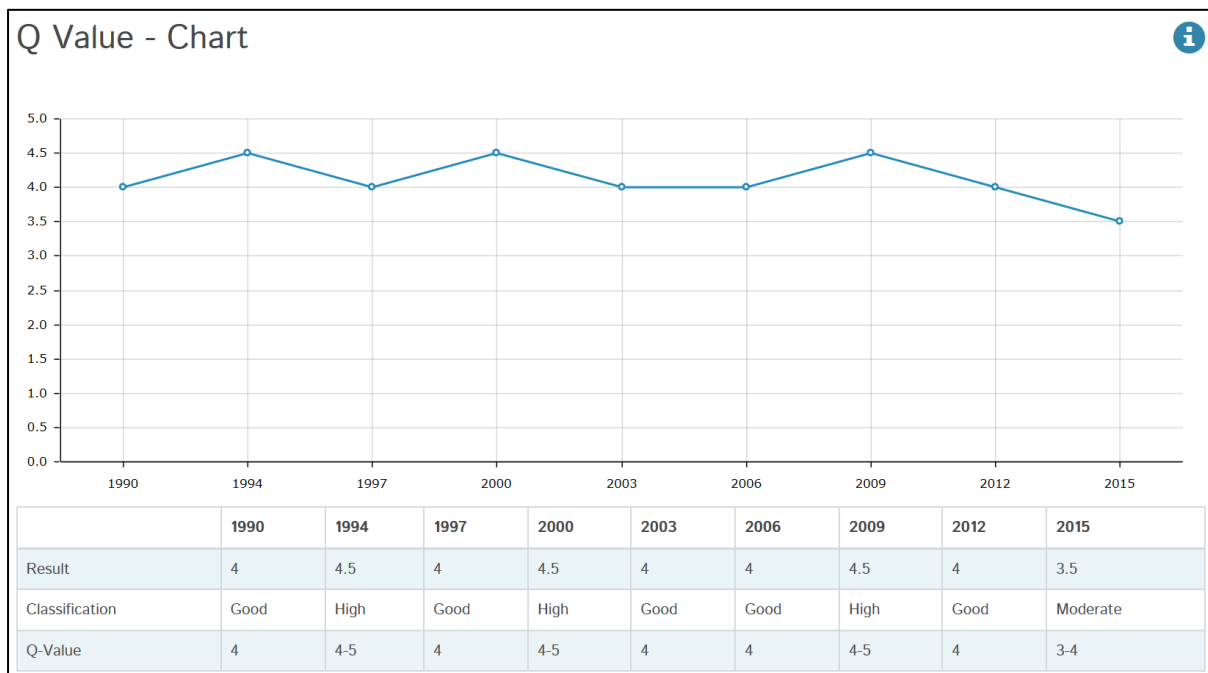
Figure 2-2: Q value, at Br at Ballyshonock, Farahy\_010

There are two operational stations on Farahy\_010 the Br nr Ballyguyroe North, RS18F010200 and the Br at Ballyshonock, RS18F010300. Q results for the monitoring point at Br at Ballyshonock are Moderate (3/4) since 2015 (see below figure 2.2). Preliminary results for 2018 indicate that biological status remains Moderate (3/4).

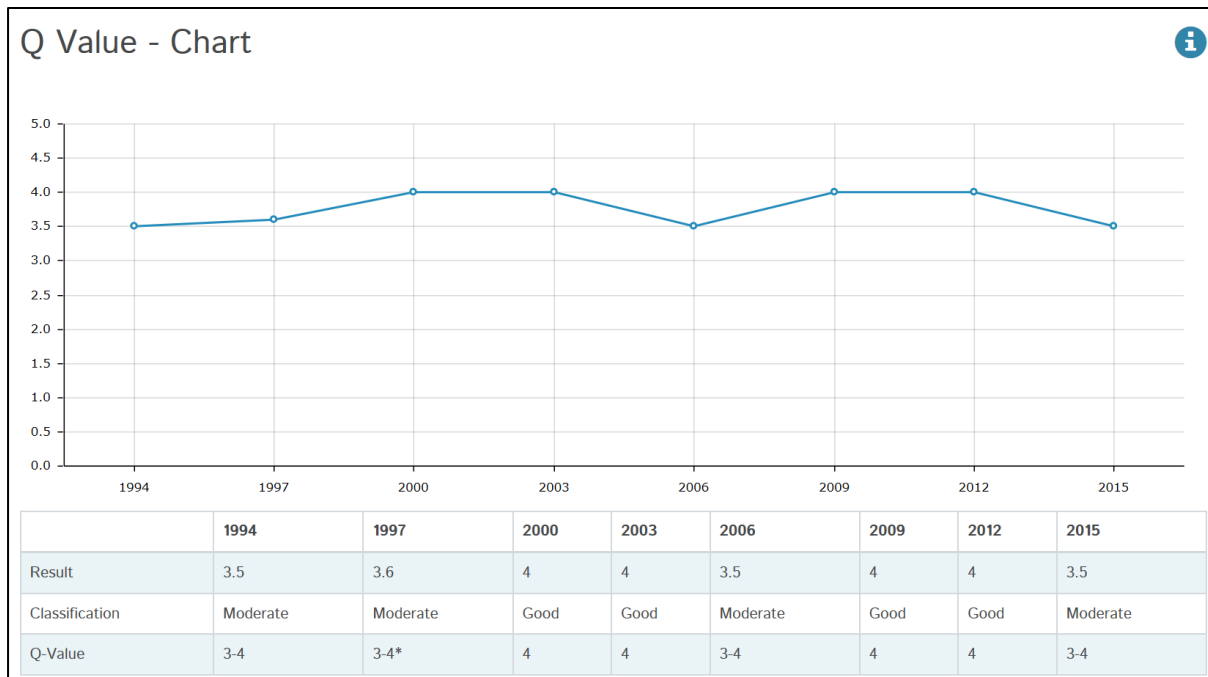
Figure 2-3: Q value, at Br nr Ballyguroe North, Farahy\_010

Biological monitoring results at this location deteriorated from good (Q4) in 2012 to moderate (Q3/4) in 2015. Q values are graphed below in figure 2.3. Preliminary results for 2018 indicate that biological status remains Moderate (Q3-4).

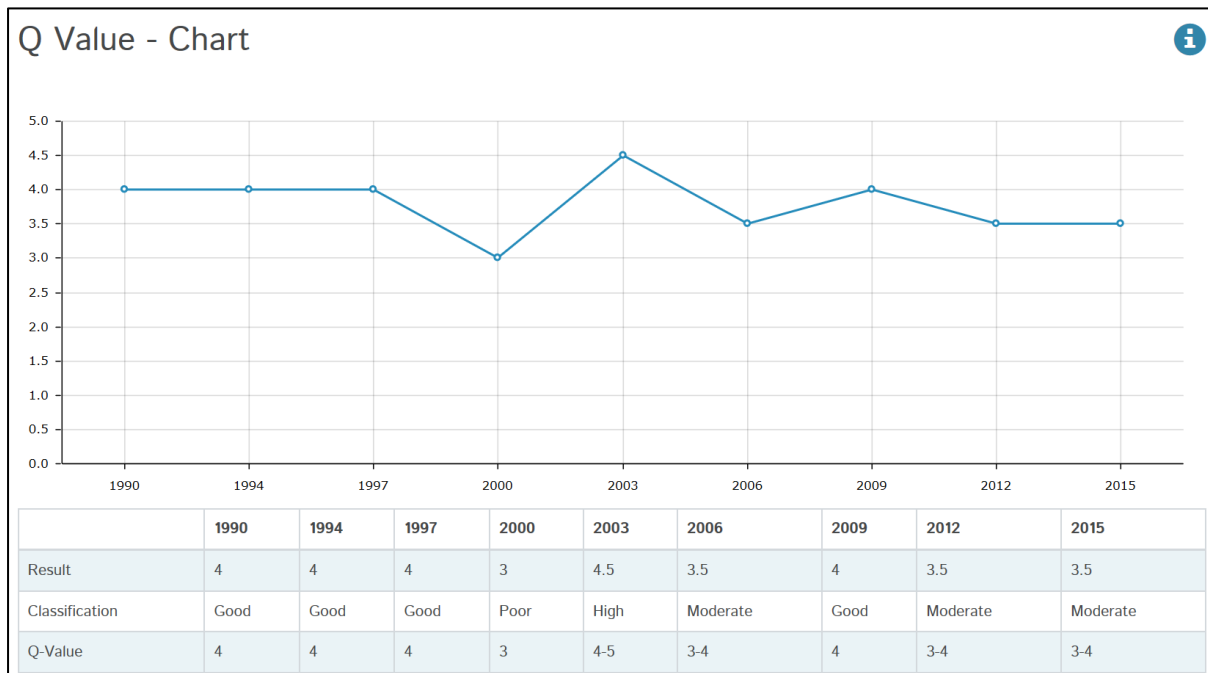
Figure 2-4: Q value, at 1st Br d/s Farahy, Farahy\_020

There is one operational station on Farahy\_020 the 1st Br d/s Farahy, RS18F010500. Q results for the monitoring point on have been consistently moderate (Q3/4) since 2012 (see below figure 2.4). Preliminary results for 2018 indicate that biological status remains Moderate (Q3-4).

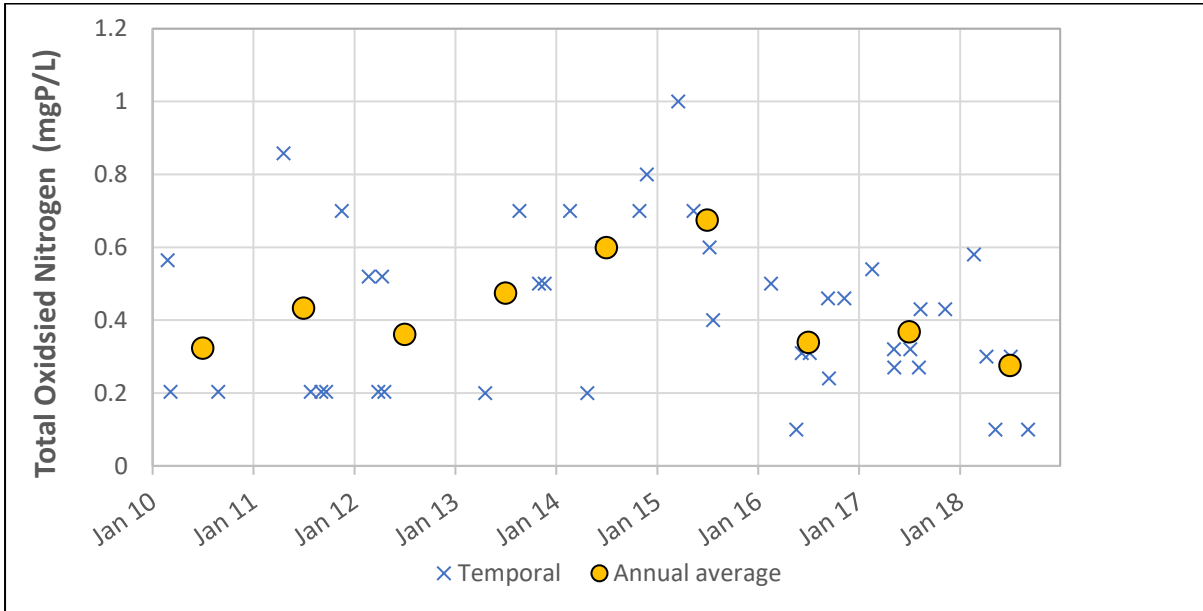
Figure 2-5: Annual average Total Oxidised Nitrogen levels (as N), at Br nr Ballyguyroe North, Farahy\_010

Annual average TON results for Farahy\_010 are satisfactory (see below figure 2.5).

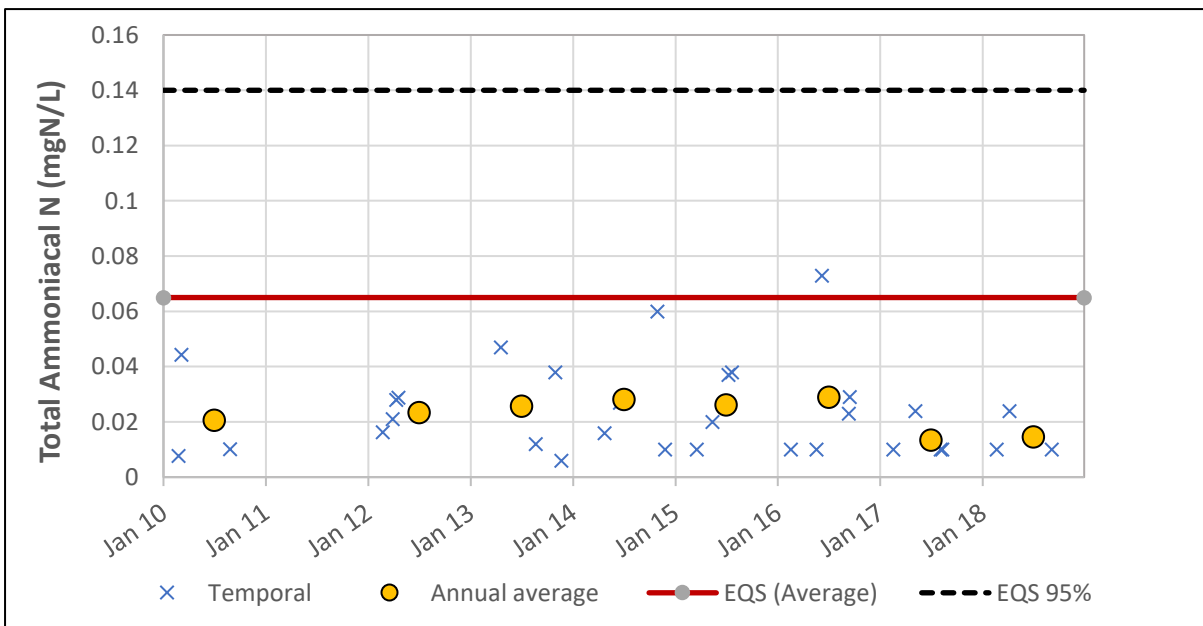
Figure 2-6: Annual average ammonia levels (as N), at Br nr Ballyguyroe North, Farahy\_010

Annual average ammonia concentrations are low. The result for 2018 was 0.015mg/l. Results are stable with a slight upward trend. Note baseline figure was slightly higher with 0.023mg/l mean EQS (see below figure 2.6).

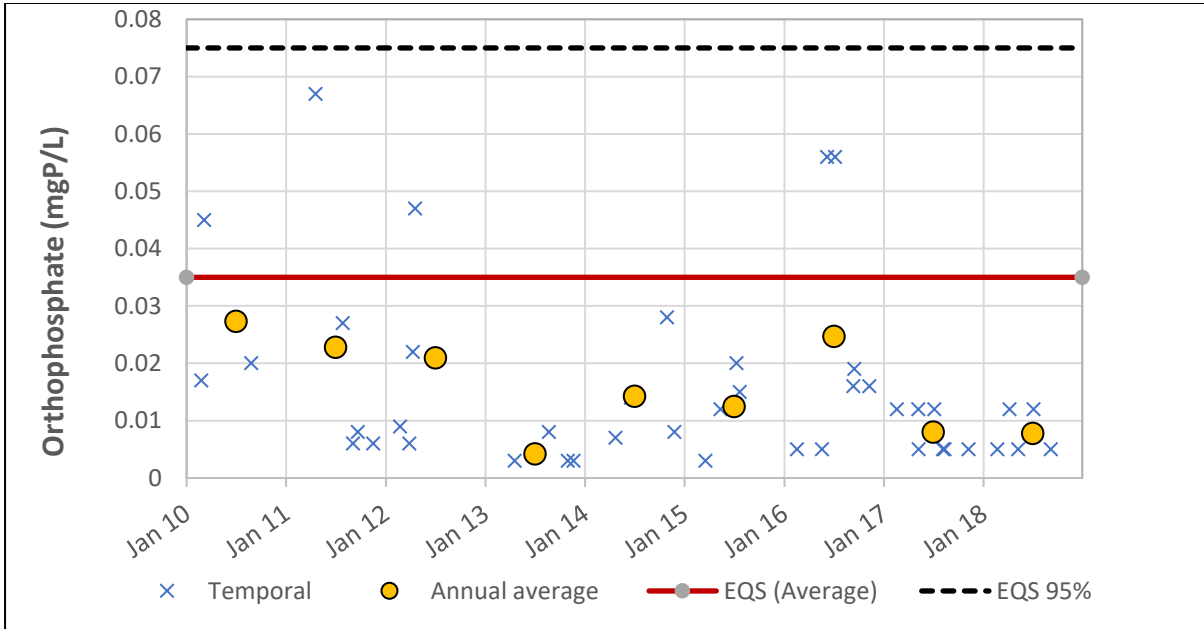
Figure 2-7: Annual average ortho-Phosphate levels (as P), at Br nr Ballyguyroe North, Farahy\_010

Annual average orthophosphate levels are low (the result for 2018 was 0.008mg/l) and are stable with a downwards trend (see below figure 2.7). The Indicative quality is high.

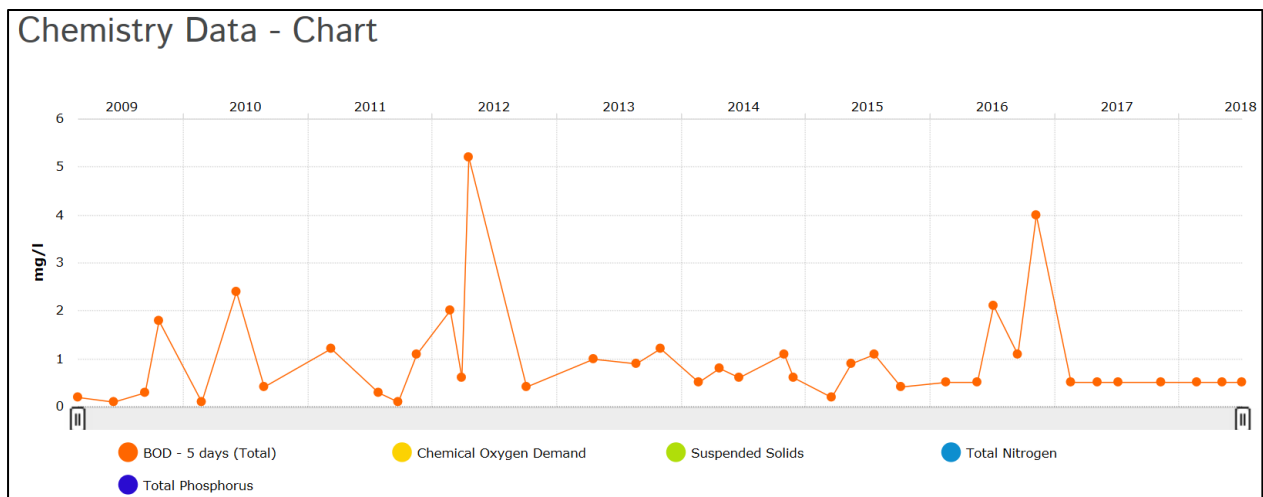
Figure 2-8: BOD results at Br nr Ballyguyroe North, Farahy\_010

BOD results are graphed in figure 2.8 (from WFD App). There are periodic spikes apparent, up to 5.2 mg/l, but these don't appear to be seasonal.
