Keel Foherish
Priority Area for Action Desk Study
AFA 0096
South-West Region

Keel Foherish Priority Area for Action Desk Study

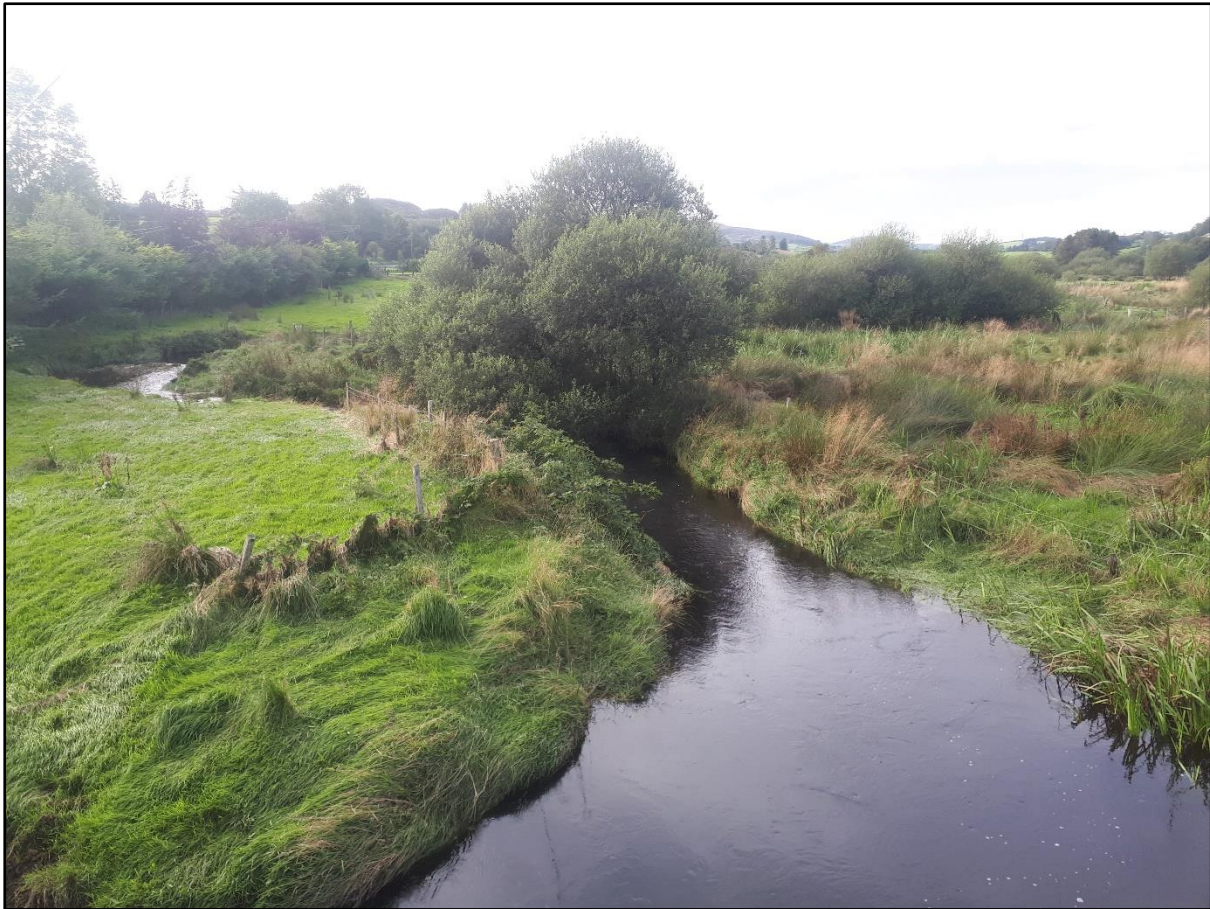
Photograph of WFD operational monitoring point at Keel Br, taken on 26th of August 2020.

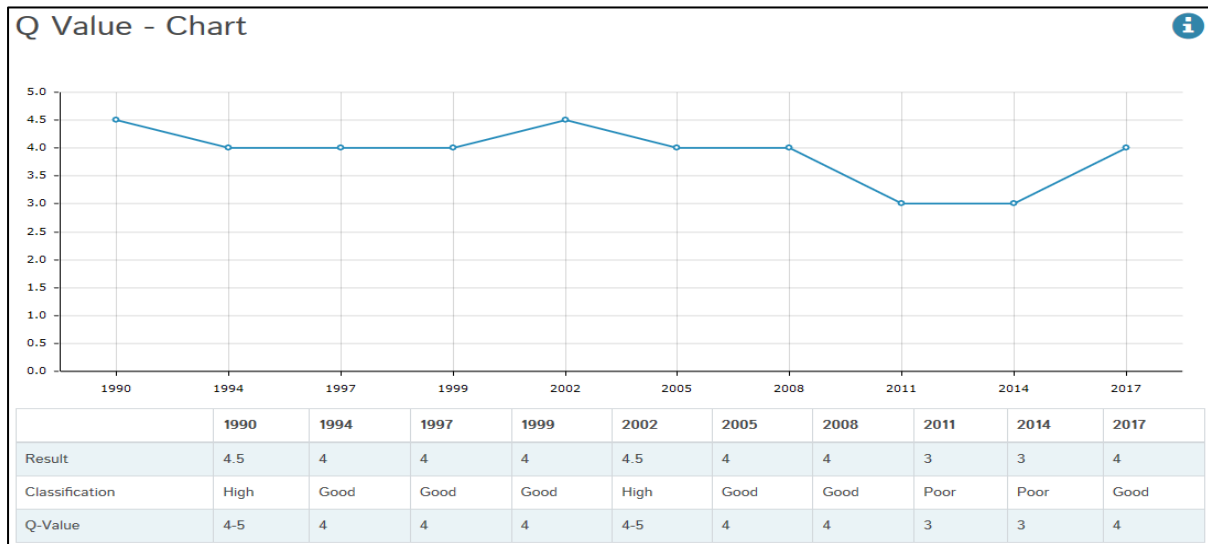
Figure 2-2: Q value, at Keel Br, Keel_010

There is one operational station on Keel_010 the Keel Br, RS19K020200. There are no chemistry data available for Keel Br. Biological monitoring results at this location deteriorated from good (Q4) in 2008 to poor (Q3) in 2011 to 2014. 2017 Q data indicates a return to good status. Q values are graphed in figure 2.2 and summarised in table 2-3.

Biological monitoring results for the operational monitoring point on Keel_010 deteriorated from good (Q4) in 2008 to poor (Q3) in 2011 to 2014. 2017 Q data indicate that it has recovered back to good (Q4) status but the cause of the deterioration between 2011 and 2014 needs to be established if possible in order to ensure that the waterbody is not at risk of deteriorating again. EPA biologists noted siltation issues in 2014 and to a lesser extent in 2017, indicating that sediment was the significant issue causing the deterioration to poor status here in 2011. There are limited chemistry data available for this waterbody. Recent results indicate that nutrients are not currently an issue; phosphate and ammonia results were below the relevant EQS's when assessed in 2019 and 2020. However no data are available on nutrient levels prior to the 2011 deterioration here.

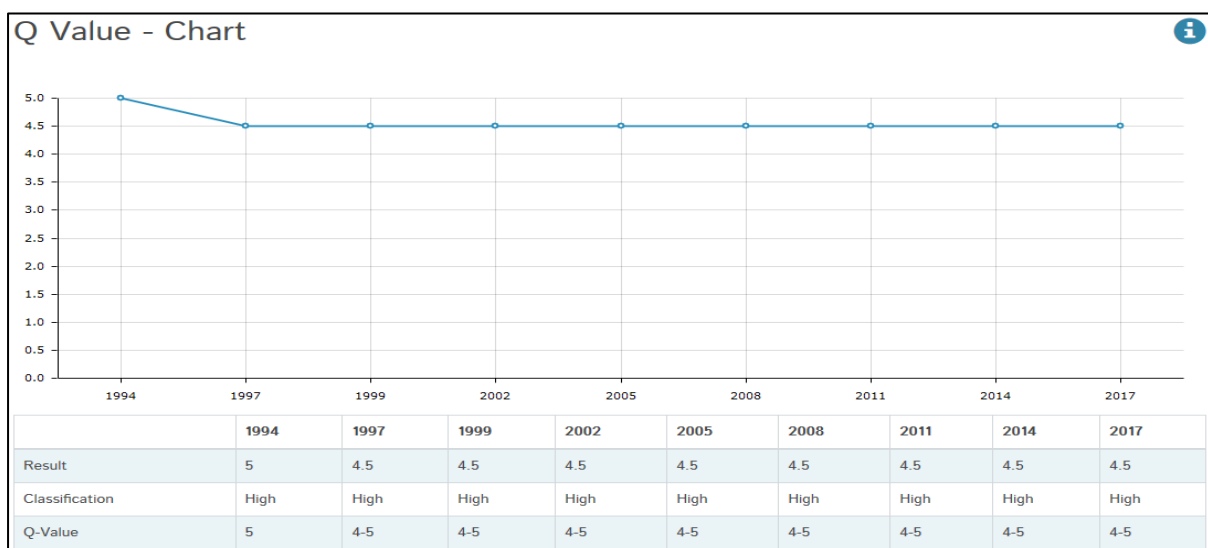
Figure 2-3: Q value, at Br N of Curraleigh, Fotherish_010

There is one operational station on Fotherish_010 the Br N of Curraleigh, RS19F020100. There are no chemistry data available for this station. Q results for the monitoring point at Br N of Curraleigh have been consistently high since 1994 (see below figure 2.3 and summarised in table 2-3).

Foherish_010 is a high status objective waterbody. Biological status has been consistently high here since monitoring commenced but ecological status is currently good due to hydromorphological condition.

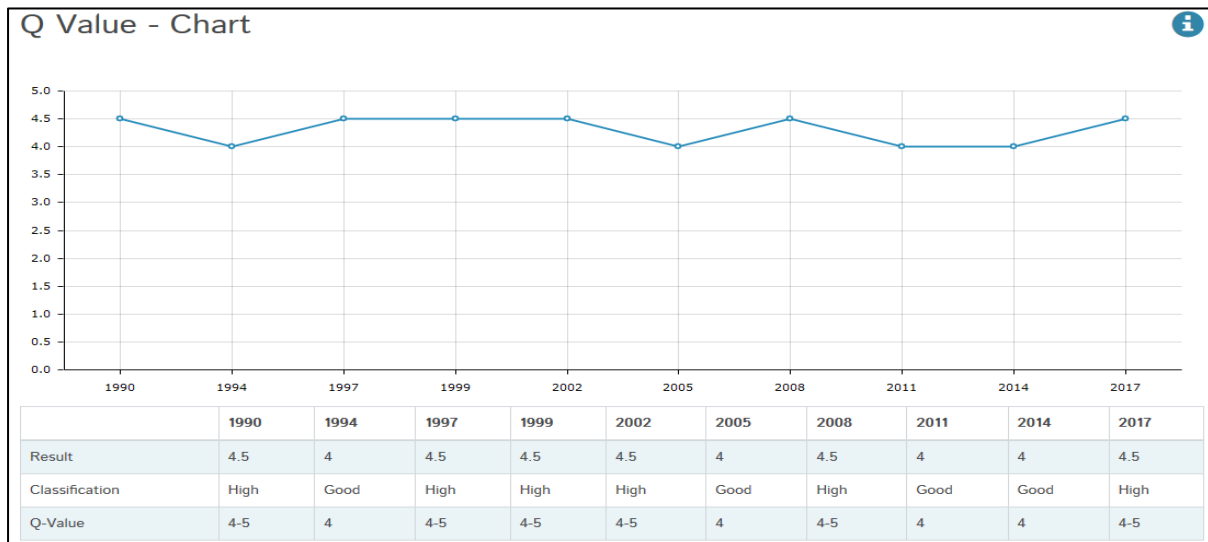
Figure 2-4: Q value, at Br u/s Foherish River, Garrane (Lee)_010

There is one WFD operational monitoring station on Garrane (Lee)_010: Br u/s Foherish River, RS19G030200. There are no chemistry data available for this station. Biological results for the monitoring point have been consistently dropping from high to good since 1990. 2017 Q data indicates a return to high status. Q values are graphed in figure 2.4 and summarised in table 2-3.

Garrane (Lee)_010 is a good ecological status objective waterbody (*Not at risk*) but discharging to a high status objective waterbody (Foherish_020). Biological results for the monitoring point have varied between high and good from 2002 to 2017, with 2017 results at high (Q4/5). Note that good hydromorphological conditions are preventing the waterbody from achieving its high ecological status objective. There are no chemistry data available for this waterbody.

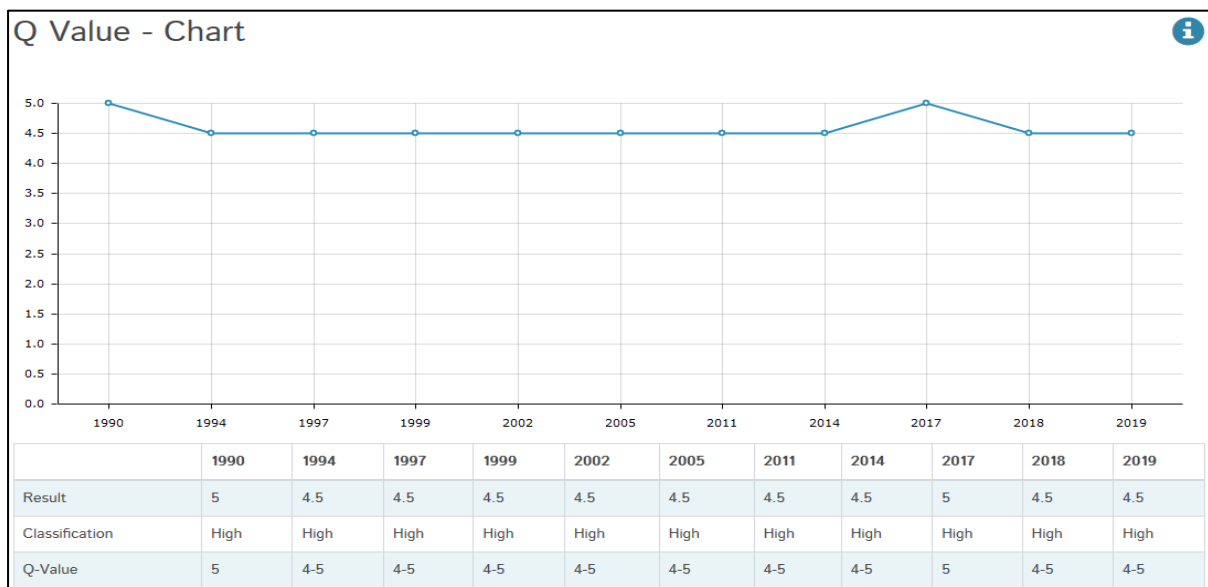
Figure 2-5: Q value, at Foherish – Foherish Br, Foherish_020

There are two operational stations on Foherish_020: Foherish – Foherish Br, RS19F020200 and Foherish – W of Caherbirrane, RS19F020300. There are no chemistry data available for either station. Q results for the monitoring point at Foherish Br have been consistently high since 1990 (see below figure 2.5 and summarised in table 2-3).

Foherish_020 is a high status objective waterbody with two WFD operational monitoring stations, Foherish – Foherish Br and Foherish – W of Caherbirrane. The Foherish Br station has been consistently at high biological status since monitoring commenced. Foherish-W of Caherbirrane was at high biological status until 2011 when it dropped to good. 2017 and 2018 Q data indicate that it has recovered back to high (Q4/5) but ecological status here is good, failing on hydromorphological condition. The RHAT assessment score for both monitoring points is poor for bank vegetation and moderate for riparian land cover. Land use in the vicinity of both stations is under agriculture. The hydromorphological issues need to be addressed in order for the waterbody to achieve its high status objective.

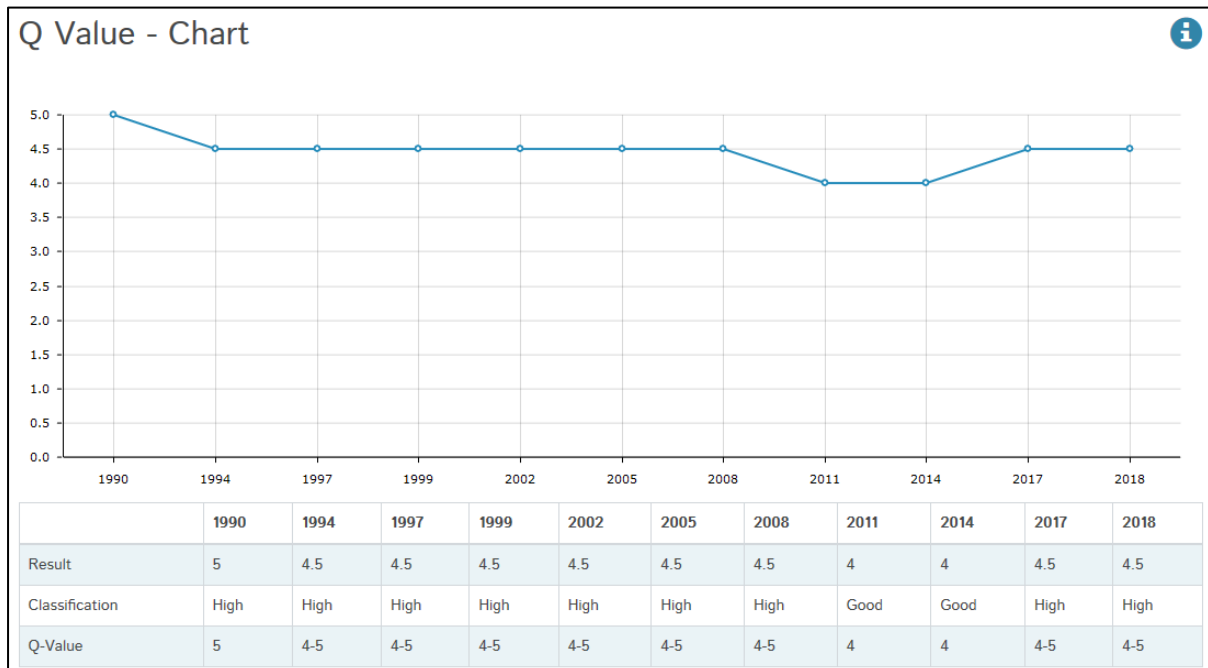
Figure 2-6: Q value, at Foherish – W of Caherbirrane, Foherish _020

Biological monitoring results at Foherish-W of Caherbirrane deteriorated from high (Q4/5) in 2008 to good (Q4) in 2011 to 2014. 2017 and 2018 Q data indicate a return to high status. This monitoring point is located 4kms downstream of the Foherish bridge station, where no status deterioration occurred in 2011 to 2014, suggesting that the pressure responsible for the 2011-2014 deterioration did not originate in Foherish_010 or Garrane (Lee)_010 headwaters to Foherish_020. It is also possible that if the significant issue here is sediment, the sediment may have arisen in either of these headwaters but did not deposit on the river bed here due to higher flows/steeper gradient. Q values are graphed below in figure 2.6 and summarised in table 2-3.

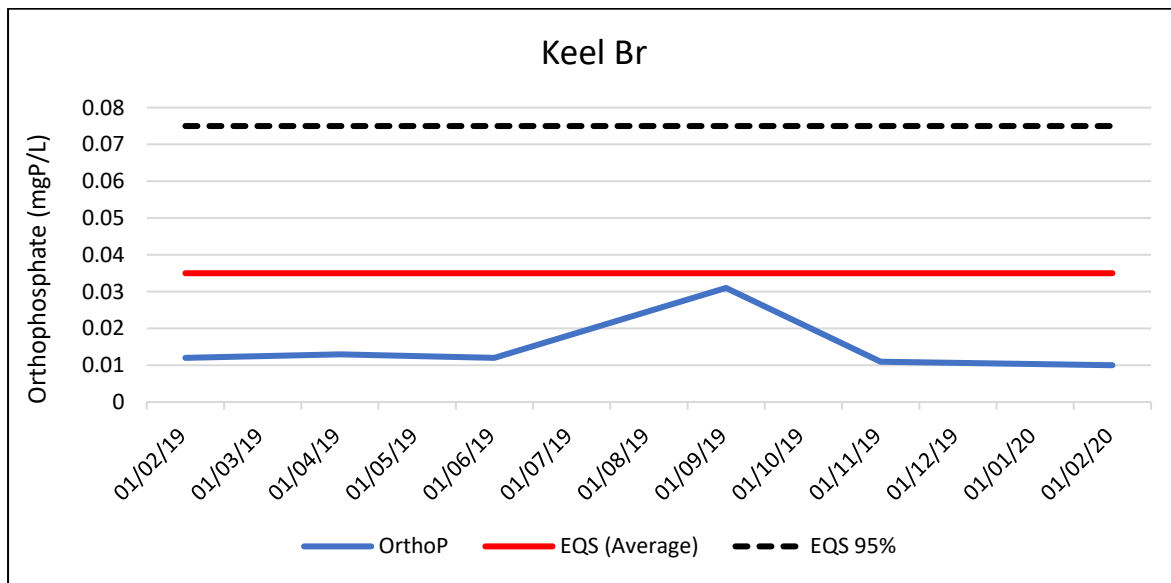
Figure 2-7: Orthophosphate results at Keel Bridge, Keel_010

Keel_010 and Foherish_020 are monitored under WFD for biology only. However the EPA undertook monitoring on both waterbodies between February 2019 and February 2020. BOD results have been generally satisfactory with all results below the good status EQS of 1.5 mg/l (annual average). Orthophosphate and ammonia levels are below the good status for both the mean and 95%ile Environmental Quality Standard (EQS) from the European Communities Environmental Objectives (surface Waters) Regulations. Results are graphed in figures 2.7 and 2.8.

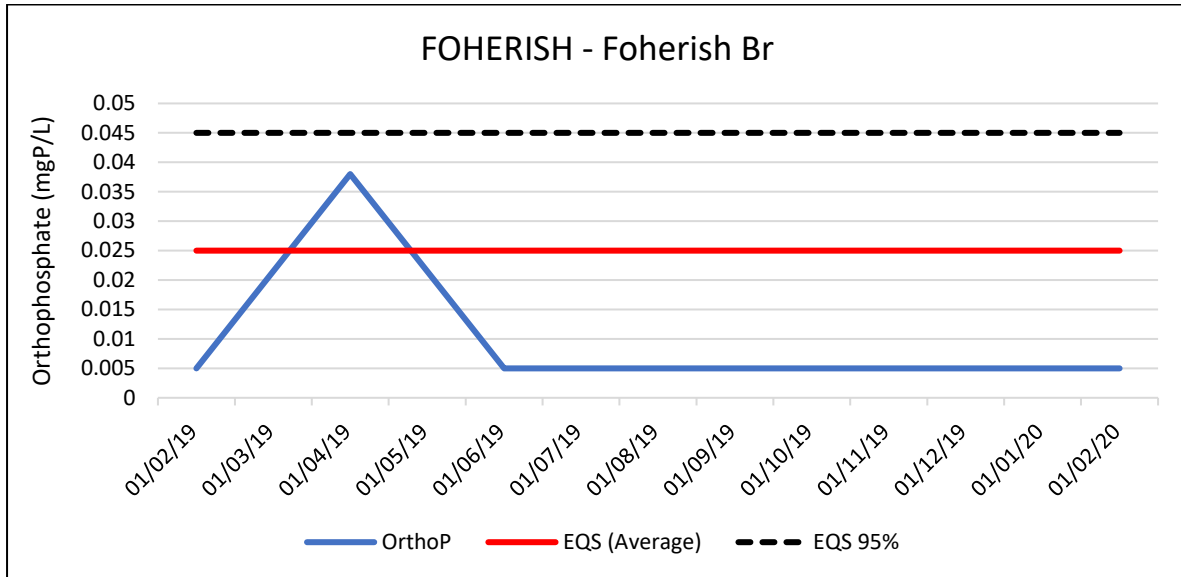
Figure 2-9: Orthophosphate results at Foherish – Foherish Br, Foherish_020

BOD results were satisfactory, with all results below the high status EQS of 1.3 mg/l (annual average). Orthophosphate and ammonia results were also within the relevant mean EQS. Results are graphed in figures 2.9 and 2.10.

- Foherish_020 is not monitored for chemistry under WFD but six monitoring rounds were undertaken by the EPA in 2019 and 2020, at Foherish Bridge. Results indicate that nutrients are not currently an issue here. No data are available for Foherish-W of Caherbirrane where the 2011- 2014 deterioration occurred.

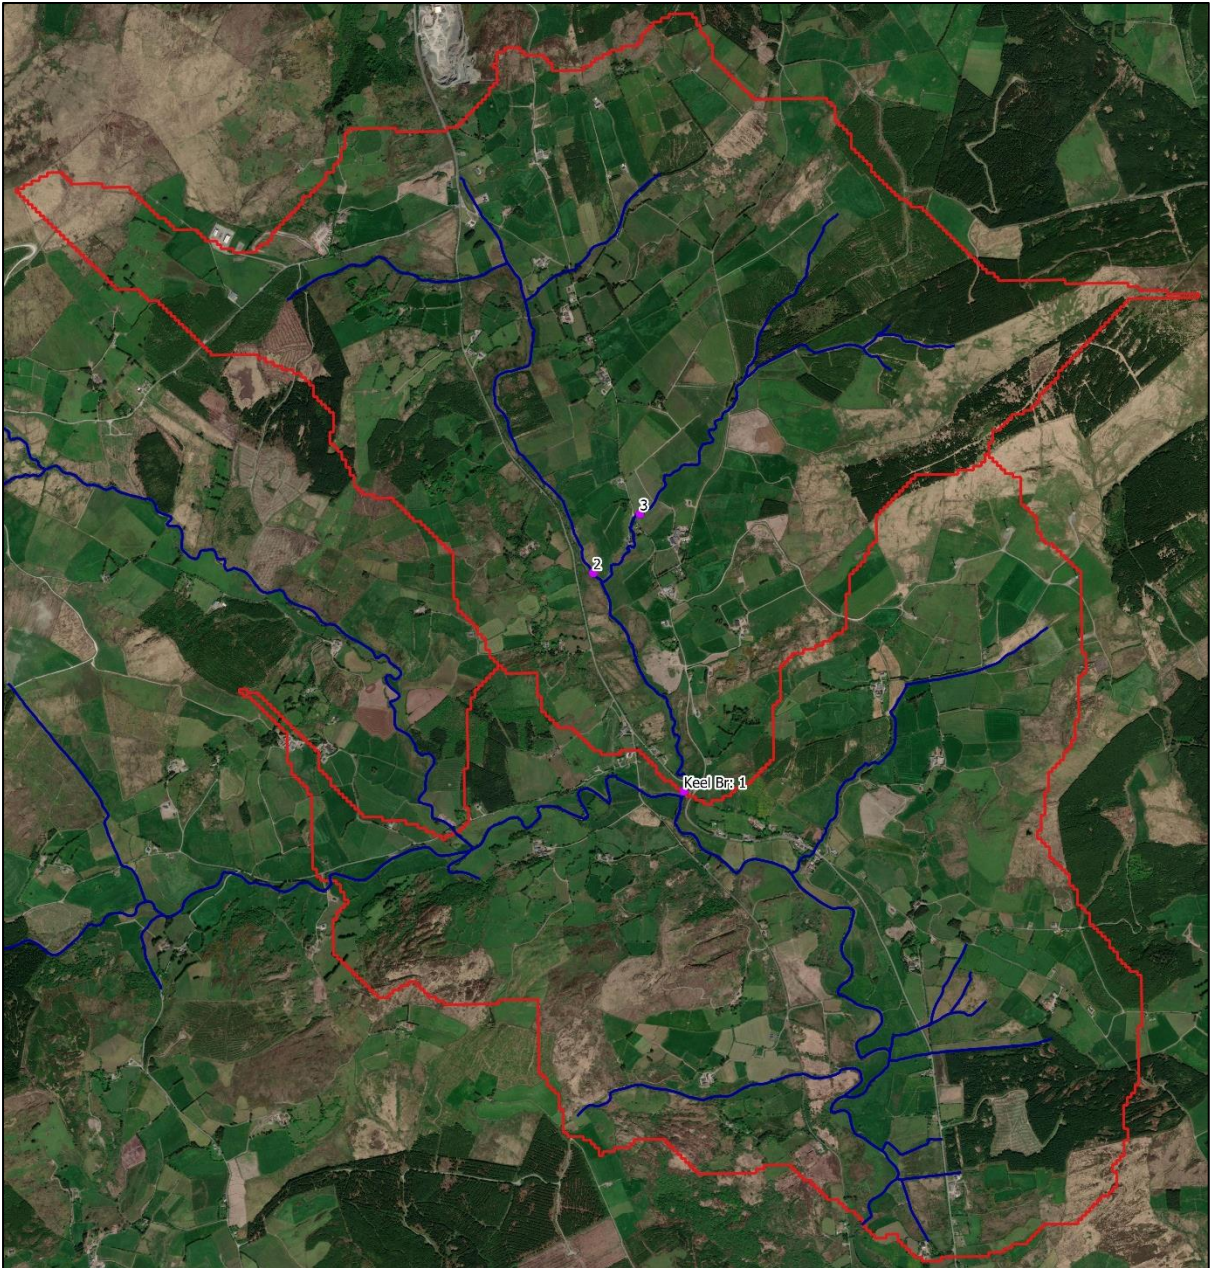
Figure 7-1: Sample locations for Keel_010

Field investigations to be undertaken at the following locations as outlined below and as shown on figures 7.1 and 7.2. The assessment will commence in the Keel_010 headwaters as the 2011 deterioration on Foherish_020 may have been driven by pressures impacting on Keel_010.

Keel_010 dropped from good to poor status in the 2011 monitoring round. It returned to good status (its WFD objective) in 2017. However, limited assessment is needed to i) confirm whether the site is still at good status and if not, to identify the pressures currently impacting on water quality here and ii) to try to determine the cause of the 2011 deterioration.
