Tyshe Priority Area for Action

Desk Study

(AFA0175)

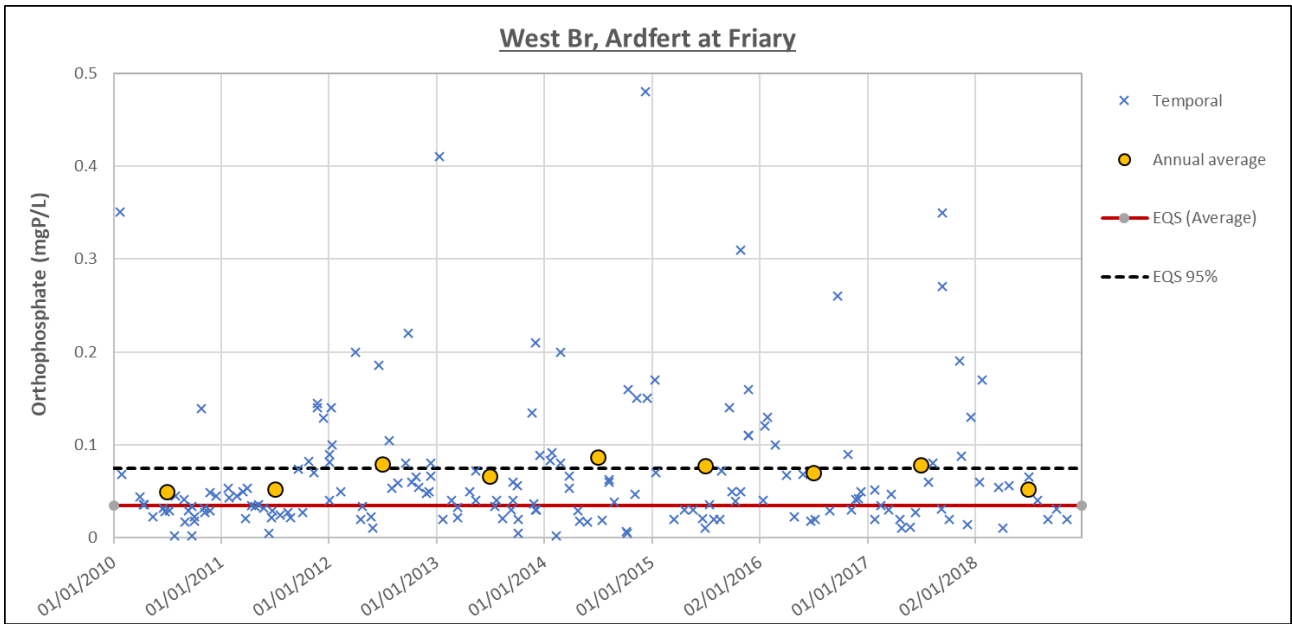
Figure 2-3-1 Orthophosphate concentrations at West Br, Ardferf at Friary.

Ortho-phosphate, Nitrate and Ammonium levels for West Bridge, Ardferf at Friary from 2010 to 2019 are graphed below in Figures 2-3-1 to 2-3-3 respectively. Also shown on the graphs are the mean and 95%ile EQS's for each parameter.

As can be seen from the graphs, annual average nutrient concentrations nearly always exceed the mean EQS for all three nutrients and sometimes even exceed the 95%ile EQS for ortho-phosphate and ammonium. The individual grab samples frequently exceed the 95%ile EQS for ortho-phosphate and ammonium with peaks in excess of 0.4mg/L recorded for ortho-phosphate and in excess of 1mg/L recorded for ammonium. Nitrate concentrations are mostly within the 3.5mg/L (mean EQS) – 5.4mg/L range (95%ile EQS).

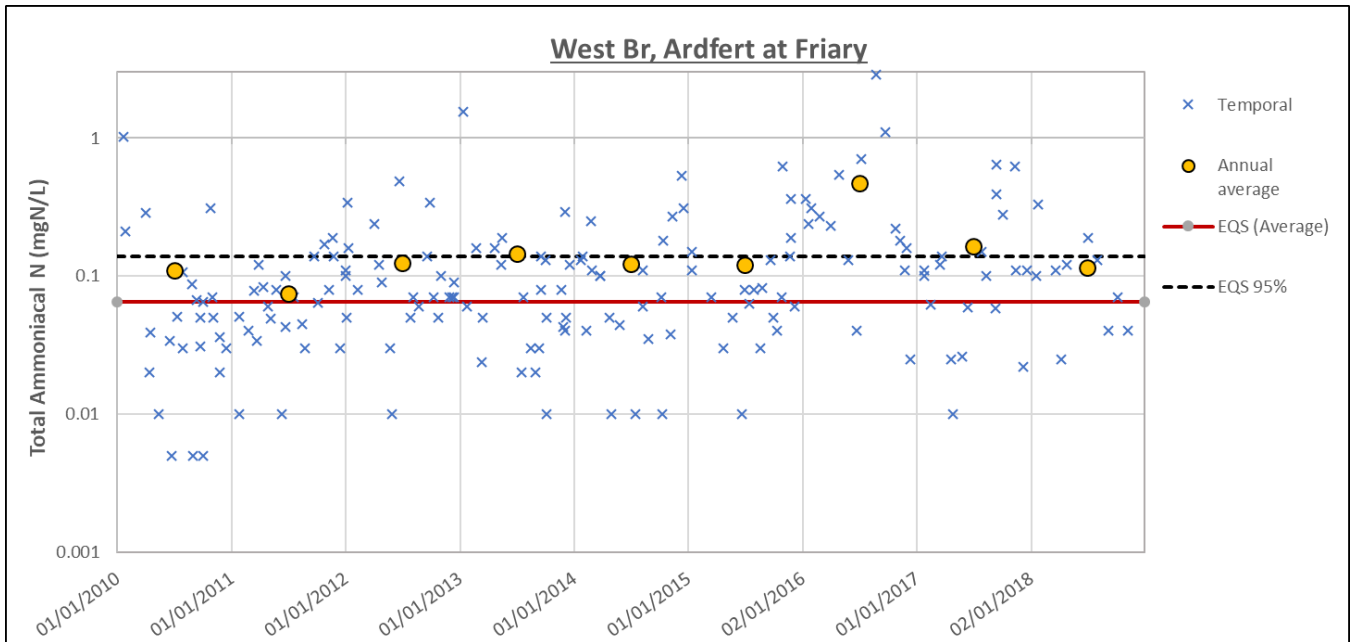
Figure 2-3-3 Total Ammoniacal N concentrations at West Br, Ardfert at Friary. Log scale is used here to accommodate the full range of values.
