Owenriff

Desktop Assessment

Western Region

(AFA0148)

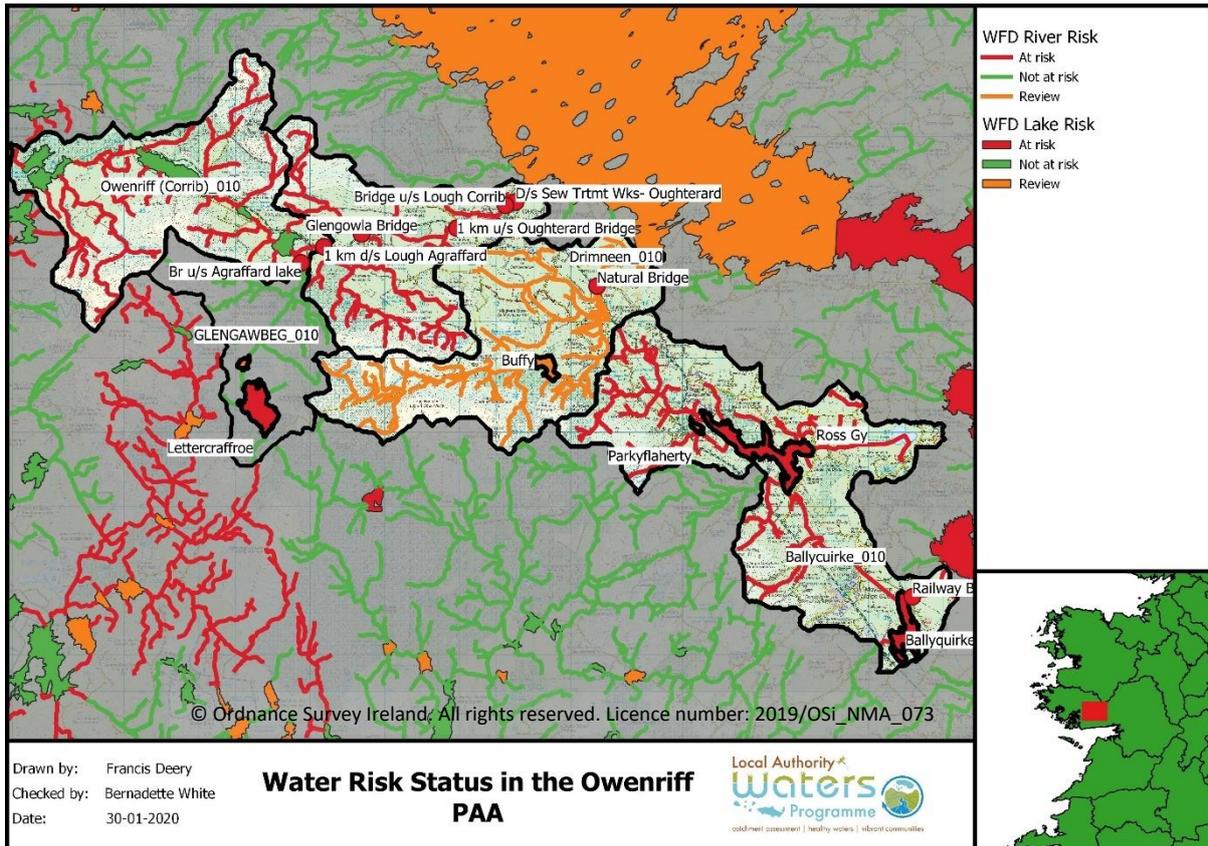
Figure 1: Water Risk Status in the Owenriff PAA

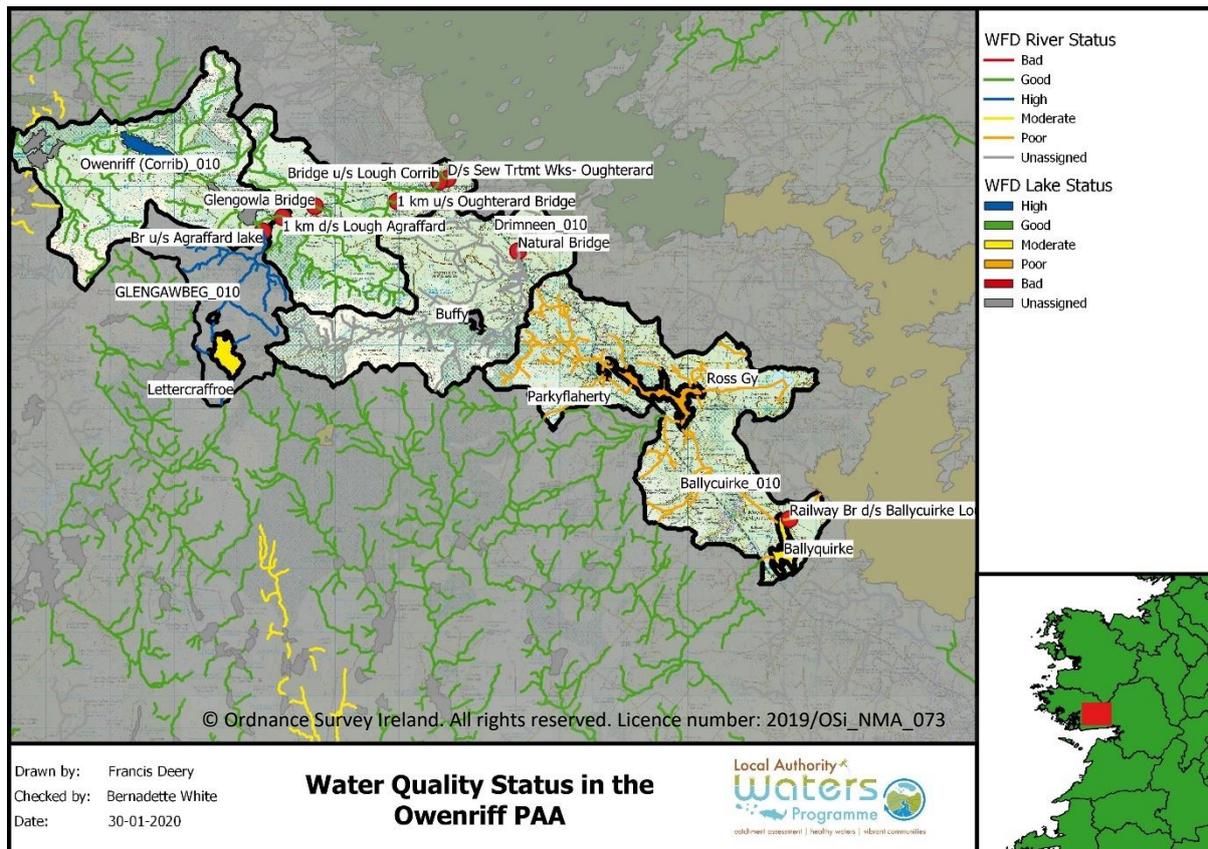
Figure 2: Water Quality Status in the Owenriff PAA

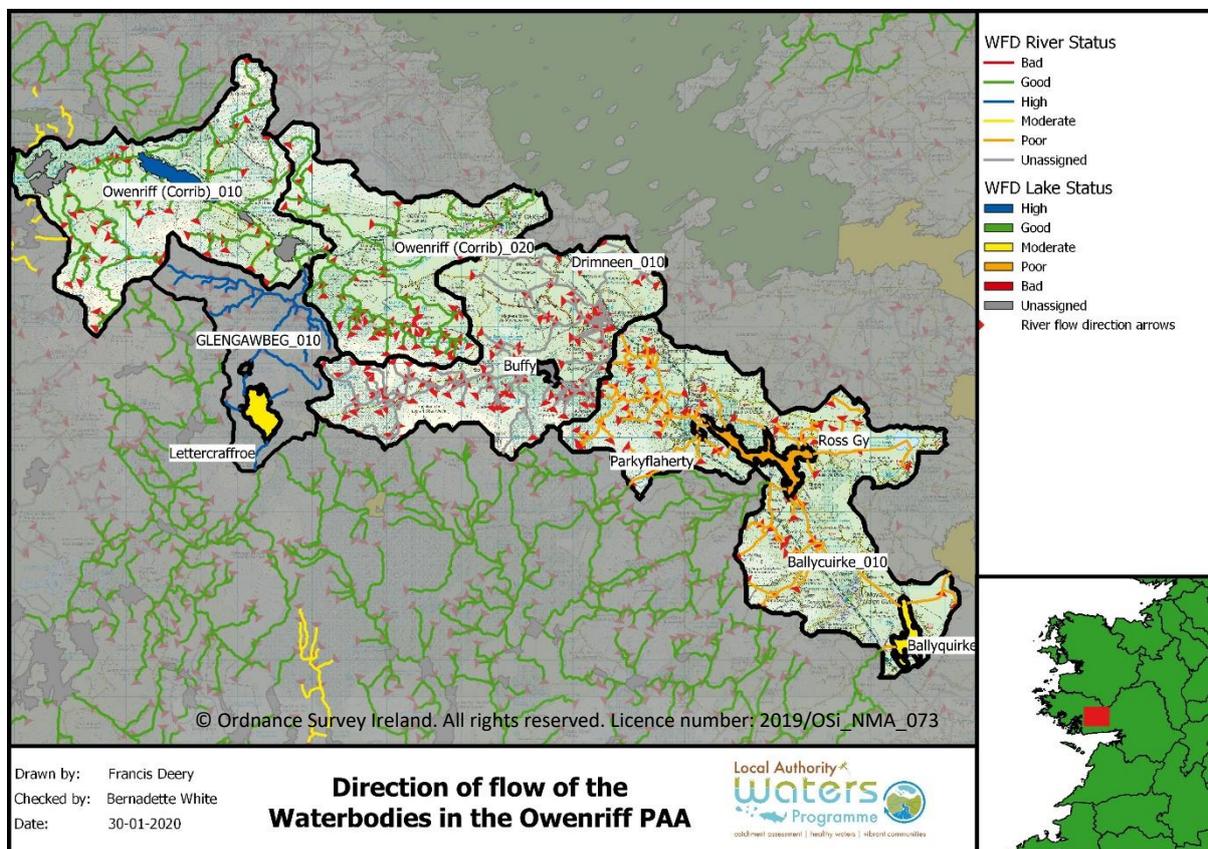
Figure 3: Direction of flow in the Owenriff PAA

The PAA consists of four river water bodies and six lake bodies. The Owenriff_010 flows into Lough Bofin (**Figure 3**) from the townland of An Leim from the west and from the Letterfore on the east. Lough Bofin outflows into the Owenriff_010, and flows into Adrehid lough, which flows into the Owenriff_010 through the Quiet man bridge and into Lough Agraffard and flows out of the lough into Owenriff_010 again. It is at this point that Glengawbeg_010 flows into the Owenriff_010. The Glengawbeg_010 flows from the west to east from above Lettercraffroe lake and flows into Acogga lake, flows out of that lake and flows onto the Owenriff_010. The Owenriff_010 then flows into the Owenriff_020, which flows towards Oughterard adjacent to the N59, with numerous tributaries flowing into the main Owenriff_020 channel. The Owenriff_020 flows through Oughterard and then flows into Lough Corrib.

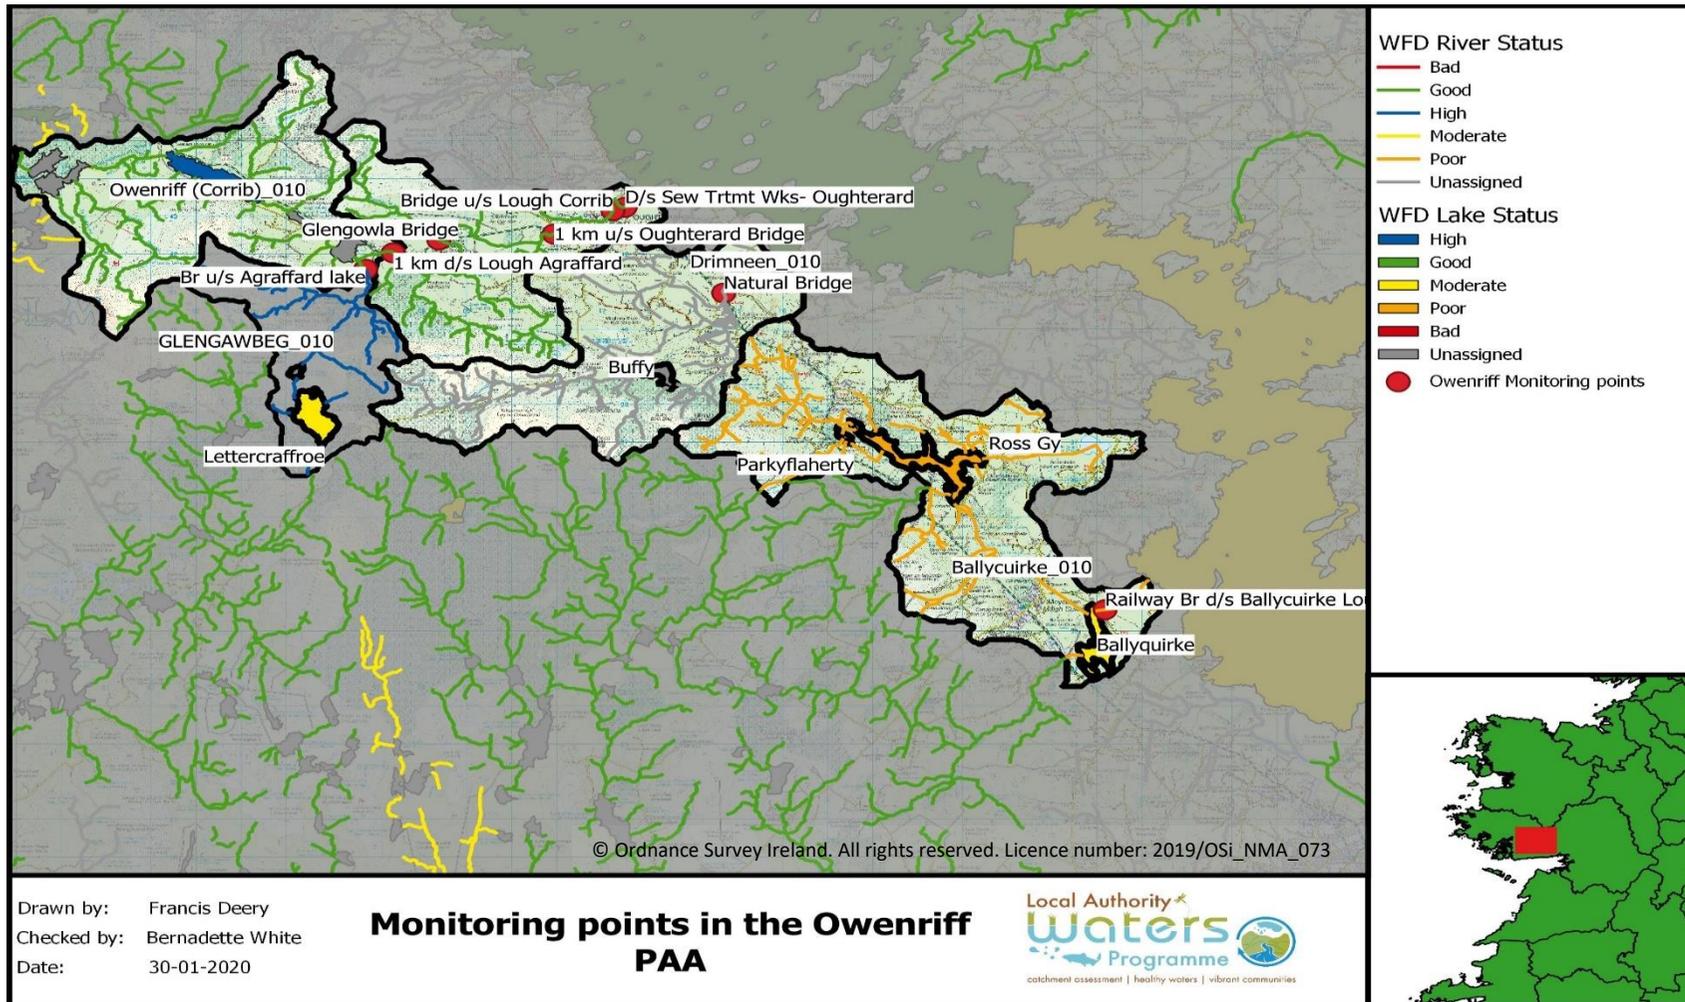
Figure 4: Monitoring points in the Owenriff PAA

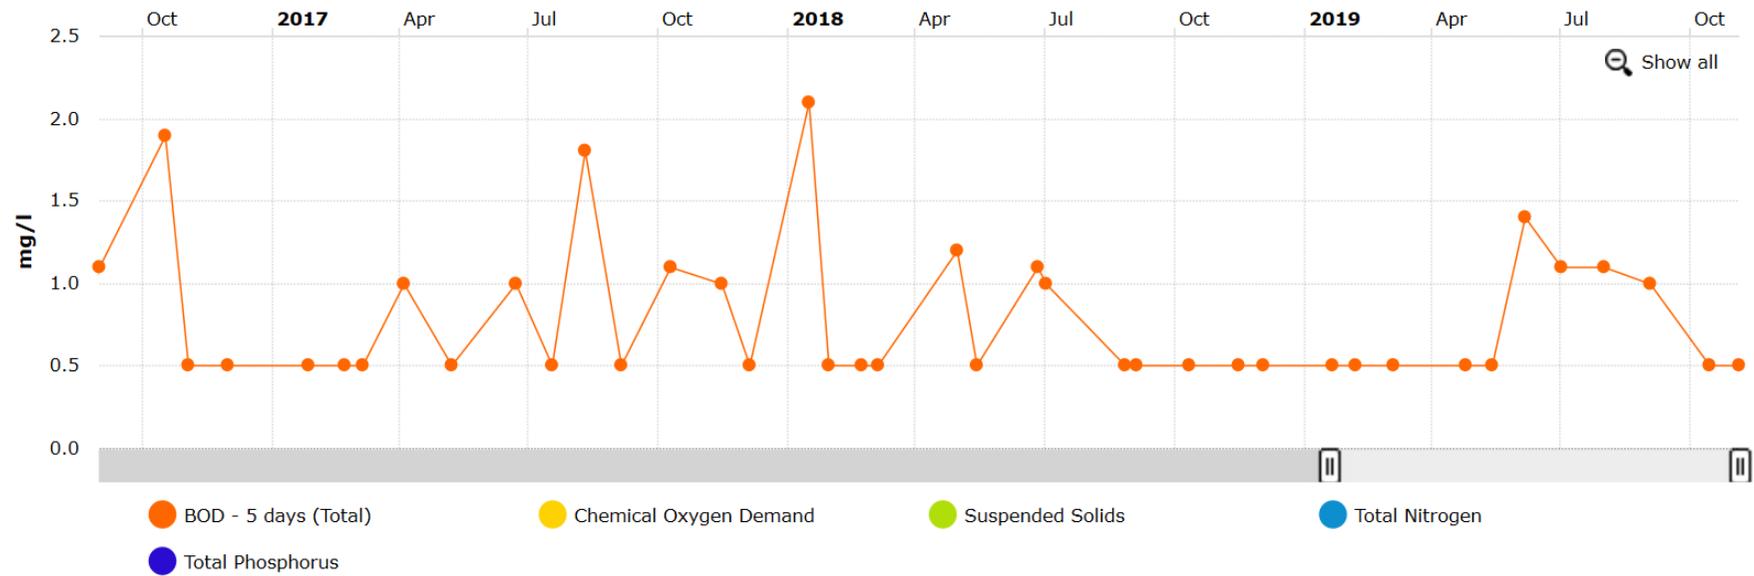
Figure 5: BOD at the Monitoring Point "1KM U/S of Oughterard Bridge"(High status <1.3 (mean) or <2.2 (95%ile)

| Waterbody | | Owenriff (Corrib)_010 | Owenriff (Corrib)_020 | | | | Glengawbeg_010 |
|---|---|--|---|---|---|---|---|
| Supporting Conditions: Chemical oxygenation and acidification conditions. | | No Data available | BOD exceeds the limits of the surface regulations in 2017, 2018, and 2019 once every year. As seen in figure 5. | There are BOD exceedances in 2010 and 2017, as seen in figure 6. | There are BOD exceedances from 2016 onwards at this monitoring point, see figure 7. | | No Data |

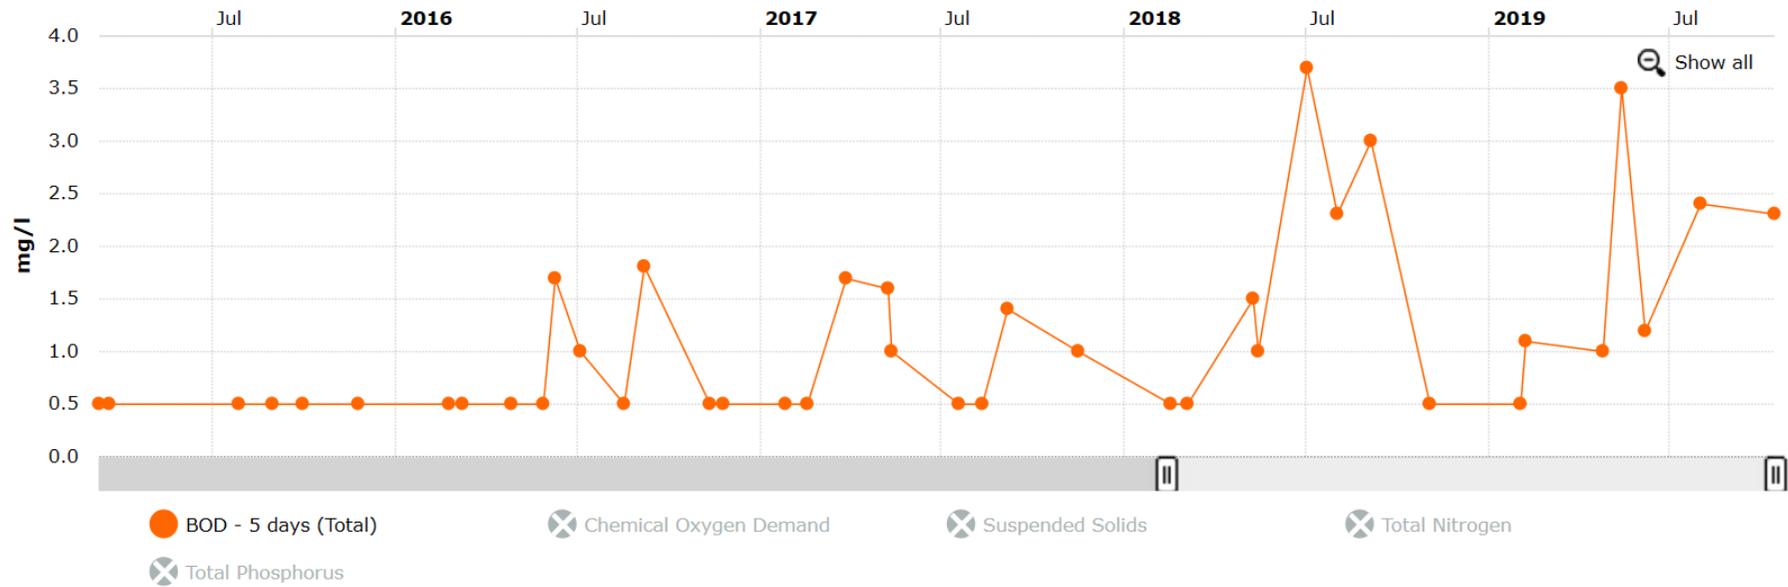
Figure 6: BOD graph of the Monitoring Point "Bridge U/S of Lough Corrib"

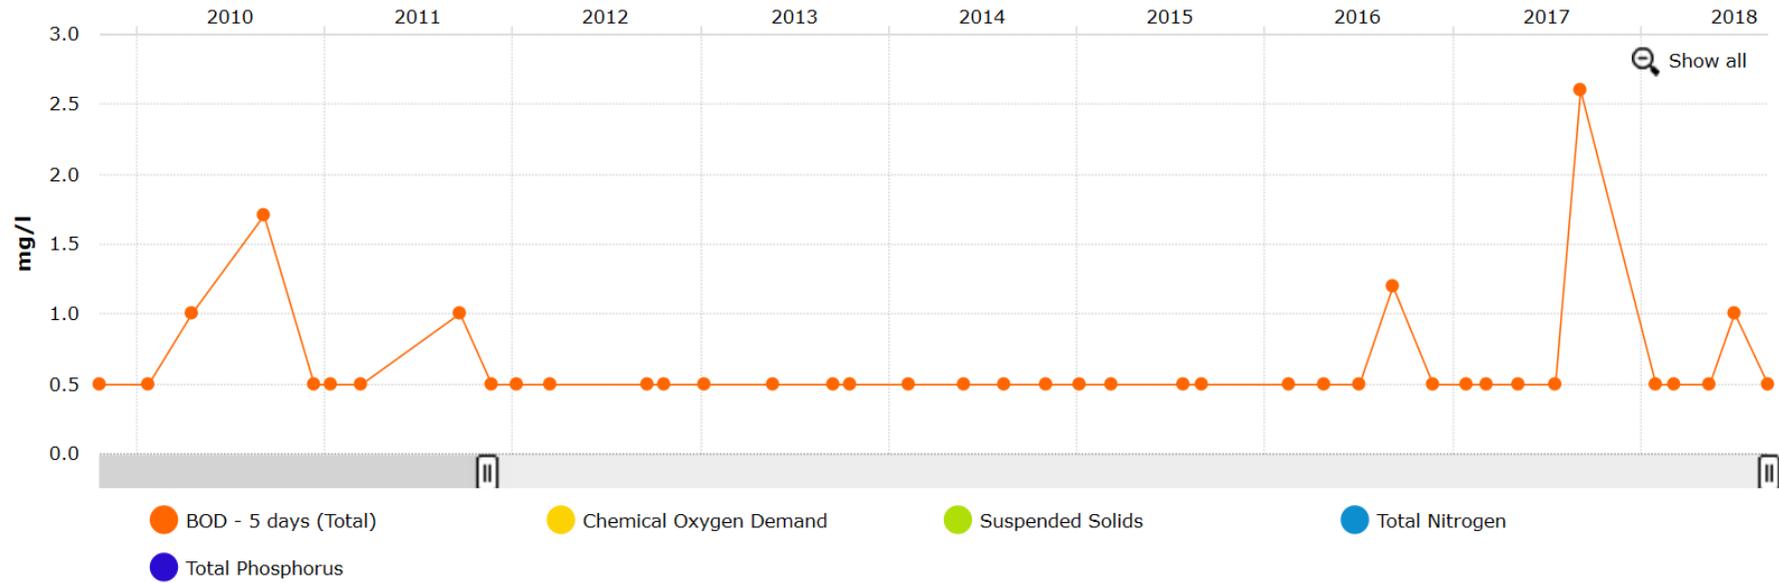
Figure 7: BOD graph at the Monitoring Point “D/S Sew Trtmt Wks – Oughterard”

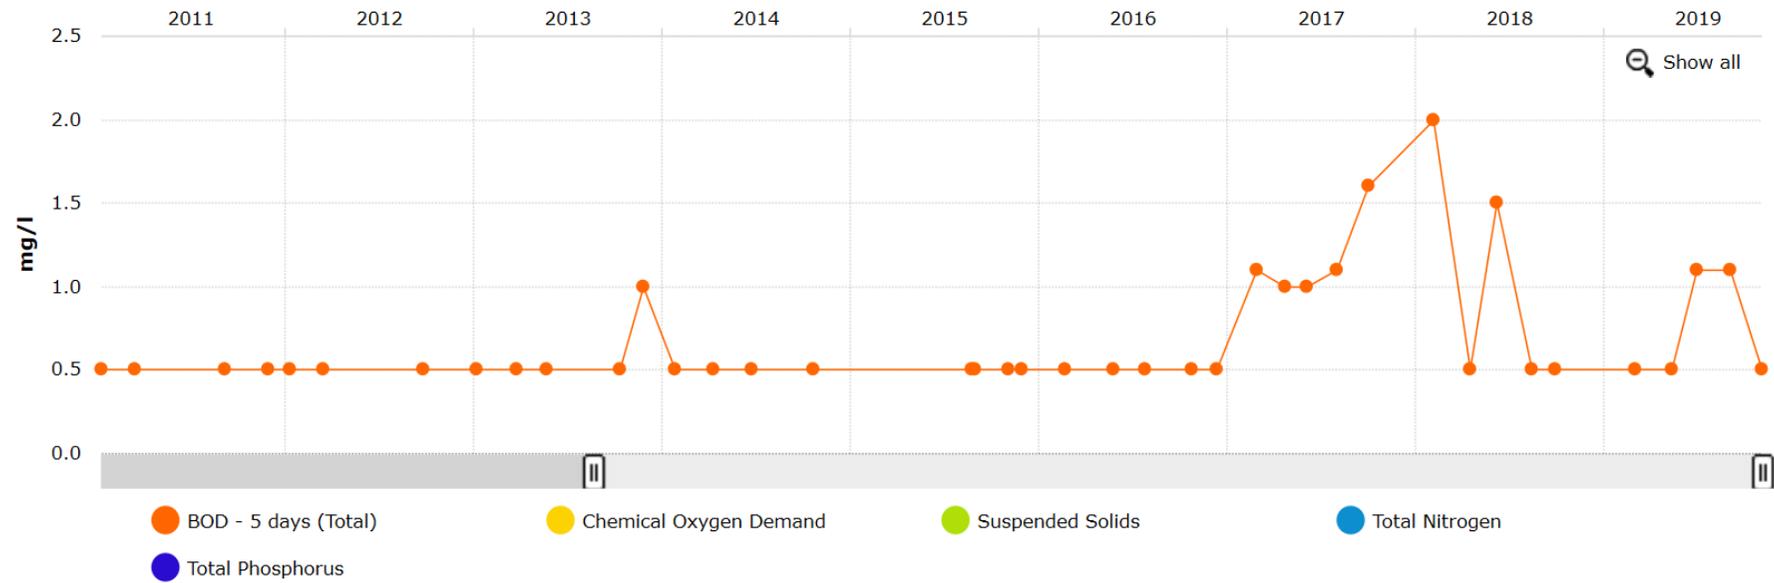
Figure 8: BOD graph for the Monitoring Point "Railway Br D/S of Ballyquirke Lough"

| Waterbody | | Drimneen_010 | Ballycurirke_010 | | |
|--|---|--|--|---|---|
| Supporting Conditions: Chemical oxygenation conditions and acidification conditions | No Data available | There are exceedances in the BOD at this monitoring point in 2017, see figure 8. | There are spikes in the Total Nitrogen from July 2018 to June 2019. There are also exceedances in the BOD between the | There are spikes in the Total Nitrogen from July 2018 to June 2019. There are also exceedances in the BOD between the same | |

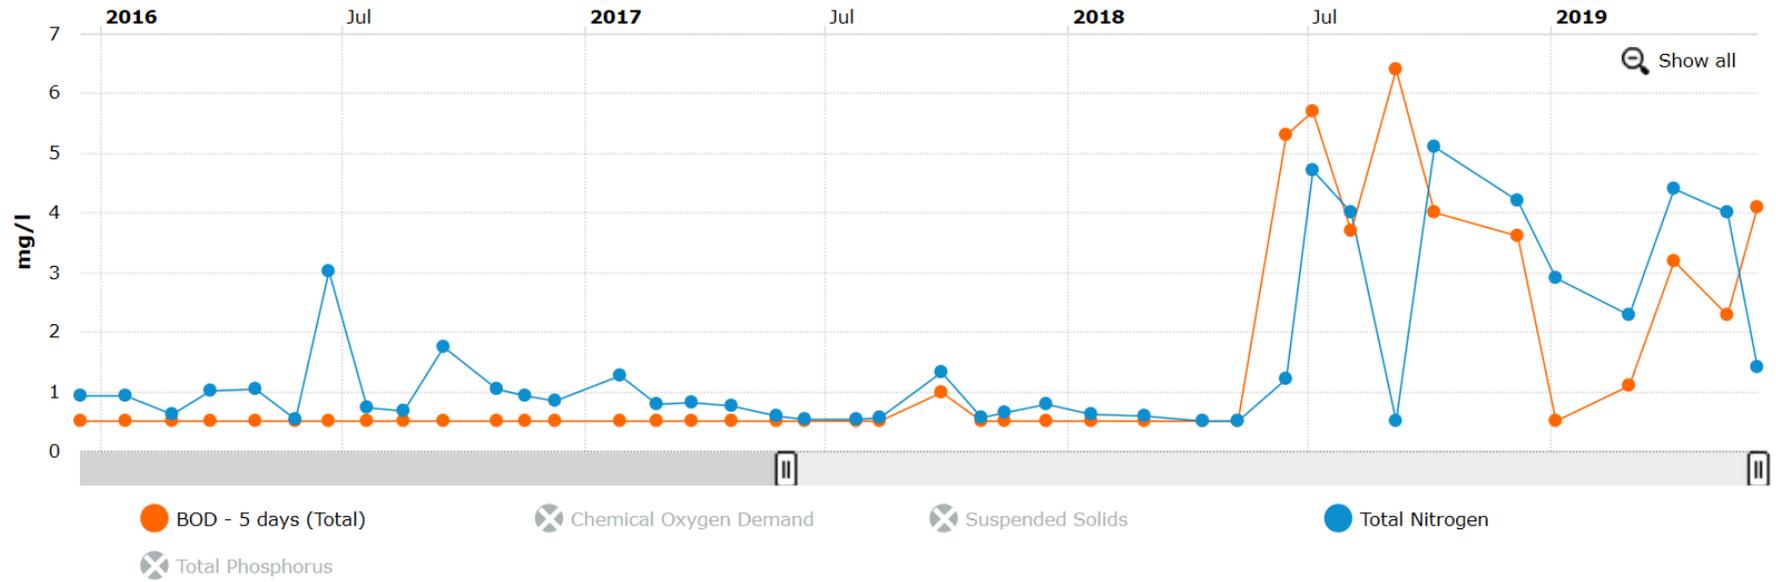
Figure 9: BOD and Total Nitrogen graph from the Monitoring Point “Br U/S Ballycurke Lough” (Upstream of the Moycullen WWTP)

Two monitoring points on the Ballycurke_010, Br U/S of Ballycurke Lough and the Downstream monitoring point of the WWTP – as shown in **Figure 22**, are showing spikes in BOD and Total Nitrogen, as seen in **Figure 23** and **24**. There are also spikes in ammonia at these two monitoring points. The LCA will focus on the sources of the Ammonia, high BOD and total nitrogen and identify what is contributing to these parameters upstream of the WWTP.

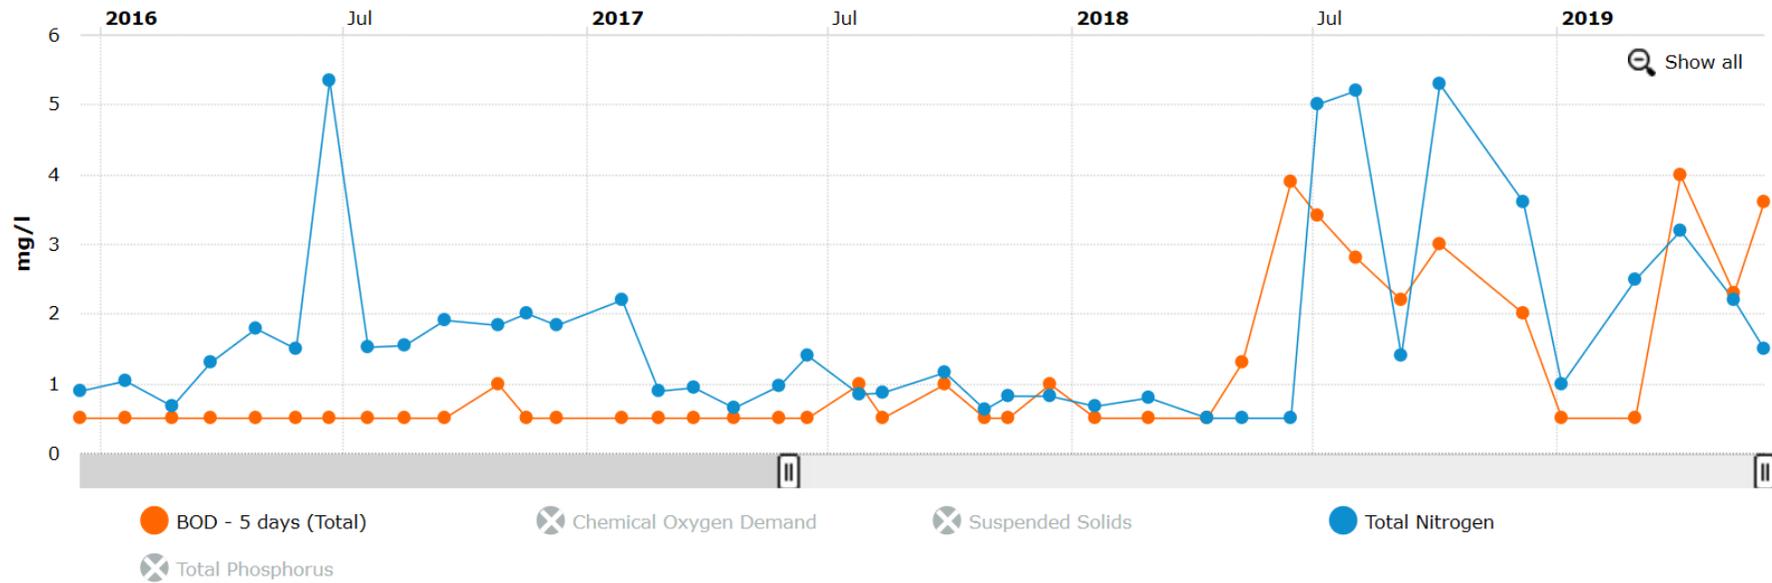
Figure 10: BOD and Total Nitrogen graph from the Monitoring Point "Downstream Monitoring of TPEFF1200D0191SW001"(downstream of the Moycullen WWTP)

| Waterbody | Drimneen_010 | Ballycurke_010 | | |
|---|---|---|---|---|
| Comments | This waterbody was unassigned and determined to be <i>At review</i> stage, during the initial characterisation stage. However, a sample value assessment was undertaken in 2018, and achieved good biological status. There is an OPW drainage scheme | In relation to chemistry data, Phosphate and Ammonia is below the ecological threshold, and is not statistically significant. The BOD has exceeded the EQS limits in 2017 and 2018. The biological conditions of the site are moderate. There are OPW arterial drainage schemes in this waterbody and various | Ammonia has exceeded the EQS threshold in 2016 and 2018 although the trend is currently not environmentally or statistically significant. There are also exceedances in BOD and Total phosphorus. | Ammonia and phosphate have exceeded the EQS for several years including in 2018, also total nitrogen has been seen to be high from July 2018 until December 2018, and also on a number of occasions in the years previous to that, see figure 10. |

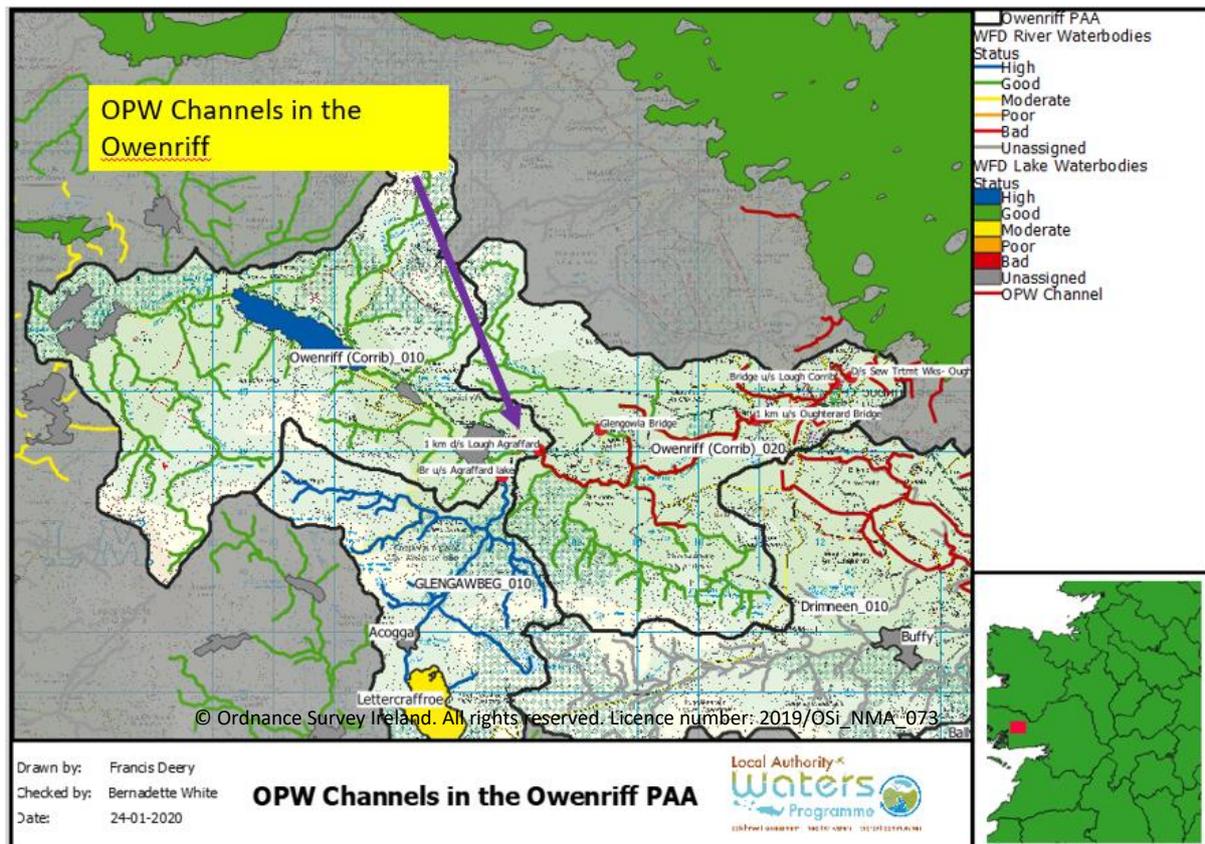
Figure 11: Corrib - Headford Drainage Scheme in the Owenriff_010

Hydromorphology in the form of channelisation, is the significant pressure affecting the Owenriff_010 by changing the hydrological and morphological conditions of the river. The Corrib – Headford arterial drainage scheme is present in the Owenriff_010, which can be seen in **Figures 11** and **12**.

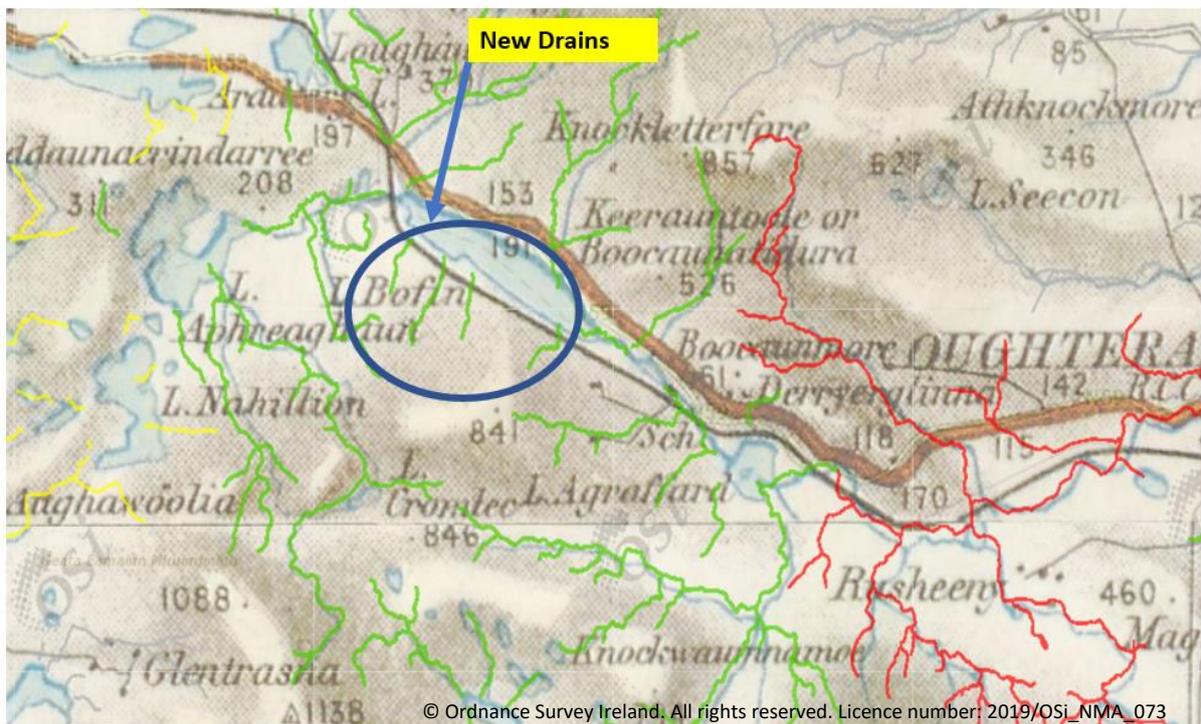
Figure 12: New Drains leading into Lough Bofin

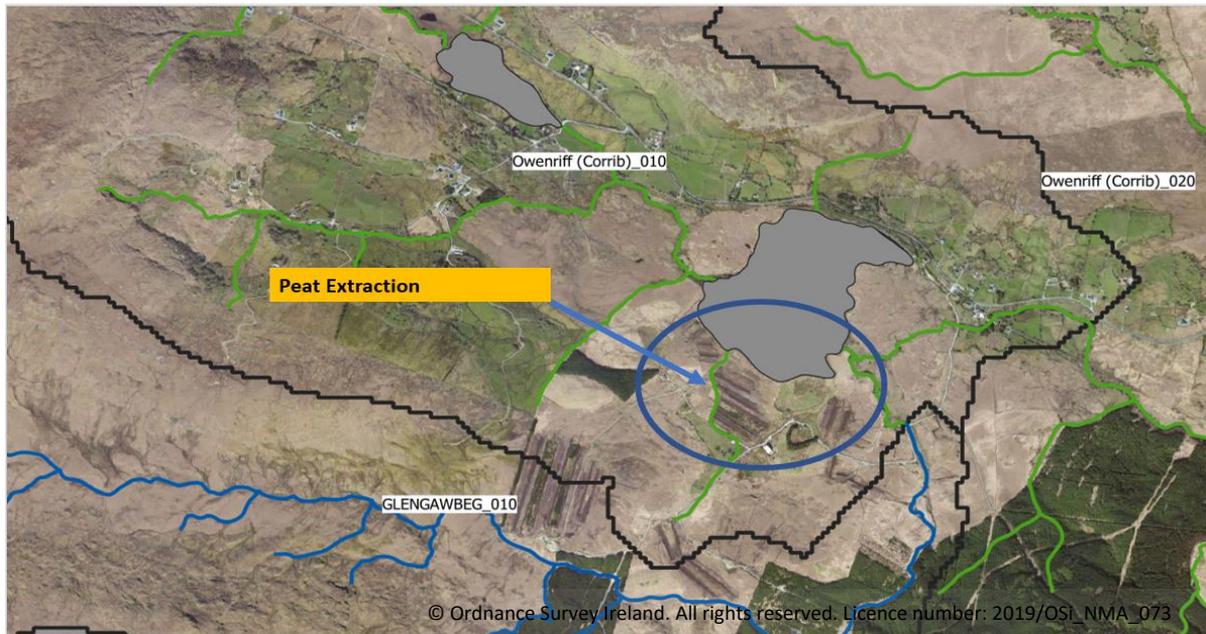
Figure 13: Peat Extraction in the Vicinity of the Owenriff_010

Peat is not listed as a pressure in the Owenriff_010, however there a number of areas of turf cutting located around the Agraffard lake which can be seen in **Figure 13**. Again, the water body is achieving a Q4-5 at the monitoring point, therefore this peat extraction area is likely only to be locally significant. The focus of the LCA will be to identify drains in this area and to assess the contributions they are making, if any, to Agraffard lake.

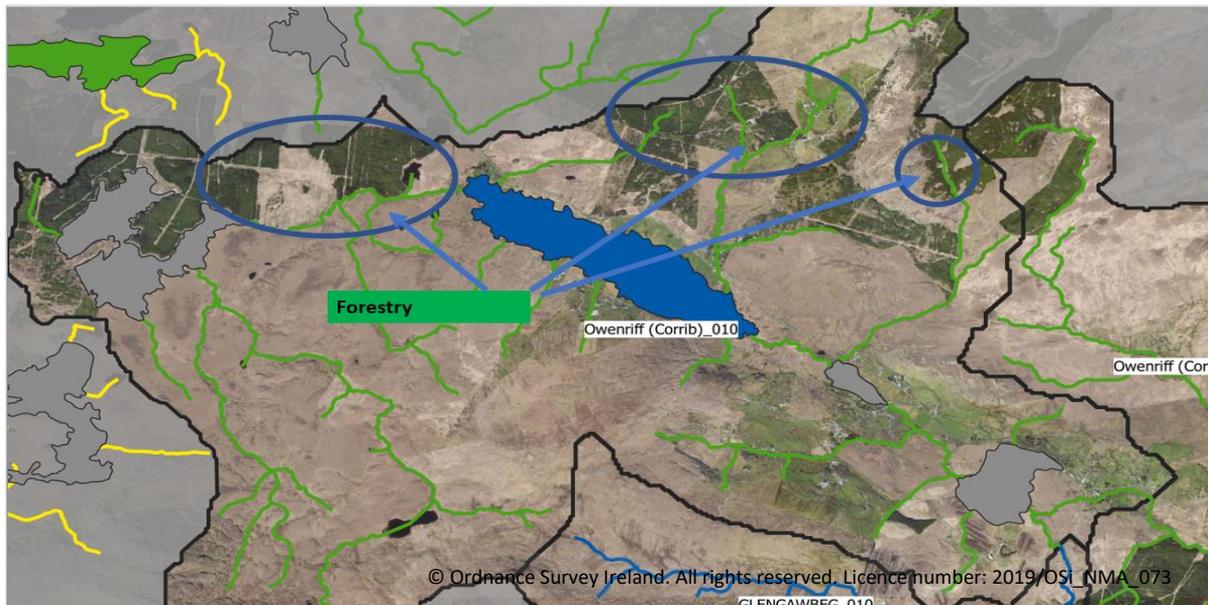
Figure 14: Forestry in the Owenriff_010 area

As with peat extraction, forestry is not listed as a pressure, although there a number of plantations located in the vicinity of the Owenriff_010, which can be seen in **Figure 14** below.

The dominant species in these plantations are Sitka Spruce and Lodge Pole Pine, and the ages of the plantation's range from the early 70s up to the 1990s. Most of the plantations are state owned forestry, but there is a small percentage of the forestry privately owned. Although unlikely to be causing a pressure at the moment, the focus of the LCA will be to identify areas of risk for future pressures e.g. where there is no buffers (pre 1990's plantations), tunnelling of streams/rivers etc.

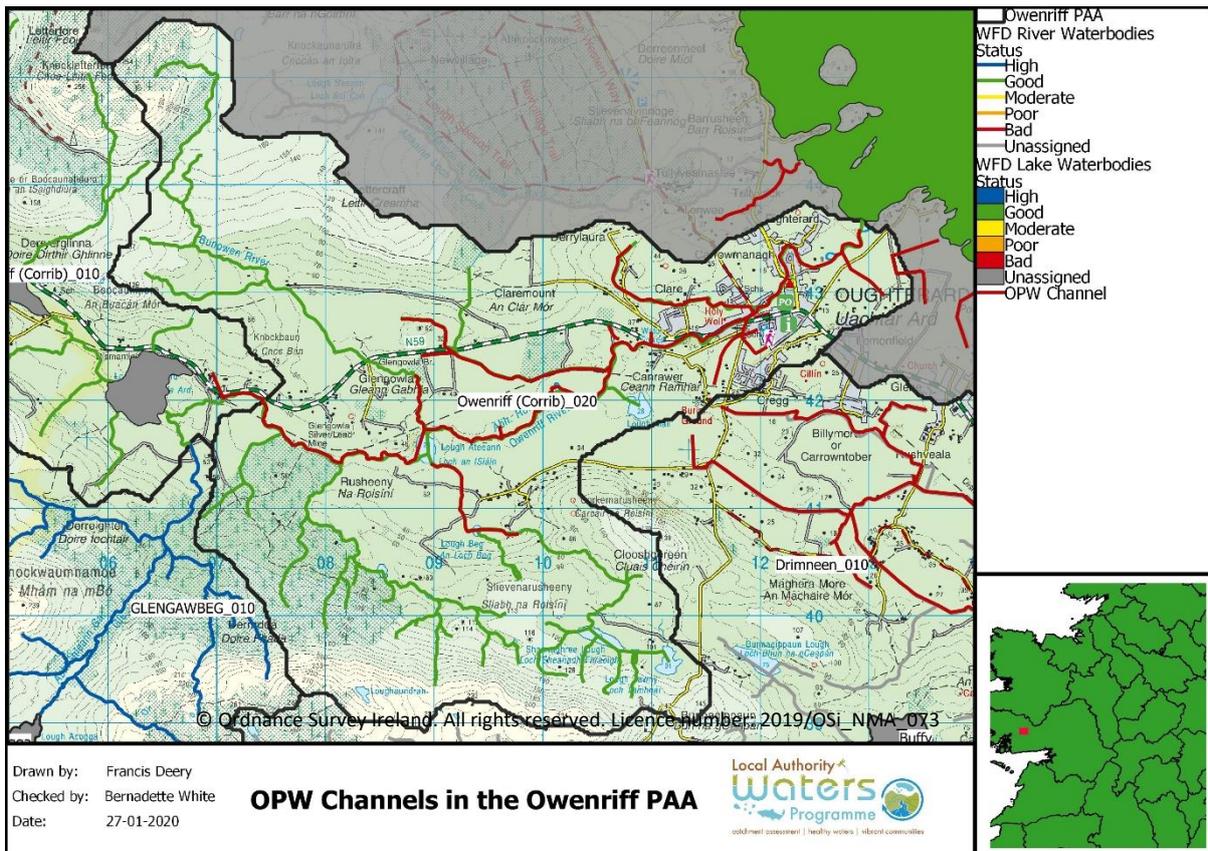
Figure 15: OPW Drainage Scheme in the Owenriff_020

Hydromorphology is the sole significant pressure identified for the Owenriff_020 in the form of channelisation, which is affecting the waterbody by changing the hydrological and morphological conditions of the river. The Corrib – Headford arterial drainage scheme is present in the Owenriff_020, which can be seen in **Figures 15 and 16**.

The OPW Corrib-Clare arterial drainage scheme is a minor drainage scheme which was active from the 1950s. There are also several weirs on the main channel of the Owenriff_020 in the town of Oughterard, and number of the tributaries have road and land bridges constructed on them, as well as fords, culverts and other concrete structures. The EPA comments in the WFD App are “There is a High HYMO/bio status site within this water body - other four sites are of Good invert status - appears like this is reflecting localised conditions. EPA to develop a morphological assessment to assess/address this issue.” As for Owenriff_010, during the LCA the focus will be to identify if the pressures identified in the RHAT survey (**Table 6**) are locally significant or significant at the water body scale. These pressures are potentially preventing the monitoring points in this water body from achieve a high Q value status.

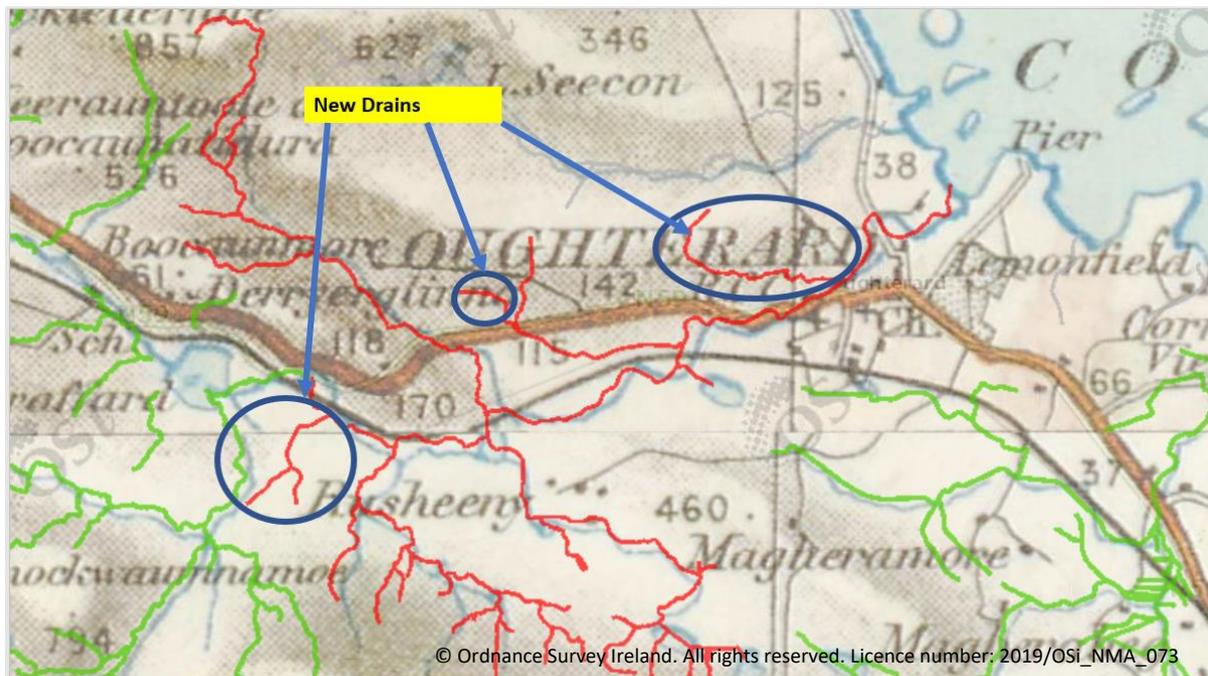
Figure 16: New Drains opened in the Owenriff_020

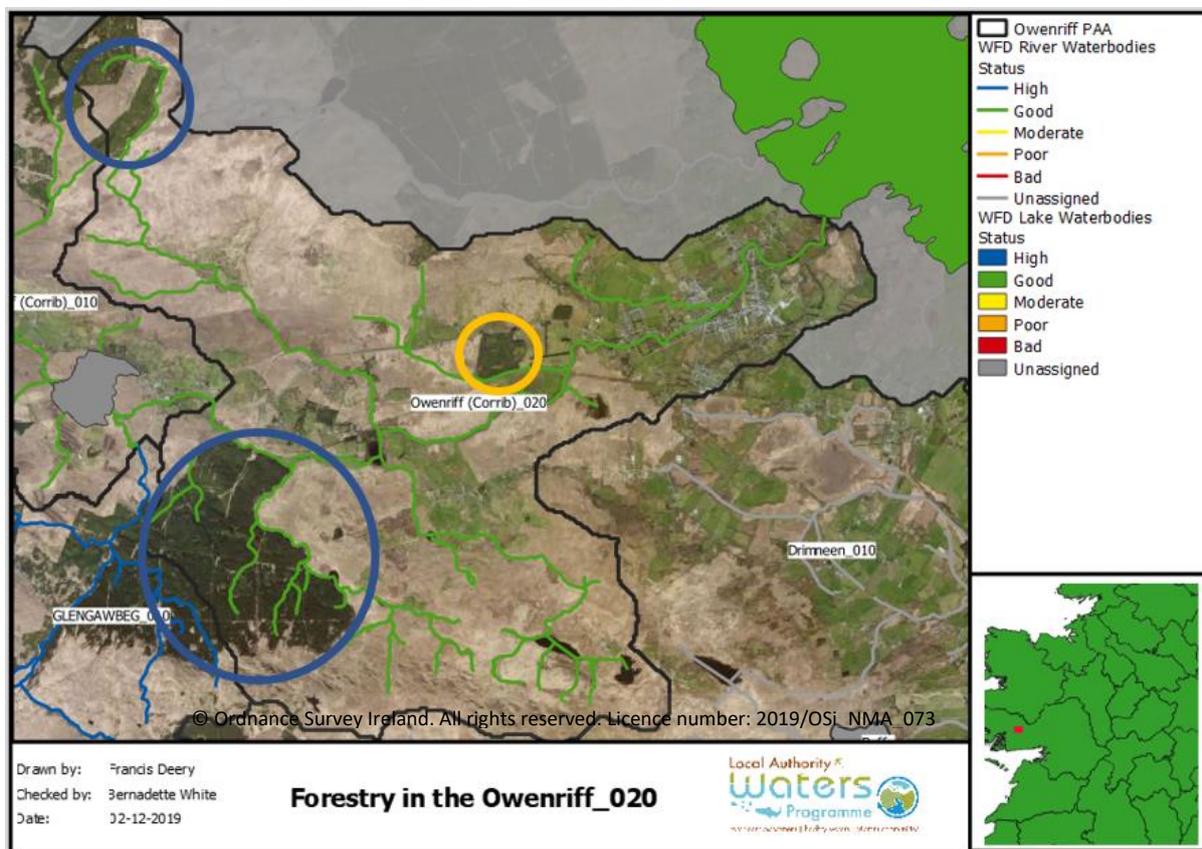
Figure 17: Forestry in the Vicinity of the Owenriff_020

There are several forestry plantations in the Owenriff_020 area, both state – owned and privately-owned forestry as can be seen in **Figure 17**. The State-owned forestry has been planted since the 1970s, while the private forestry in the Owenriff_020 area has been planted in the early 1990s, the dominant species in all the forestry plantations is Sitka Spruce. The majority of the state-owned forestry was planted before the new forest service guidelines regarding buffer zone management along watercourses e.g. within the buffer zone, ground preparation and other forest operations curtailed in order to protect water quality. In addition, drainage channels leading from the site must taper out before entering the buffer zone.

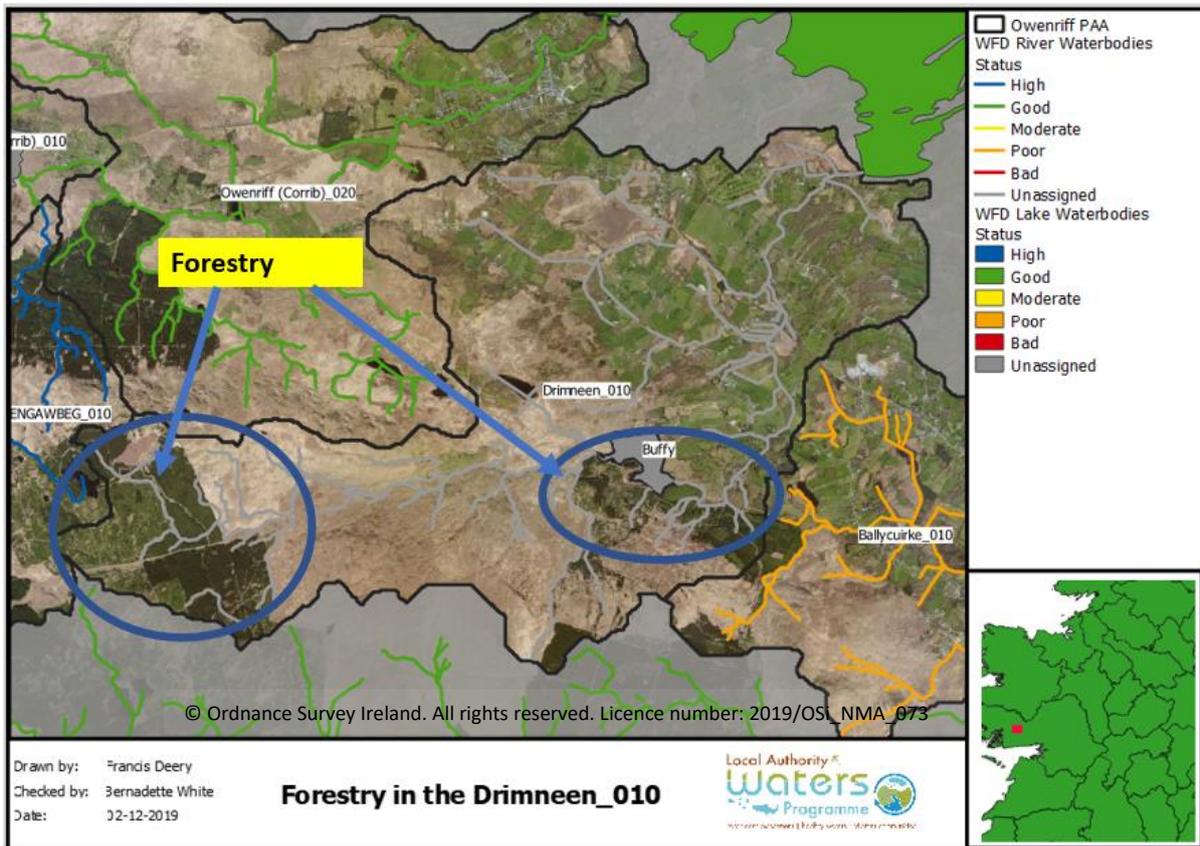
Figure 18: Forestry in the Drimneen_010 Area

Forestry is noted as a significant pressure that may be impacting upon the status of this unassigned river waterbody. There is a significant amount of forestry in the headwaters of the Drimneen_010, this forestry would be mainly state – owned forestry and there is a significant amount of forestry located around the Buffy Lough, which is also state – owned forestry. Some of this forestry has failed to establish properly. There are several standalone privately-owned forestry plantations towards the lower end of this waterbody. The forestry in the headwaters (see **Figure 18**) was planted in the early 1970s and dominated by Sitka Spruce, around the Buffy Lough the forestry was planted in the 1980s. Given that these forestry plantation were planted before the 1991, there will be no buffer zones beside the adjacent watercourses in the forestry stands.

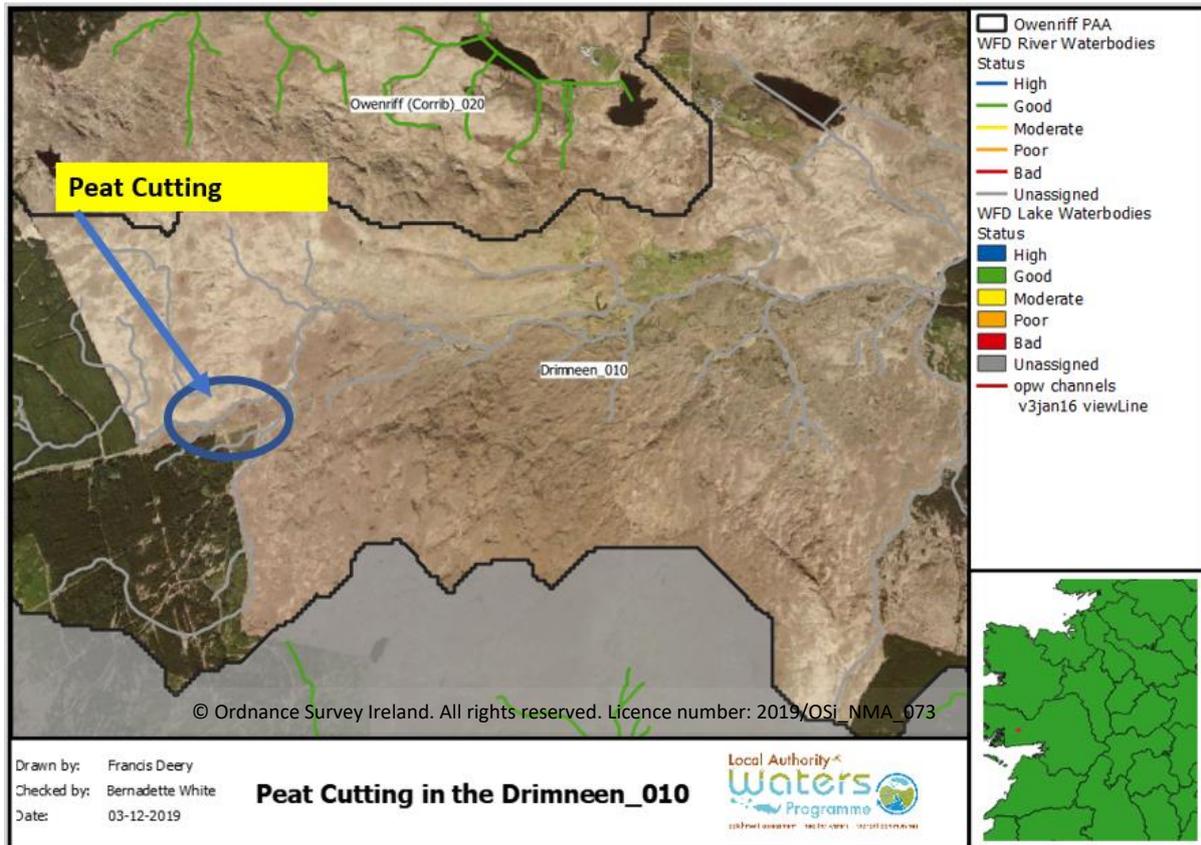
Figure 19: Peat Cutting in the Drimneen_010

Peat extraction is a significant pressure that is noted in the initial characterisation of the Drimneen_010, in the form of nutrient pollution and morphological changes. There are number of areas where peat cutting is being carried out on a small scale, near the headwaters of the Drimneen_010, which can be seen in the **Figure 19**. In comparison to the area of the Drimneen_010 catchment the areas of peat cutting are located in the headwaters and are small private peat cutting. This type of peat extraction will more than likely be impacting the river locally but not a catchment scale. The LCA will focus on sampling areas below the peat cutting and areas above the peat cutting.

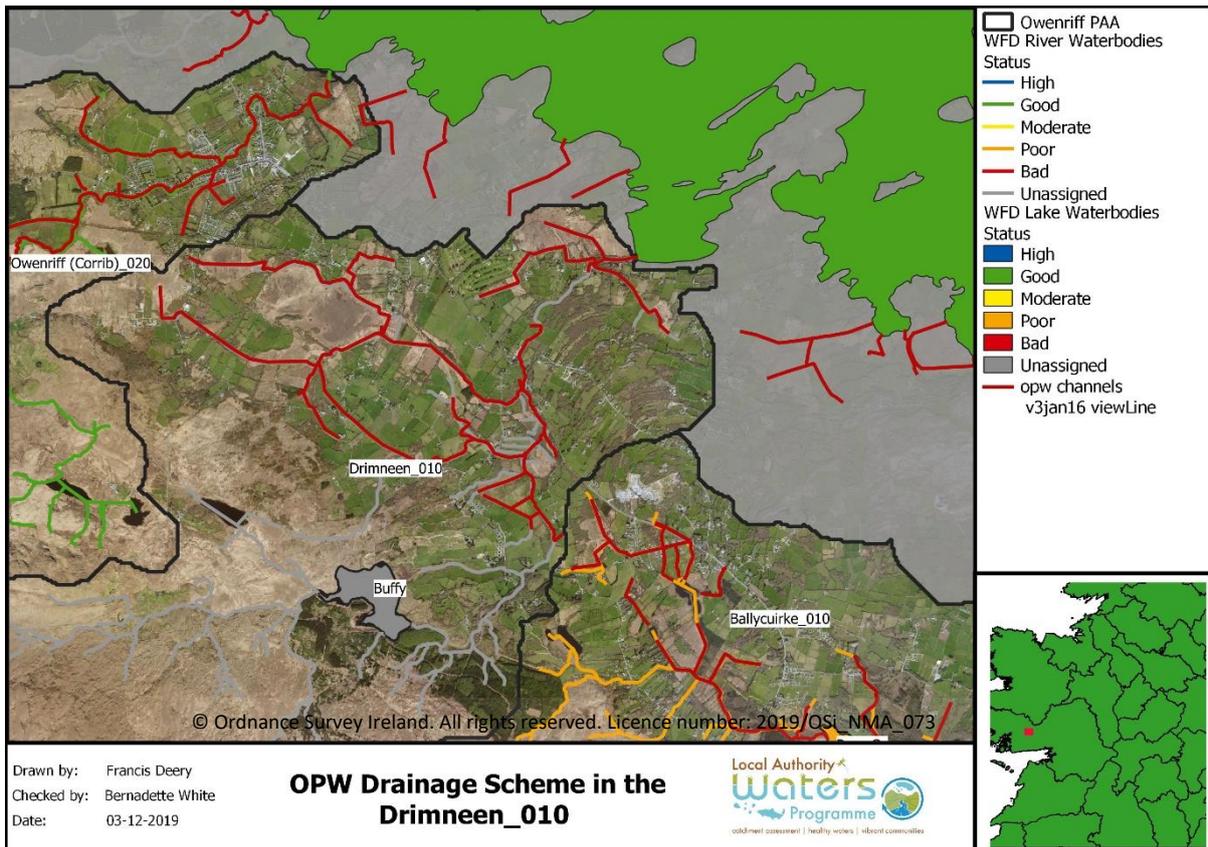
Figure 20: OPW Drainage scheme in the Drimneen_010

There is an old OPW arterial drainage scheme in the Drimneen_010, the Corrib – Headford scheme (**Figure 20**), which started in the 1950s, it is a minor drainage scheme, the scheme may be affecting the flow regime of the river which may be impacting on the biological characteristics of the water in the Drimneen_010.
