Owenriff

Desktop Assessment

Western Region

(AFA0148)

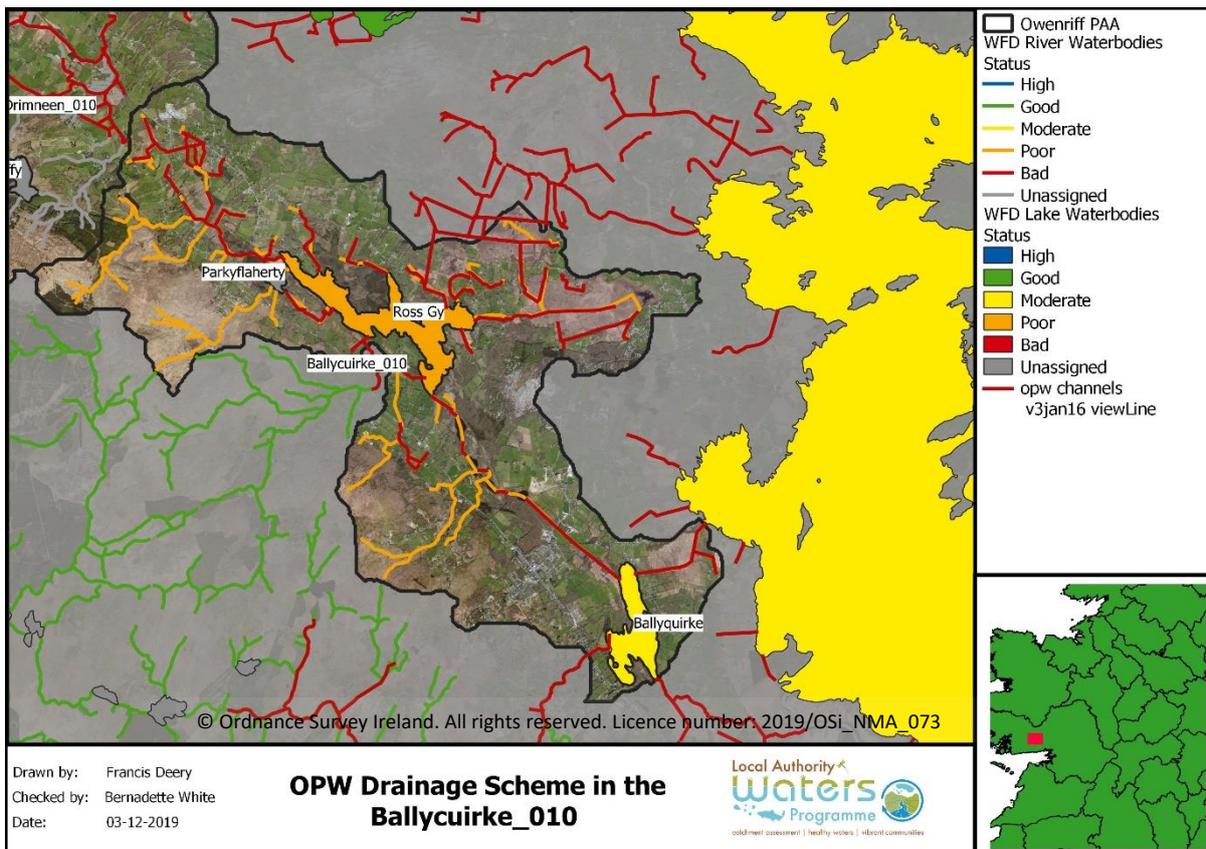
Figure 21: OPW Drainage Scheme in the Ballycurke_010

Hydromorphology is a pressure that is impacting upon the Ballycurke_010, which is changing the morphological conditions of the waterbody. The Corrib – Clare OPW drainage scheme intersects this water body. **Figure 21** shows that the scheme covers almost the entirety of the Ballycurke_010 apart from a few tributaries coming in from the west of the catchment. The scheme may be affecting the flow regime of the river which may be impacting on the biological characteristics of the water in the Ballycurke_010.

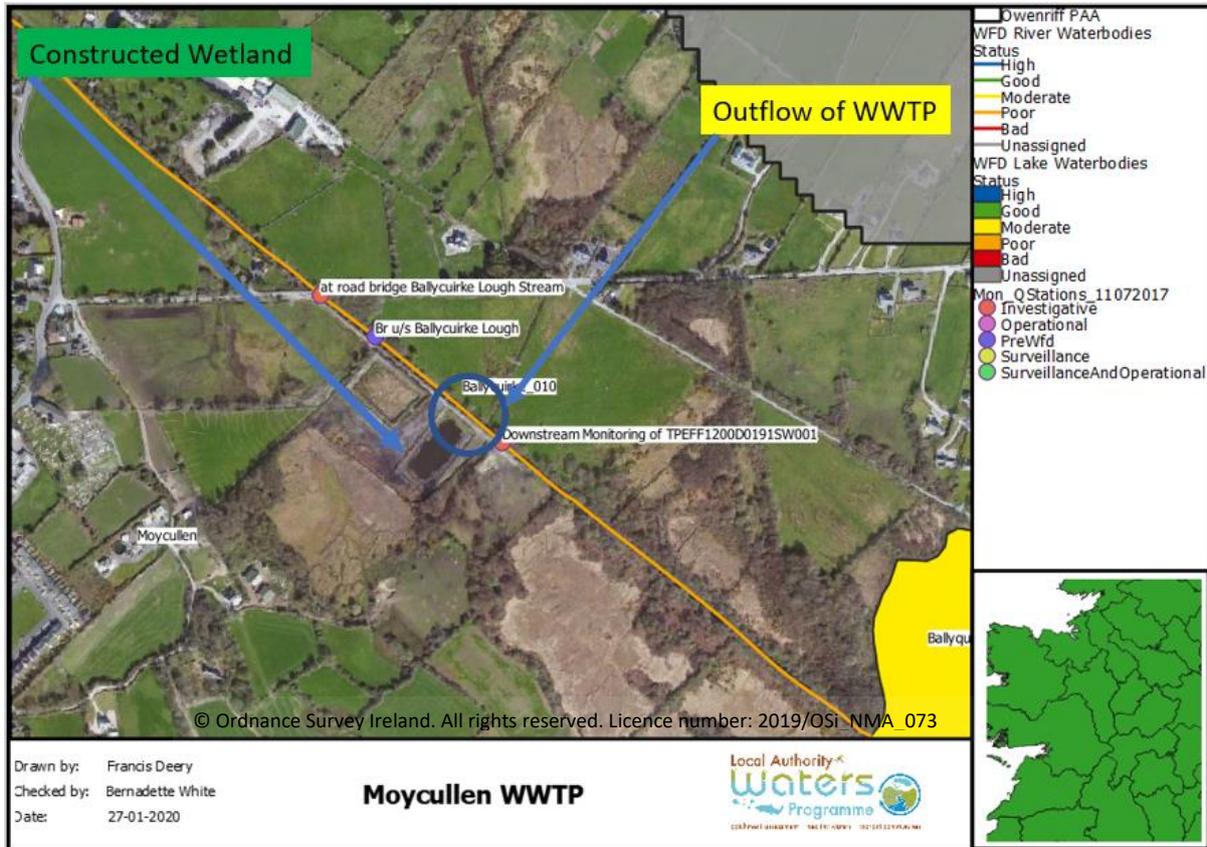
Figure 22: Monitoring Points around the Moycullen WWTP in the Ballycurke_010

Two monitoring points on the Ballycurke_010, Br U/S of Ballycurke Lough and the Downstream monitoring point of the WWTP – as shown in **Figure 22**, are showing spikes in BOD and Total Nitrogen, as seen in **Figure 23** and **24**. There are also spikes in ammonia at these two monitoring points. The LCA will focus on the sources of the Ammonia, high BOD and total nitrogen and identify what is contributing to these parameters upstream of the WWTP.

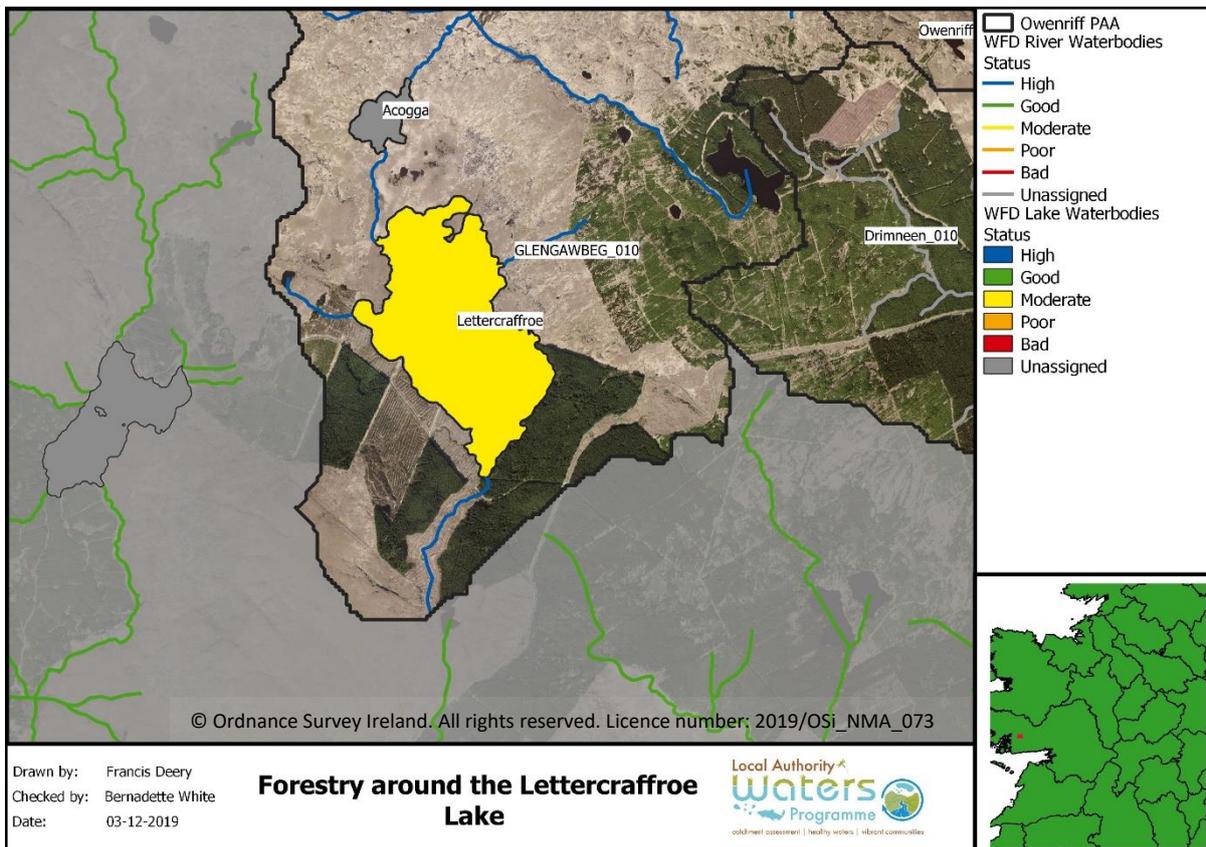
Figure 25: Forestry around the Lettercraffroe Lake

There is both state – owned and privately-owned forestry (**Figure 25**) located around Lettercraffroe the Coillte forestry has been planted since the 1960s and the main species is Sitka Spruce. To the right of the Lettercraffroe lake there is privately owned forestry that was planted in the 1990s and again the main species is Sitka Spruce. The majority of the state-owned forestry was planted before the new forest service guidelines regarding buffer zone management along watercourses e.g. within the buffer zone, ground preparation and other forest operations curtailed in order to protect water quality. In addition, drainage channels leading from the site must taper out before entering the buffer zone. While the privately-owned forestry would adhere to these regulations.

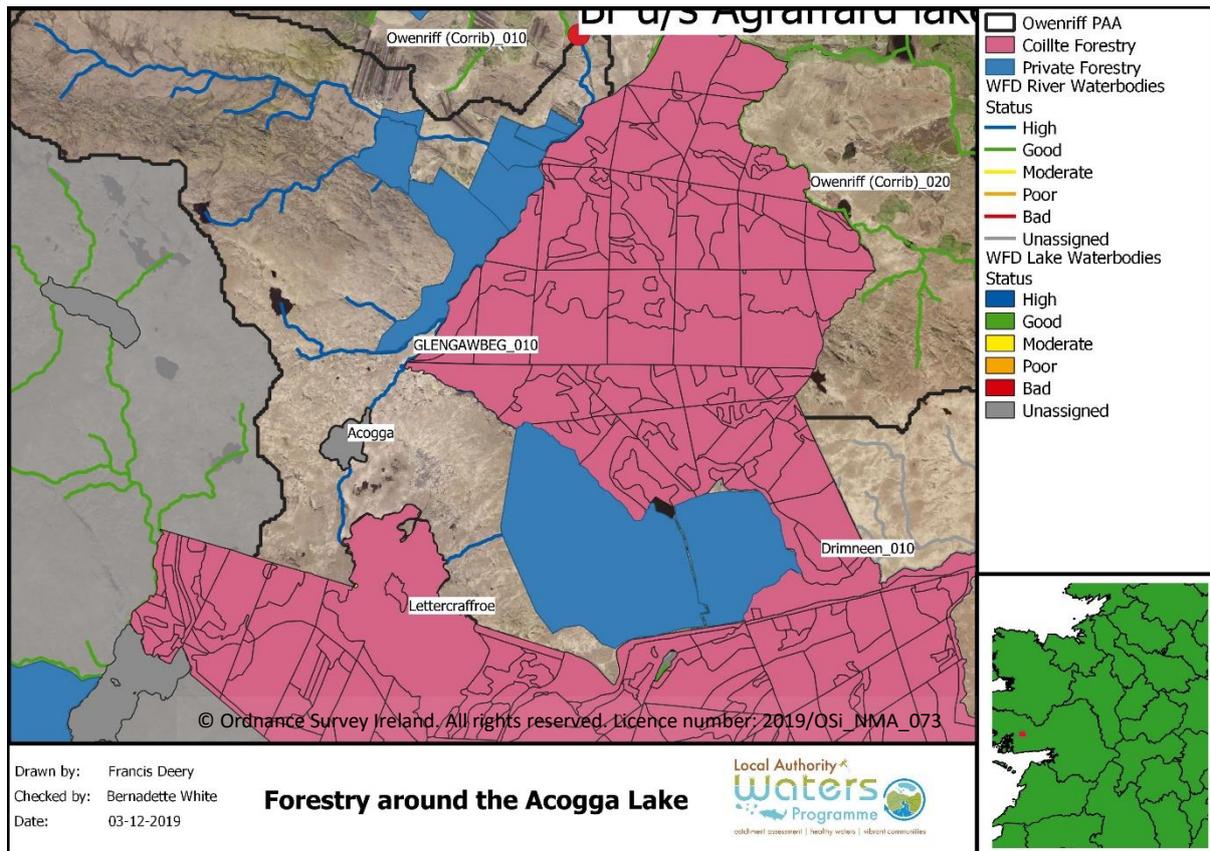
Figure 28: Forestry around Acogga

Figure 28. There is a significant amount of state-owned forestry within the area of the lake, this forestry was planted in the 1960s onwards, and the main species is Sitka Spruce. Given that these forestry plantation were planted before the 1991, there will be no buffer zones beside the adjacent watercourses in the forestry stands. There is also a good amount of private forestry in the region as well, this forestry was planted in the early 1990s and the dominant species is also Sitka Spruce. Acogga is an unassigned lake therefore there is no data to indicate that nutrients are causing an issue in the lake, the LCA will clarify this when carried out by LAWPRPO.

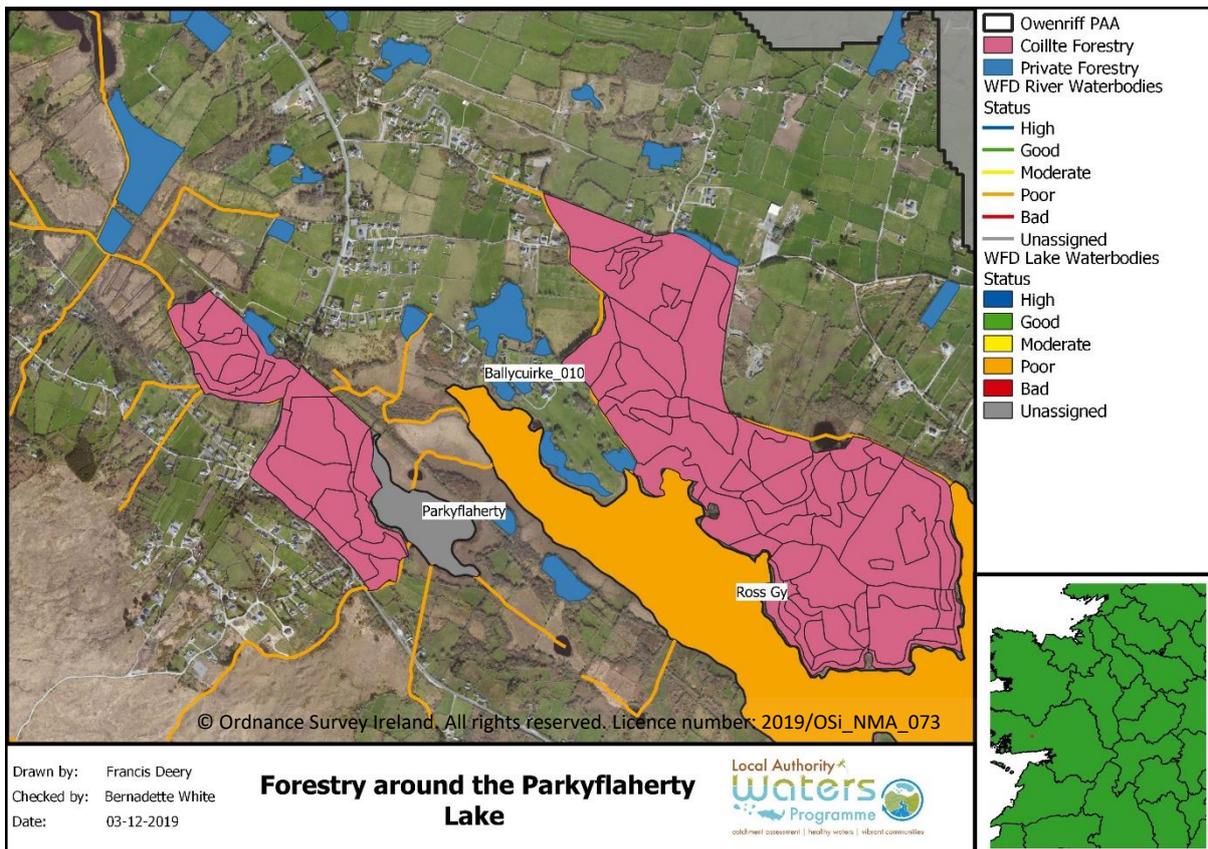
Figure 29: Forestry around Parkyflaherty Lake

The species that are in the state owned Coillte forestry is a mix of oak, birch and Sitka spruce, with varying dates of planting from the 1960s to the present day (**Figure 31**). Given that these forestry plantation were planted before the 1991, there will be no buffer zones beside the adjacent watercourses in the forestry stands. Parkyflaherty is an unassigned lake therefore there is no data to indicate that nutrients are causing an issue in the lake, the LCA will clarify this when carried out by LAWPRPO.

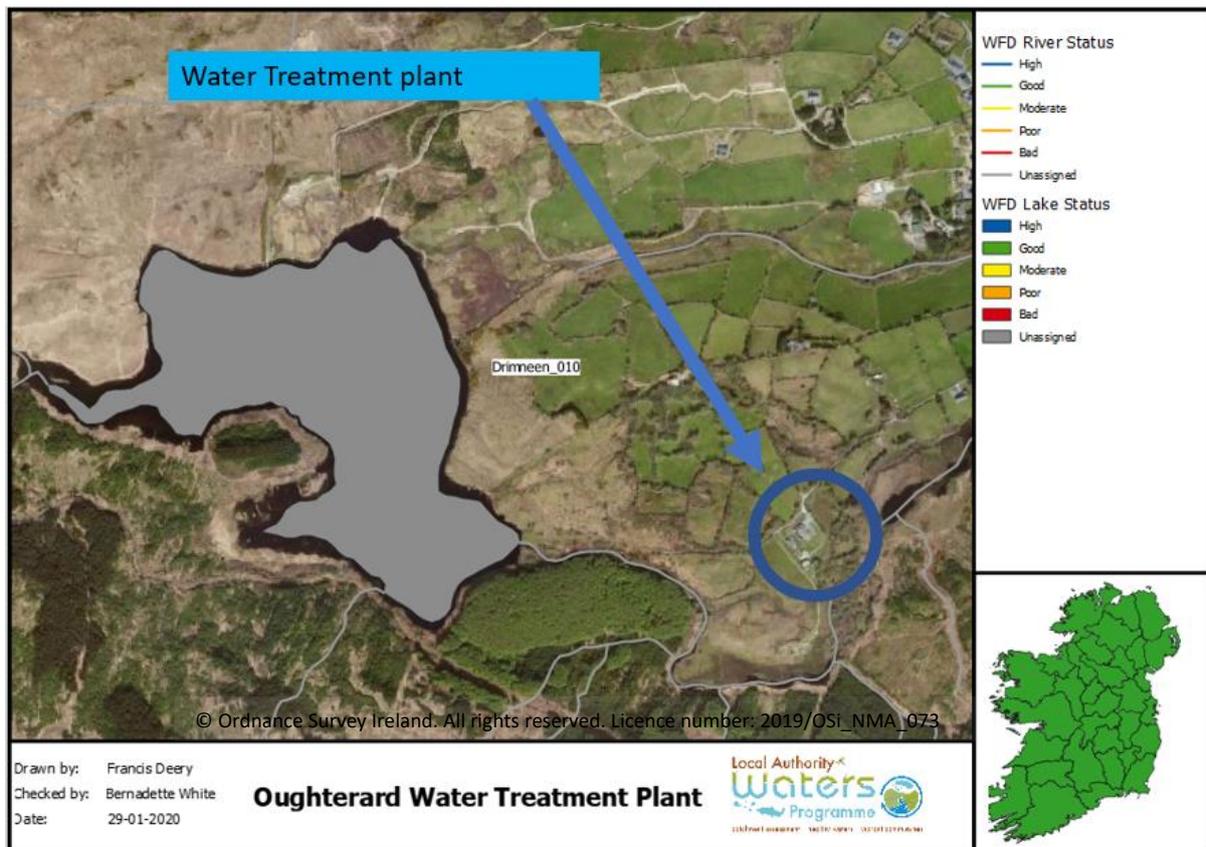
Figure 30: Water Treatment Plant beside Buffy Lough

Figure 30. The WTP is Oughterard WTP. Buffy lake supplies water to Oughterard, parts of Moycullen and Killannin, and the daily abstraction from the lake is 2516m³/day. Inland Fisheries Ireland have indicated that there is a dam at the outlet of this lake and there is currently no fish pass at this point.

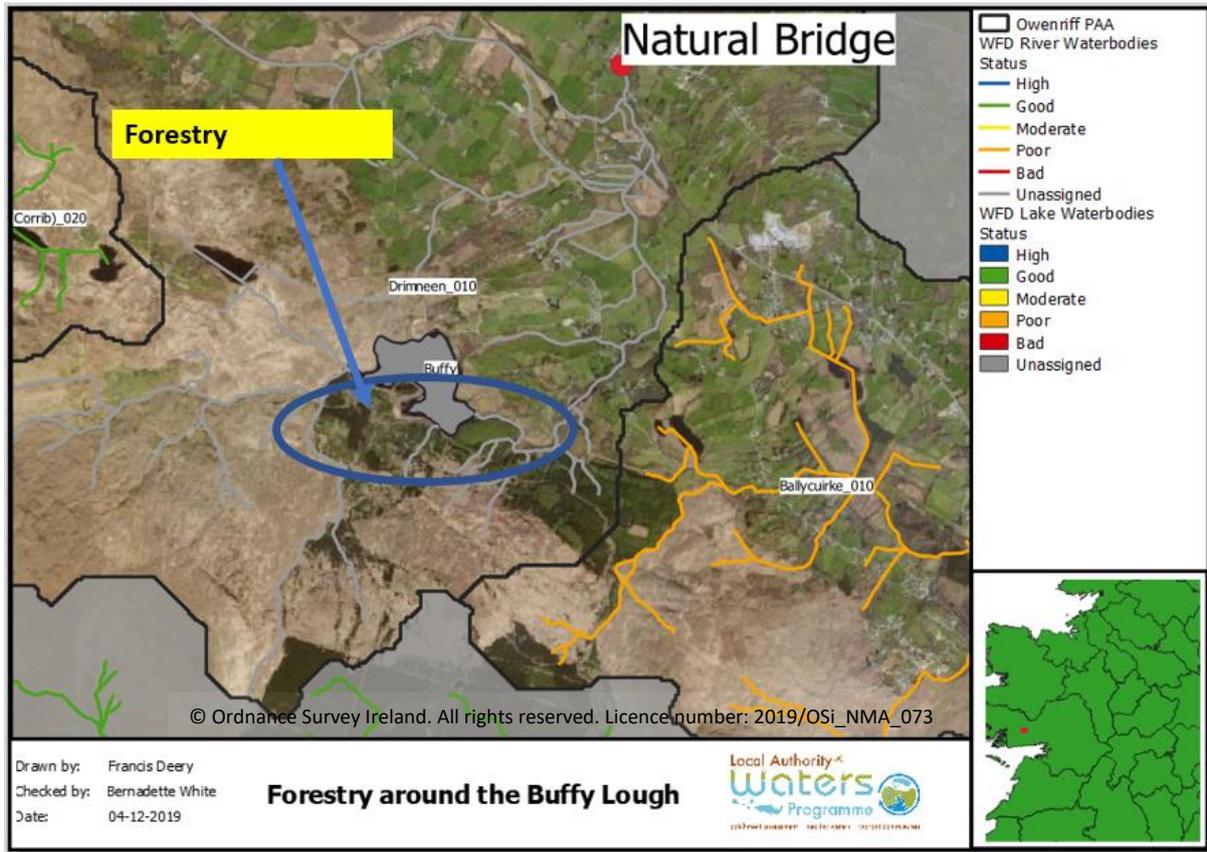
Figure 31: Forestry located around the Buffy Lough

Forestry is noted as a significant pressure impacting upon Buffy lake, in the form of nutrient pollution and morphological changes. The forestry located around the lough is all state – owned forestry, which has been planted since the 1980s, with the dominant species being Sitka Spruce. There are some areas where the forestry plantations have failed to establish. Given that these forestry plantation were planted before the 1991, there will be no buffer zones beside the adjacent watercourses in the forestry stands. Buffy is an unassigned lake therefore there is no data to indicate that nutrients are causing an issue in the lake, the LCA will clarify this when carried out by LAWPRPO.

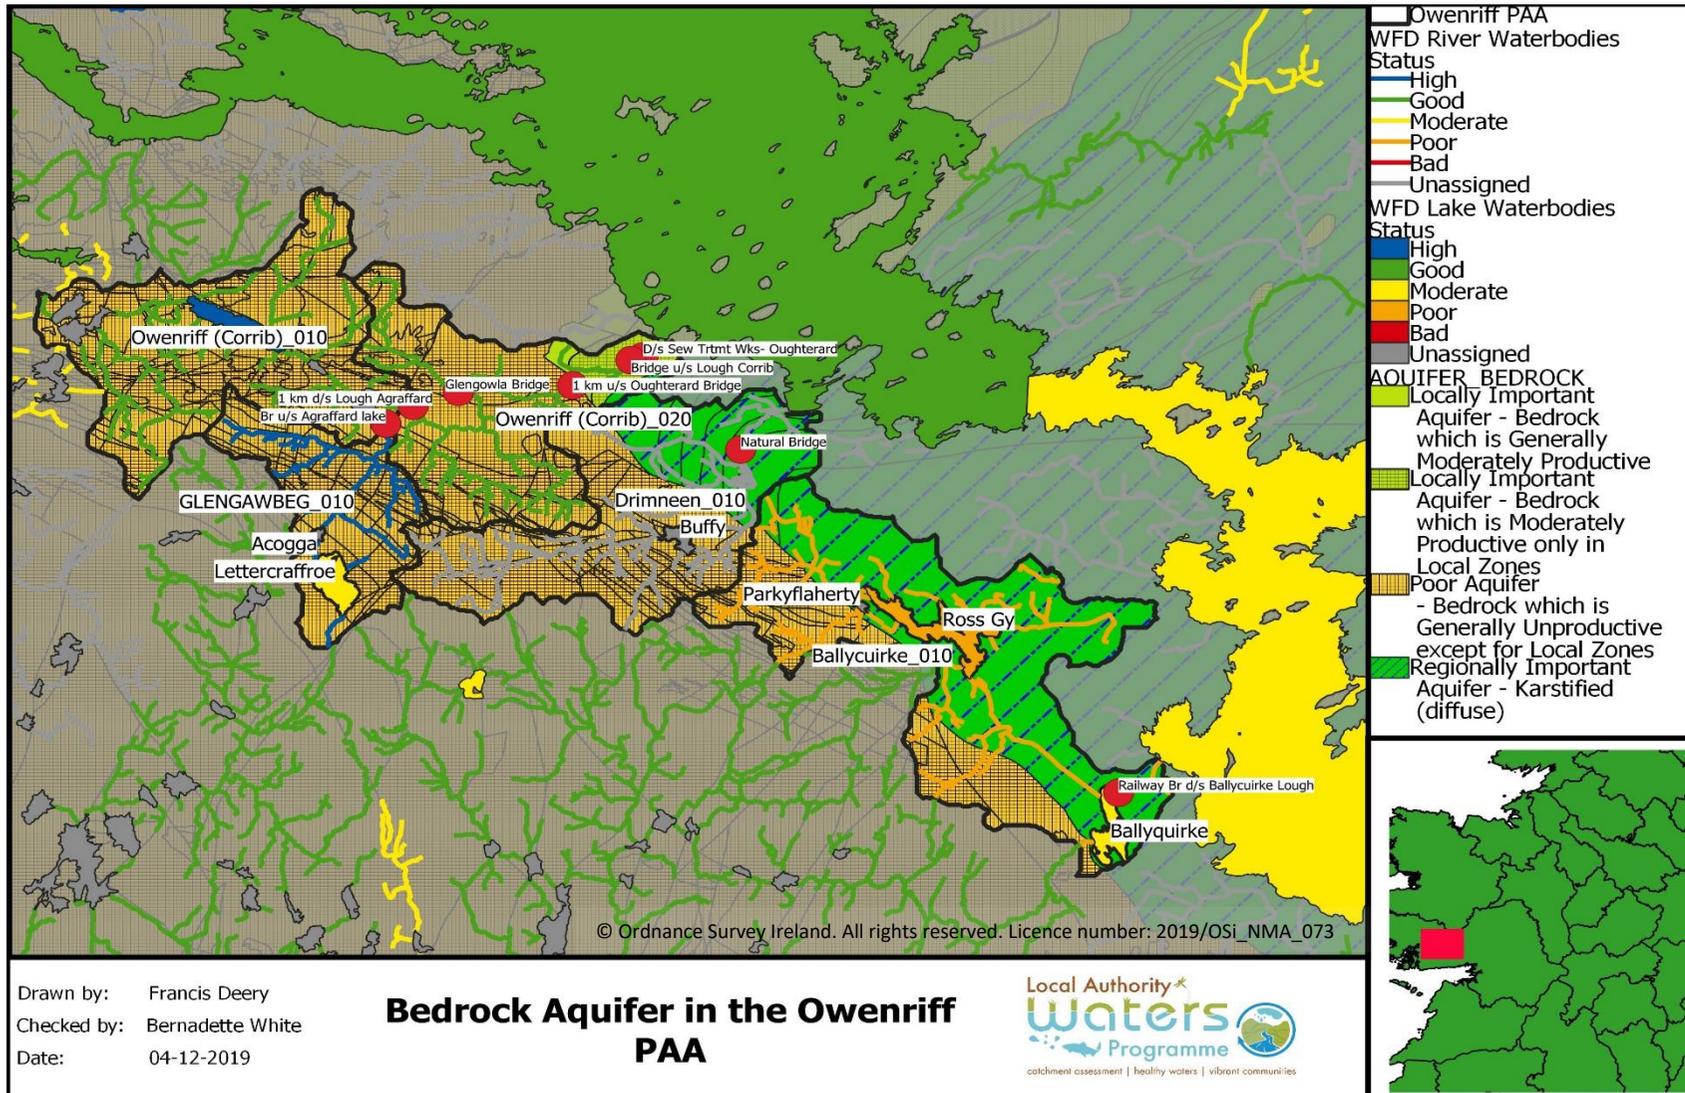
Figure 32: Bedrock Aquifer in the Owenriff PAA

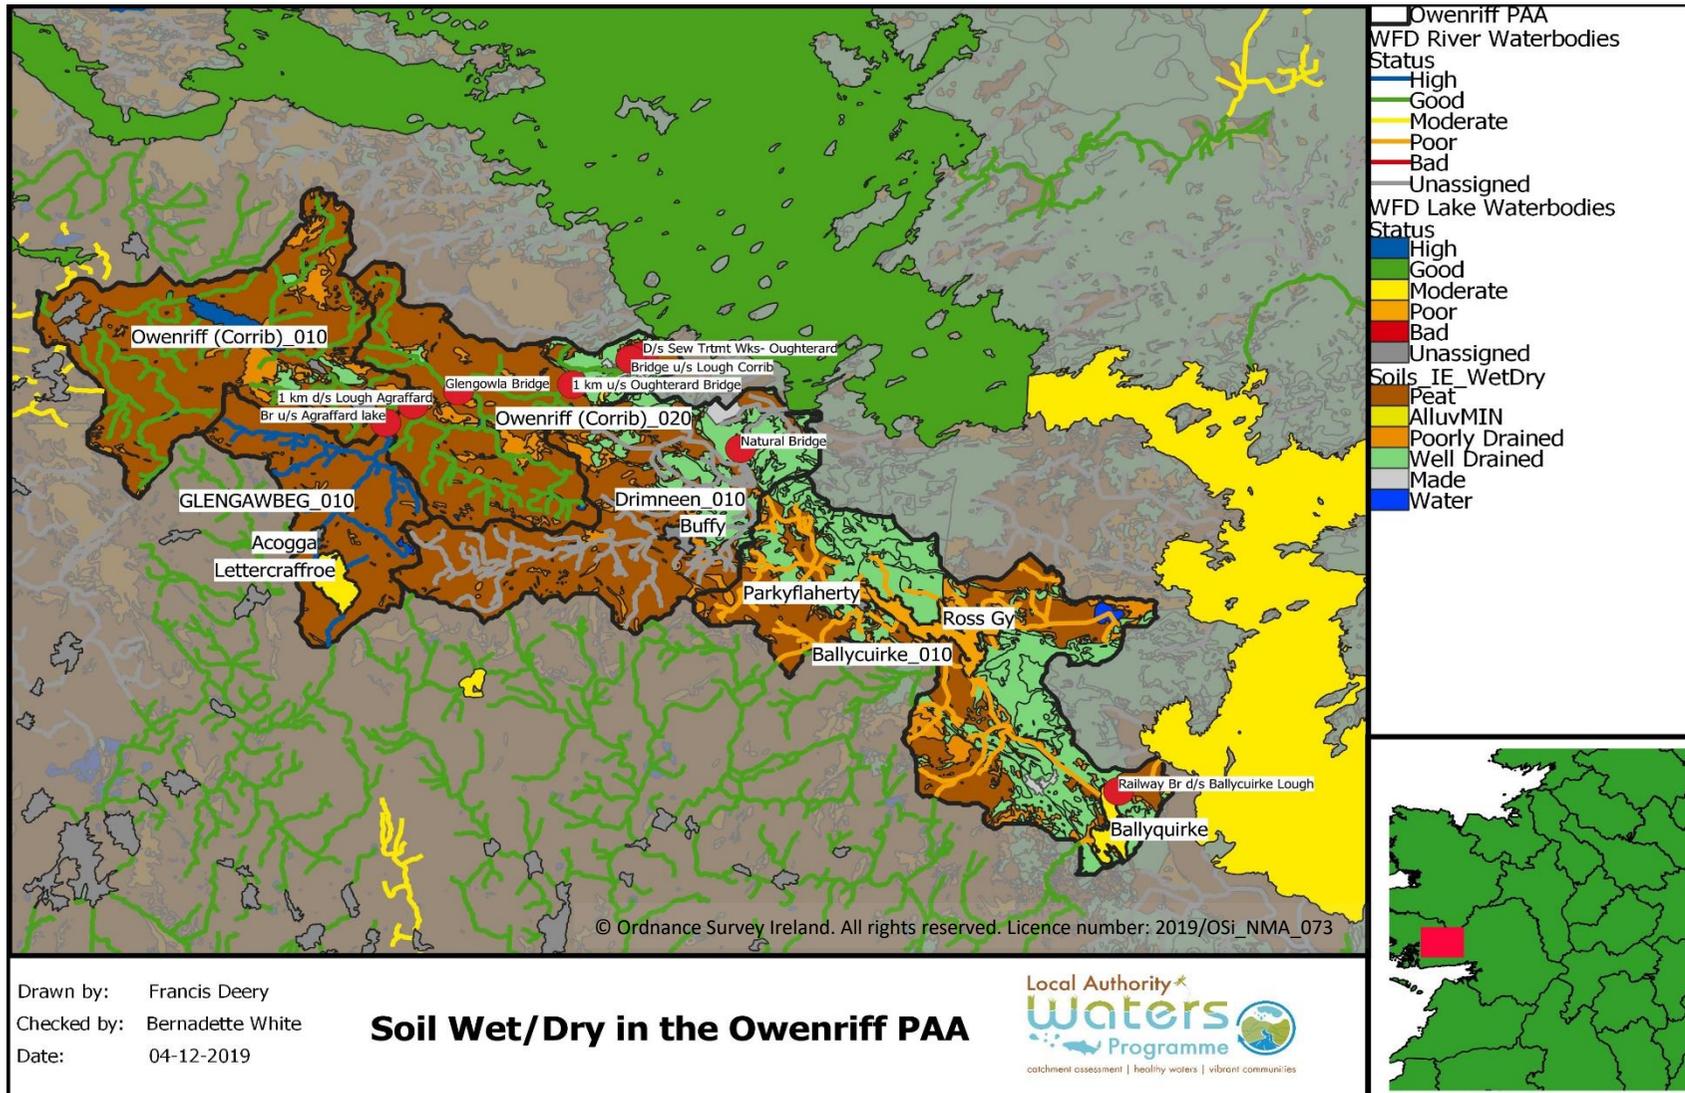
Figure 33: Wet/Dry Soils in the Owenriff PAA

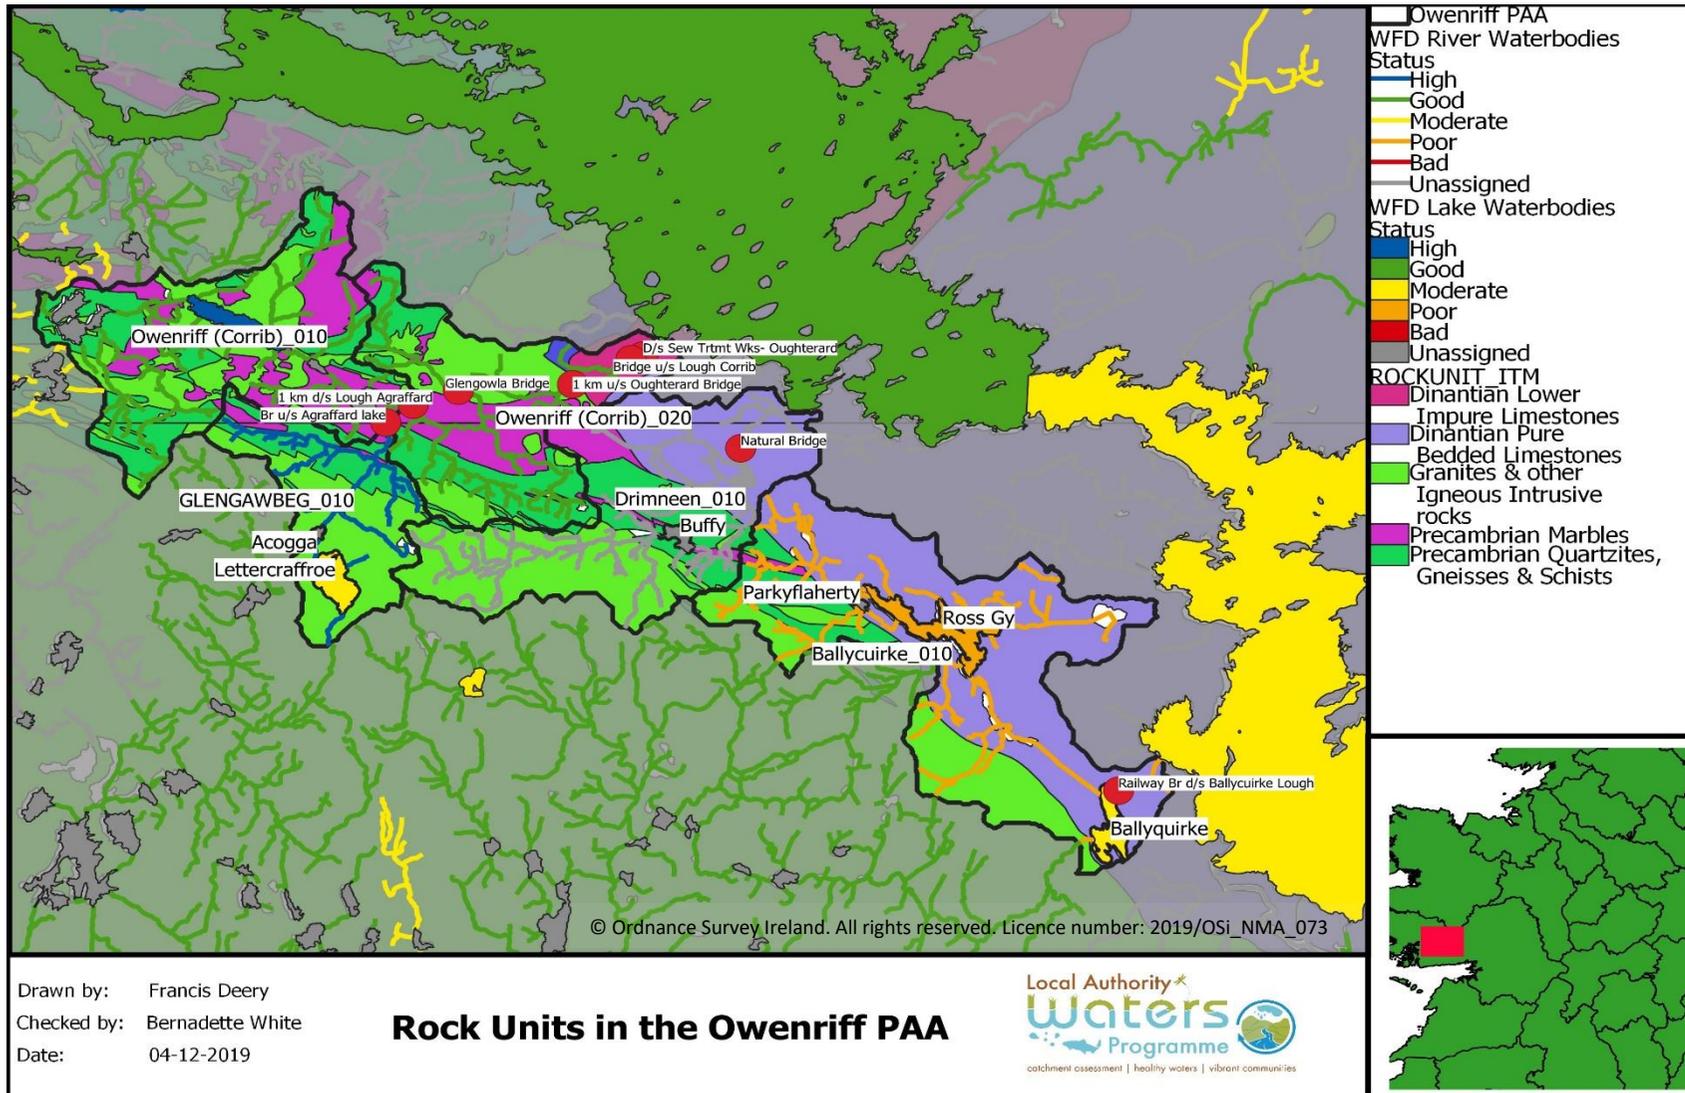
Figure 34: Rock Units in the Owenriff PAA

The rock units in this compartment comprise of Precambrian Quartzites Gneisses & Marbles, also Granites and other igneous rocks. Within these rock types the main flow paths are in a thin upper fractured zone, this would indicate that groundwater flow is limited. Also, the subsoil in Compartment one is dominated by blanket peat, this would also indicate that deep groundwater flow is limited and run off to rivers is flashy and the drainage density within this compartment is high.

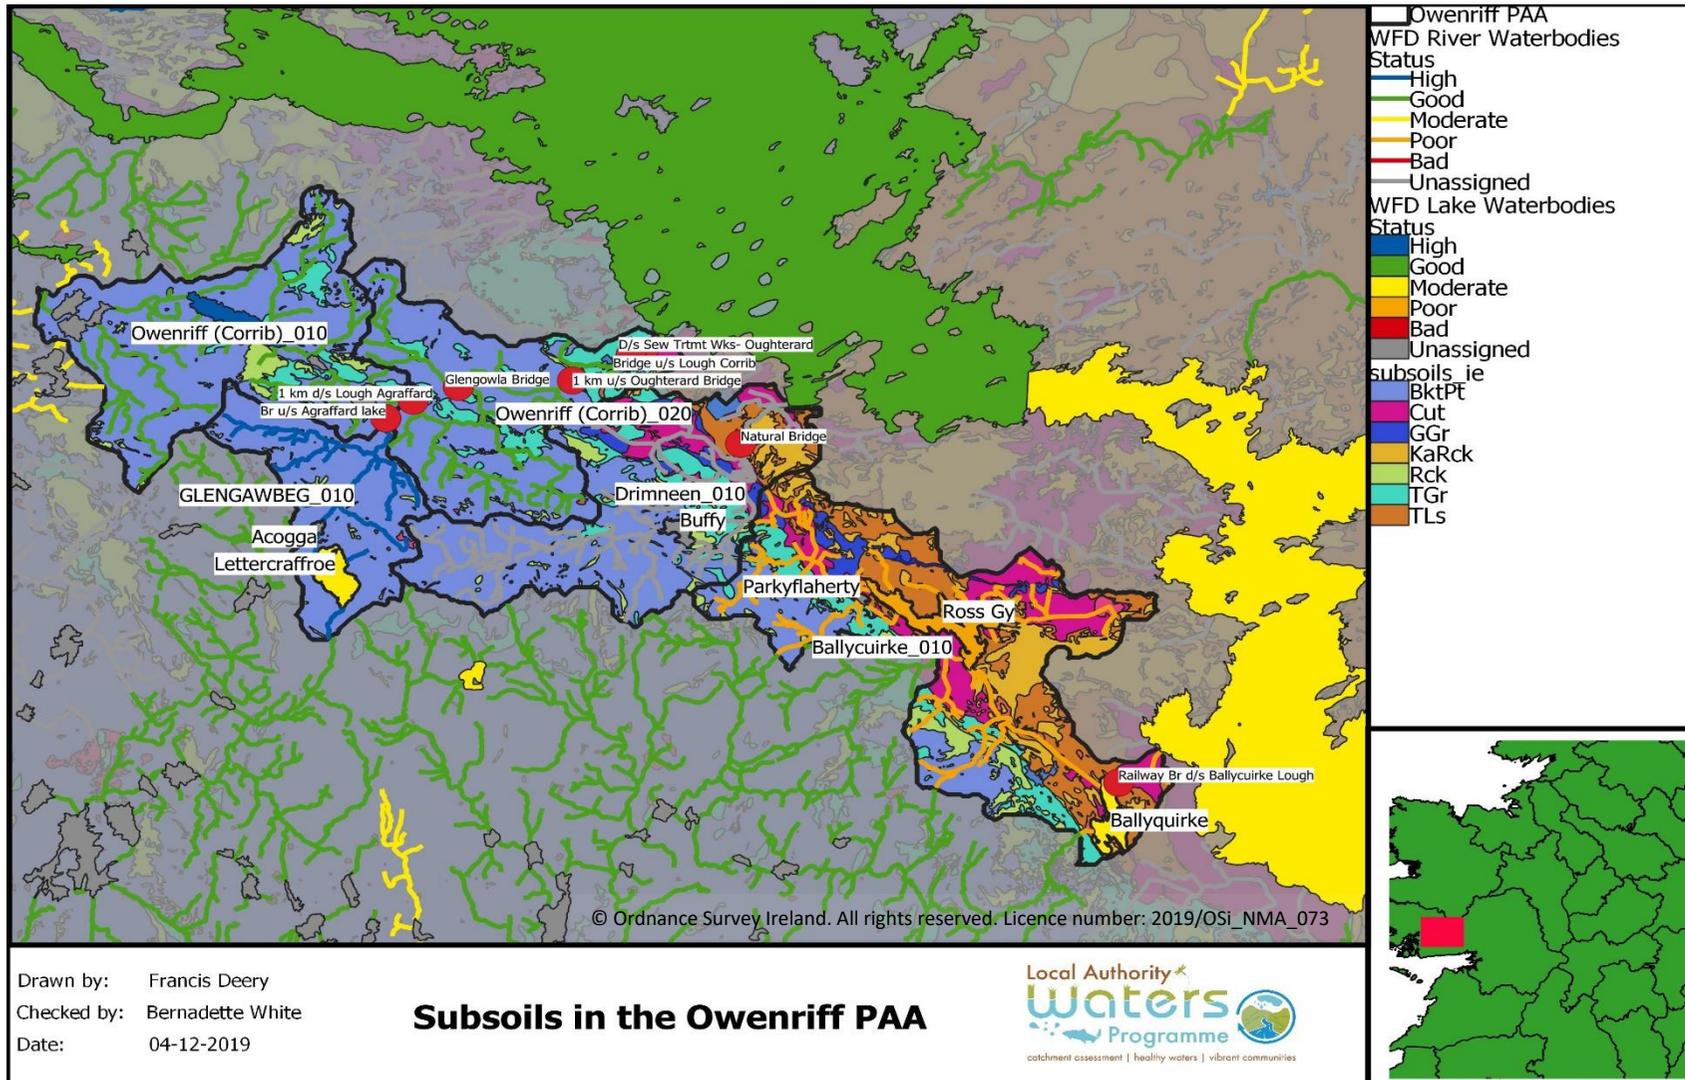
Figure 35: Subsoils in the Owenriff PAA

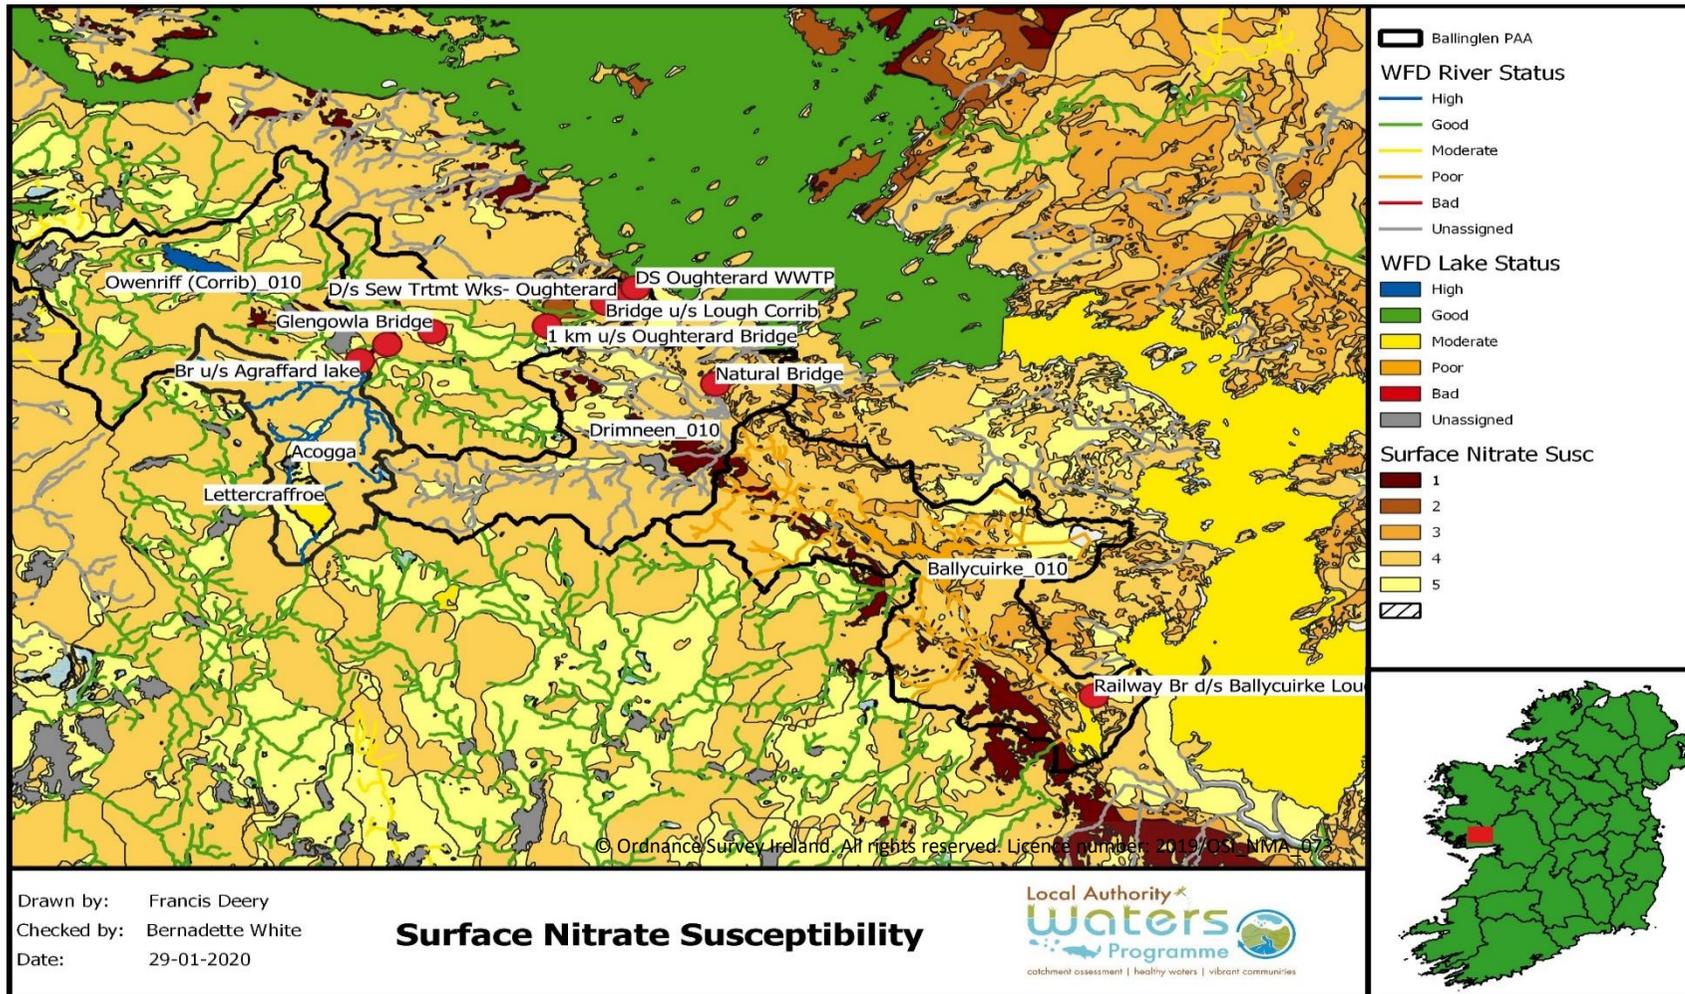
Figure 37: Surface Nitrate Susceptibility in the Owenriff PAA

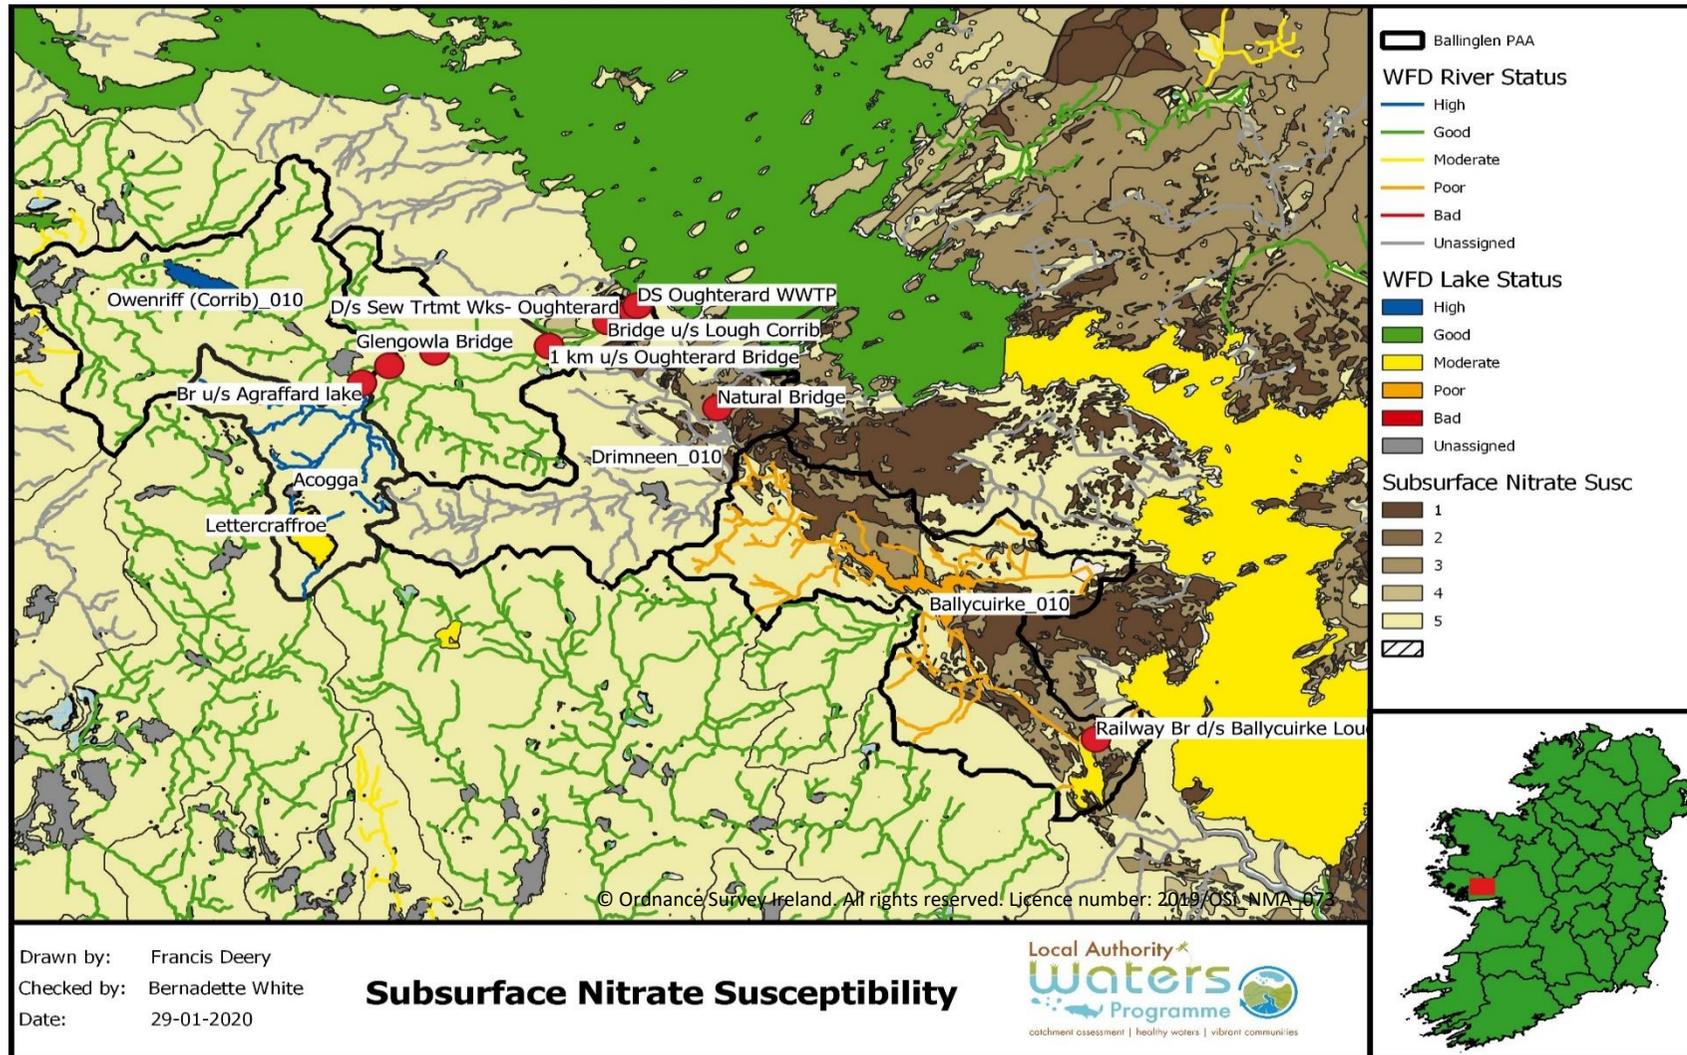
Figure 38: Subsurface Nitrate Susceptibility

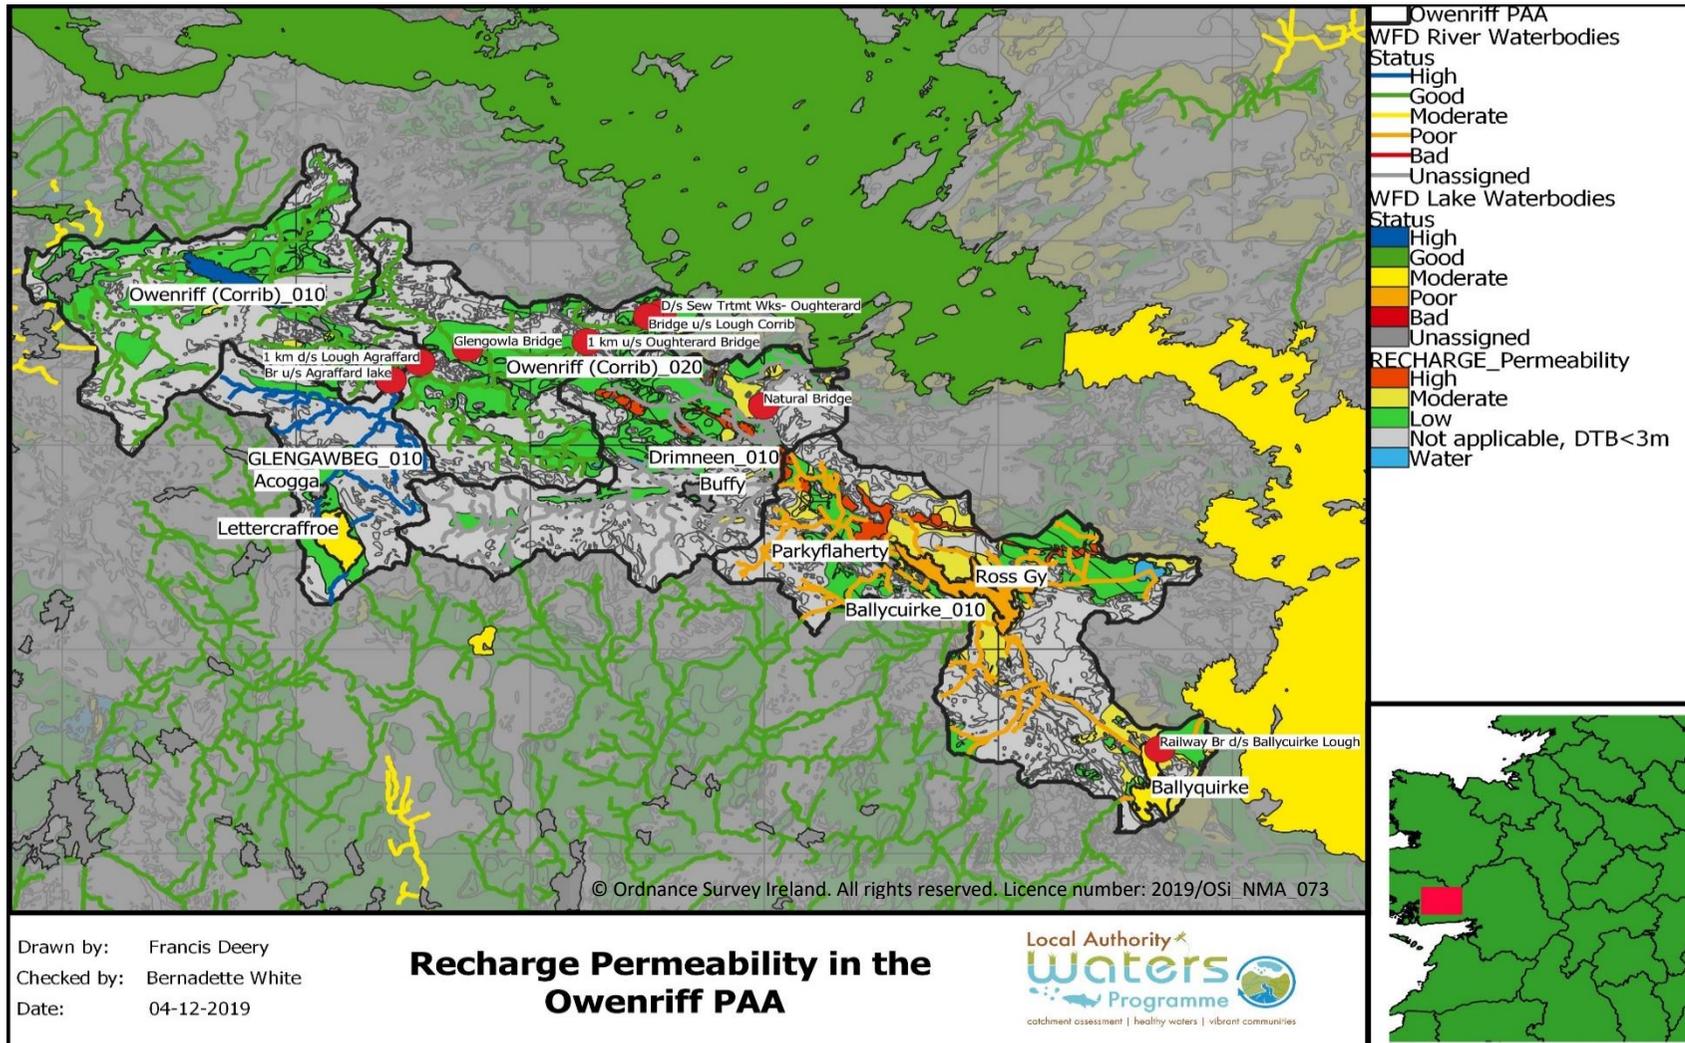
Figure 39: Recharge Permeability in the Owenriff PAA

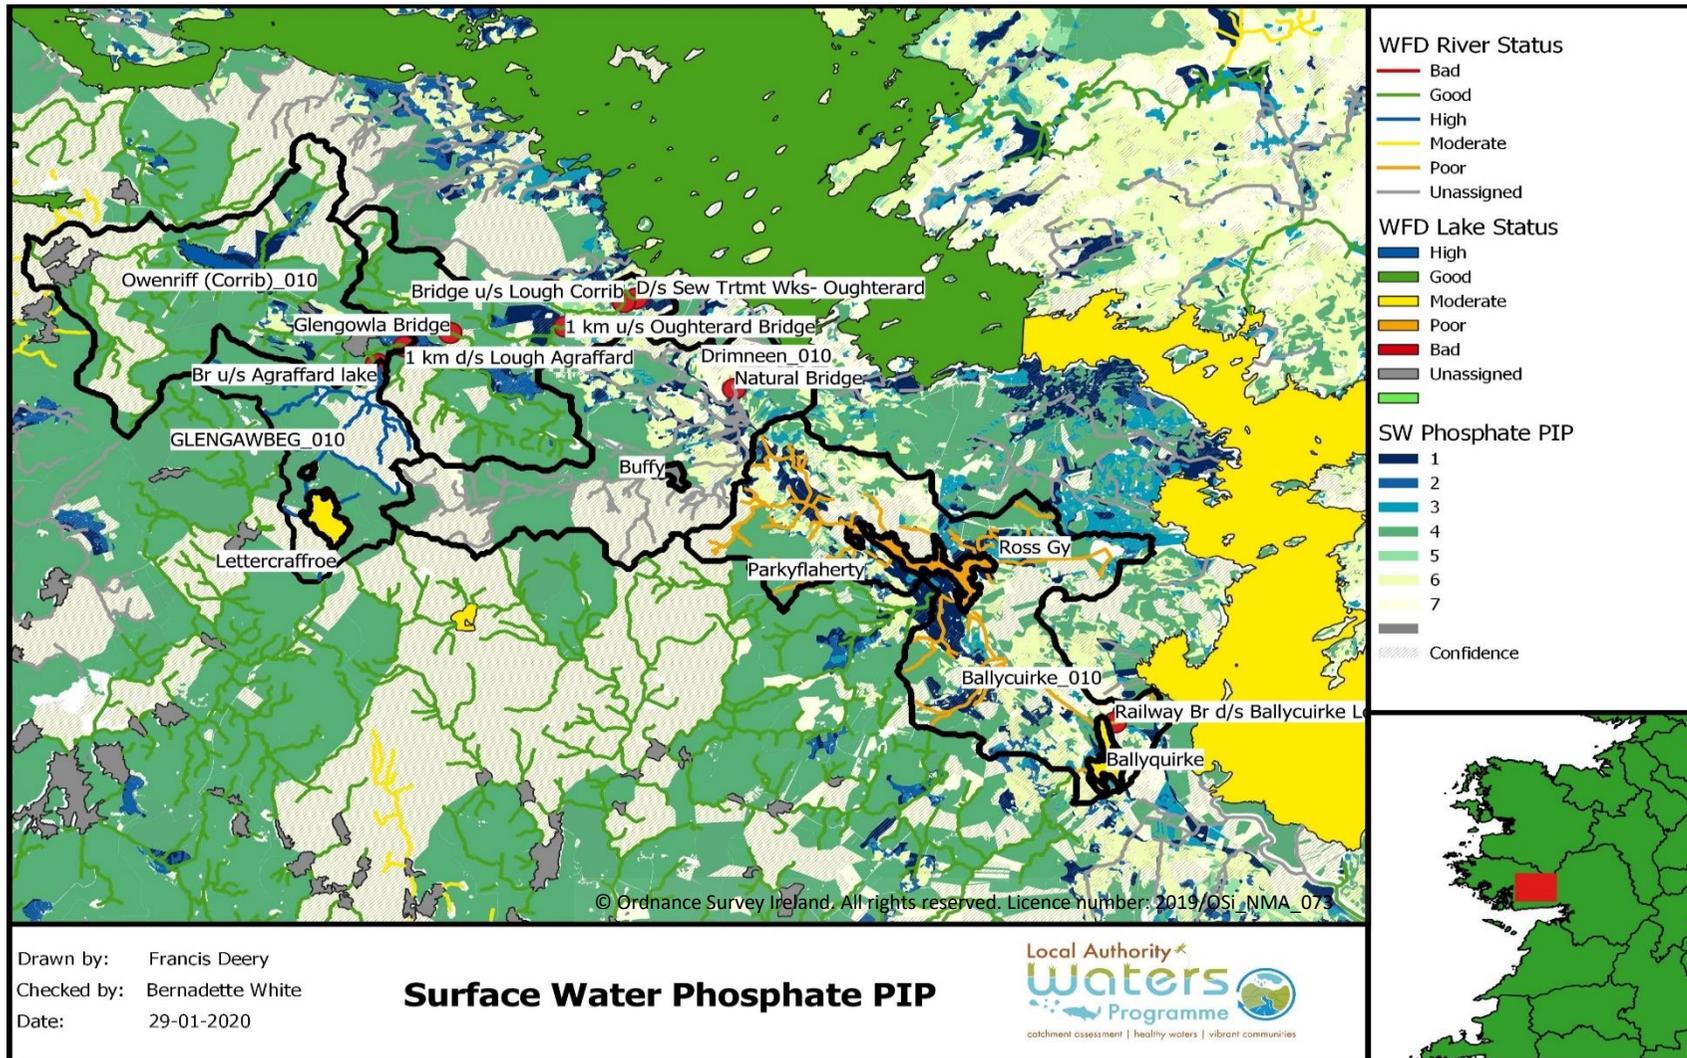
Figure 40: Phosphate PIP of the Owenriff PAA
