Owenriff

Desktop Assessment

Western Region

(AFA0148)

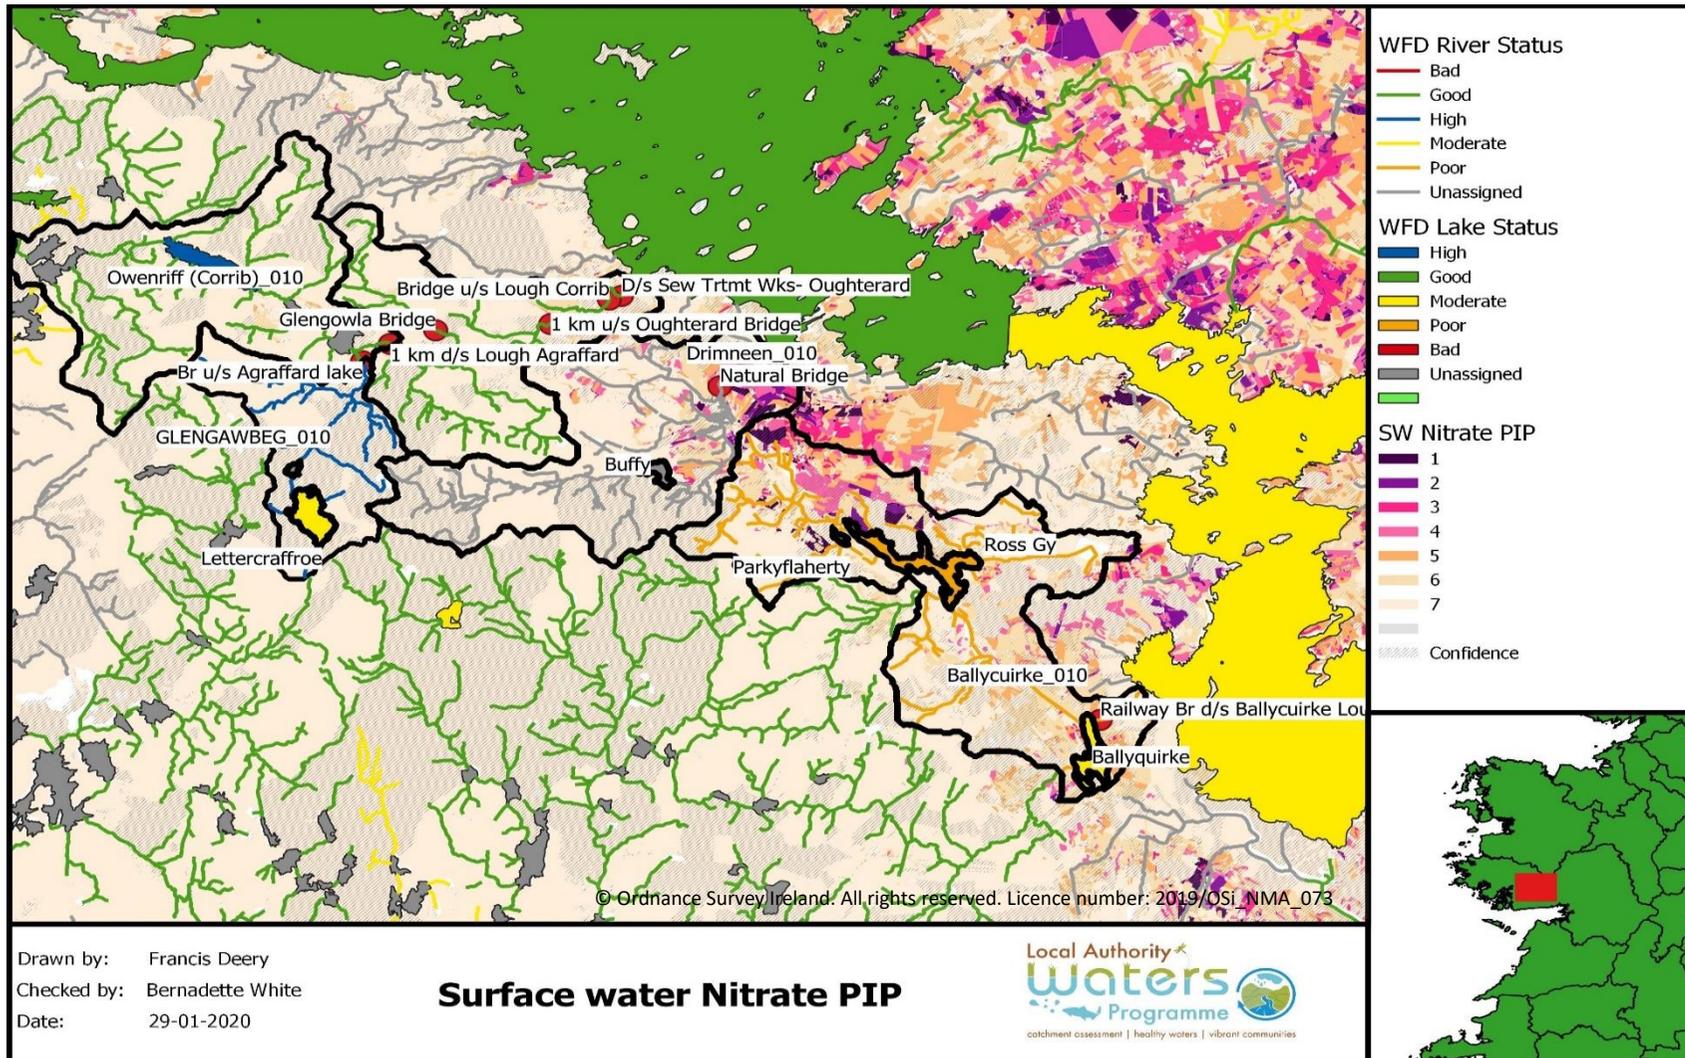
Figure 41: Surface Water Nitrate PIP Map of the Owenriff PAA

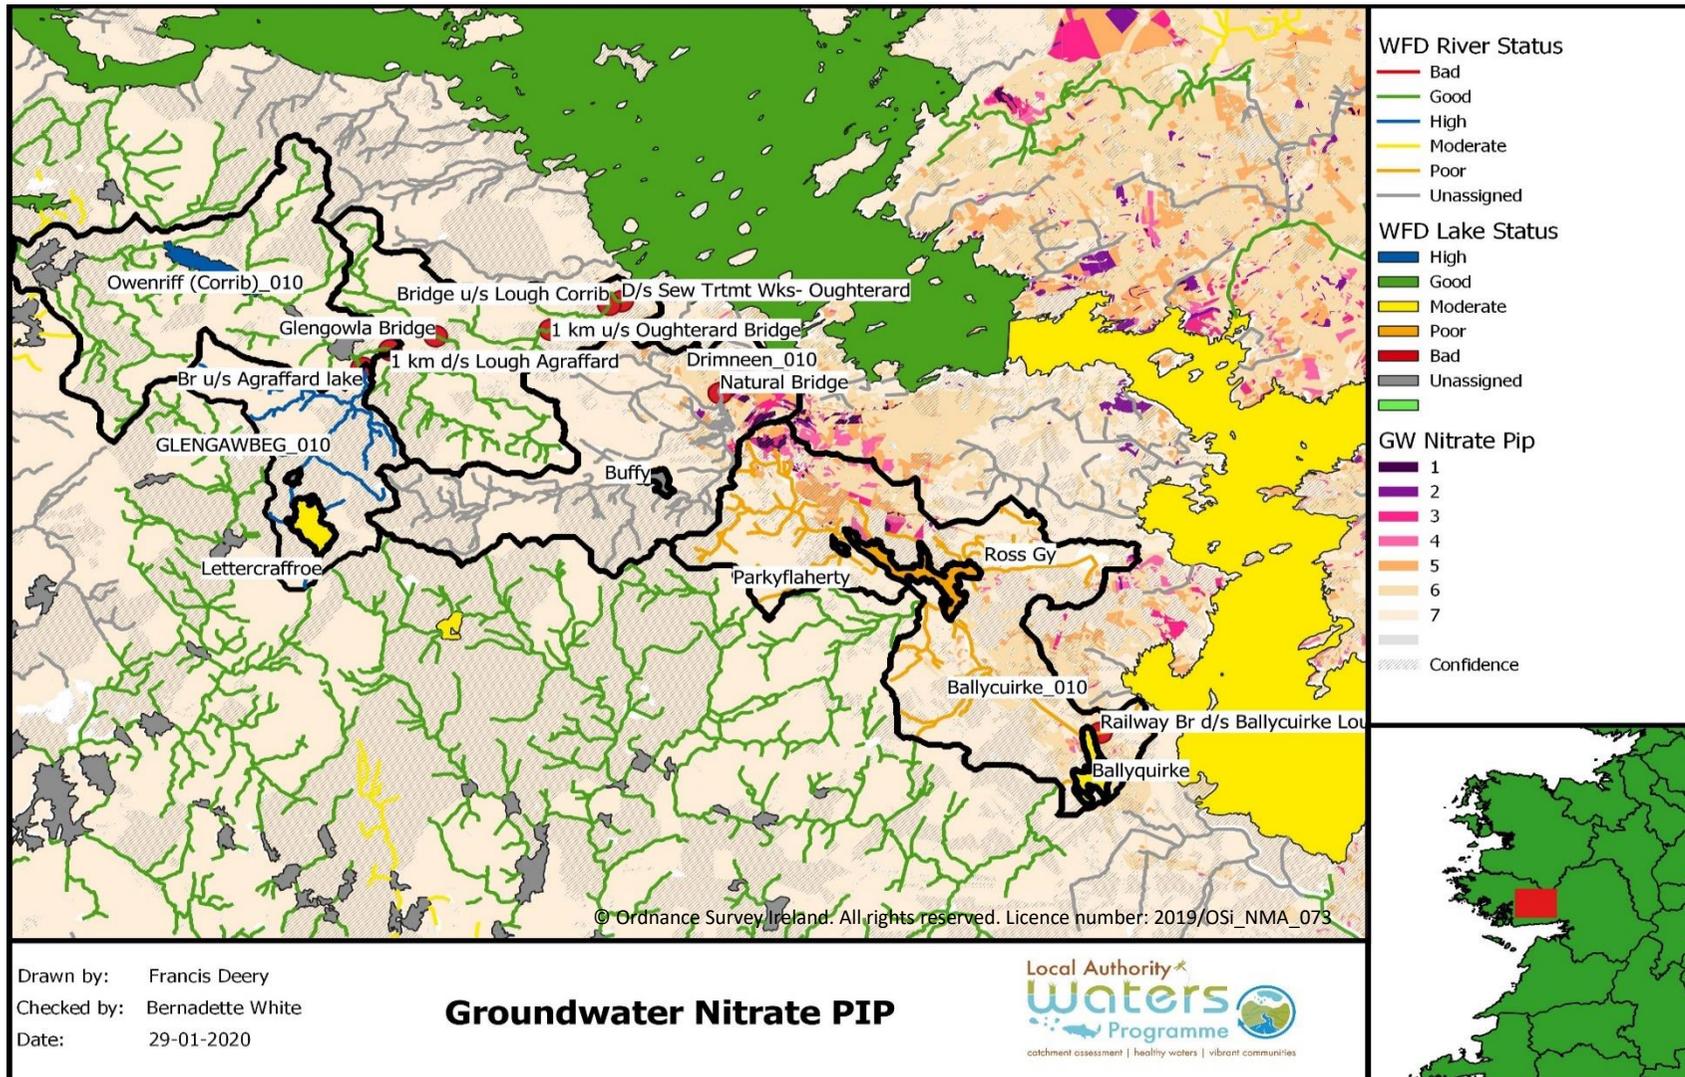
Figure 42: Groundwater Nitrate PIP Map of the Owenriff PAA

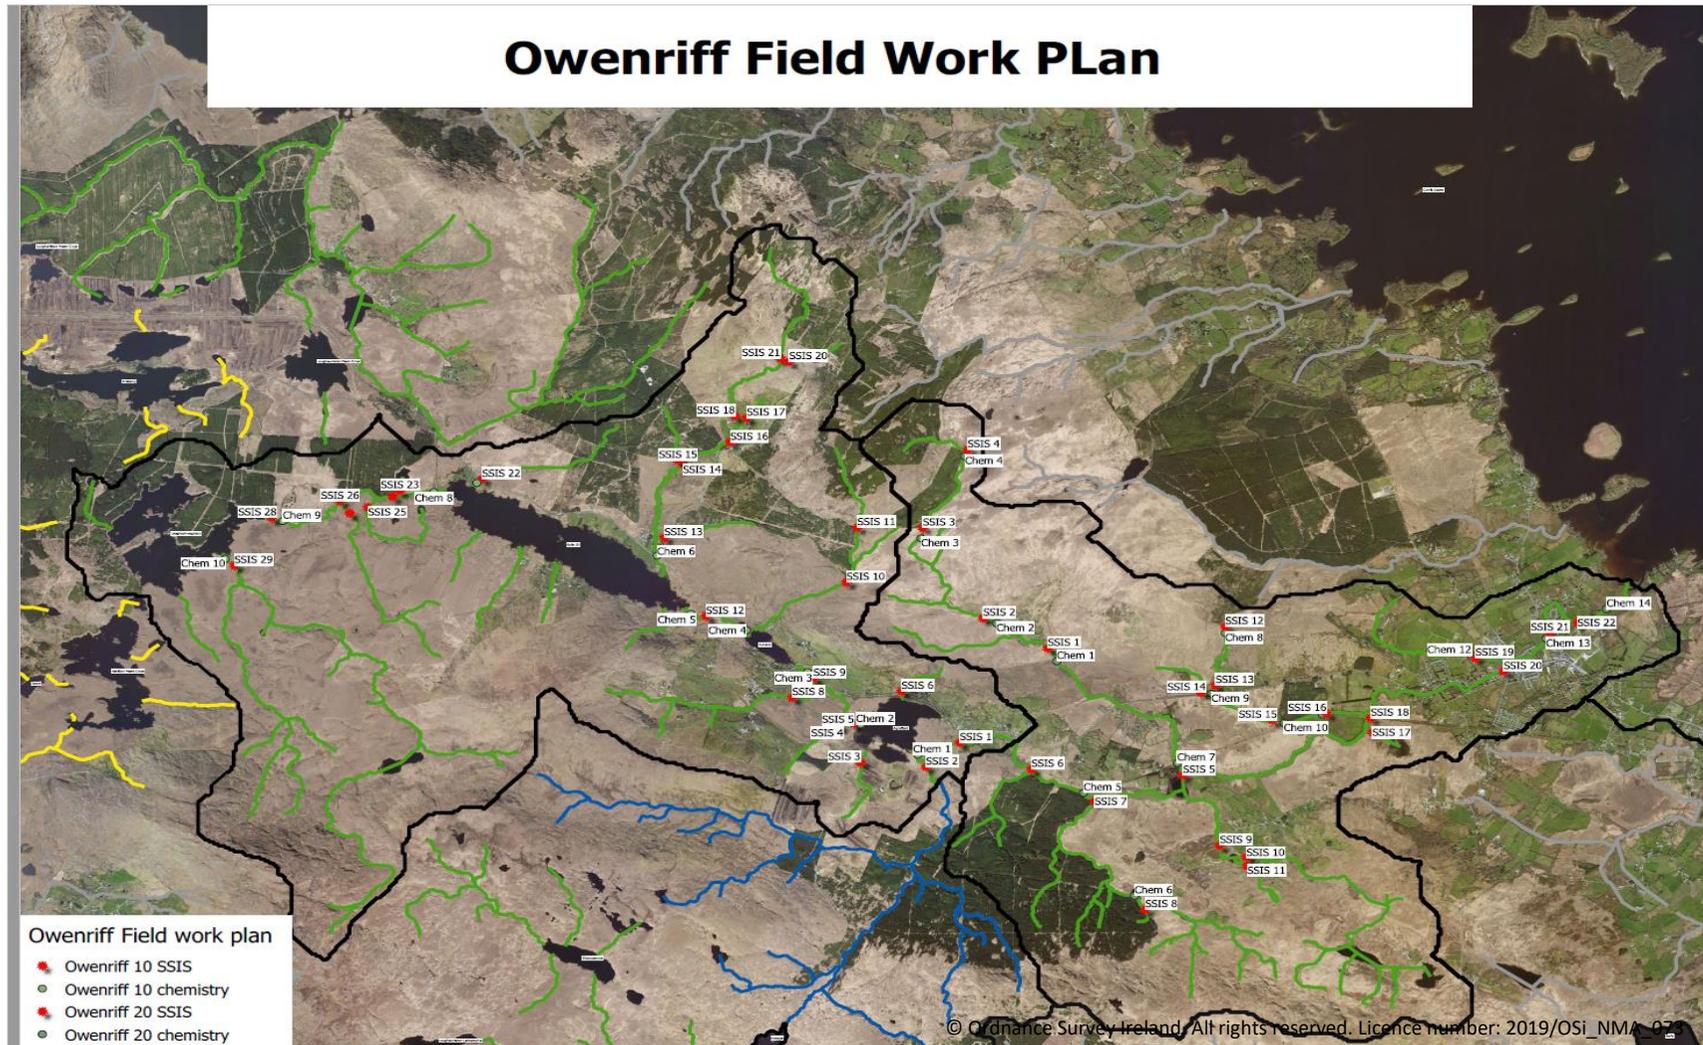
Figure 43: Field work plan for the Owenriff

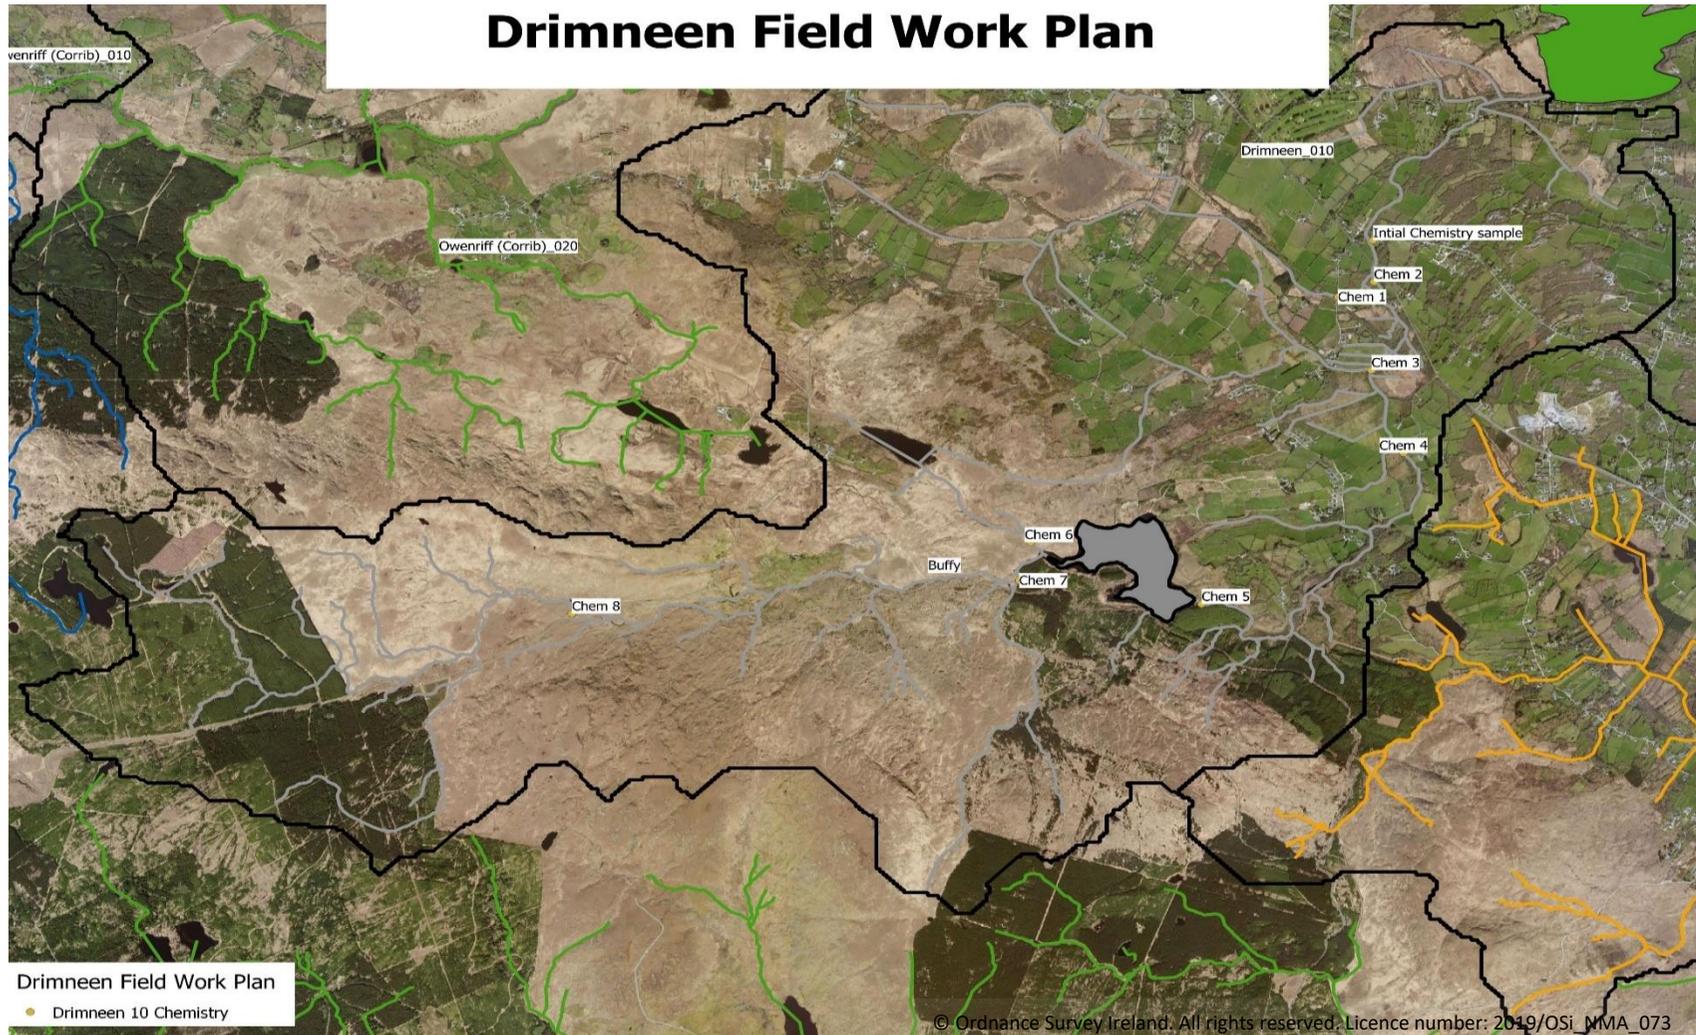
Drimneen Field Work Plan

Figure 44: Chemistry sampling plan for the Drimneen_010

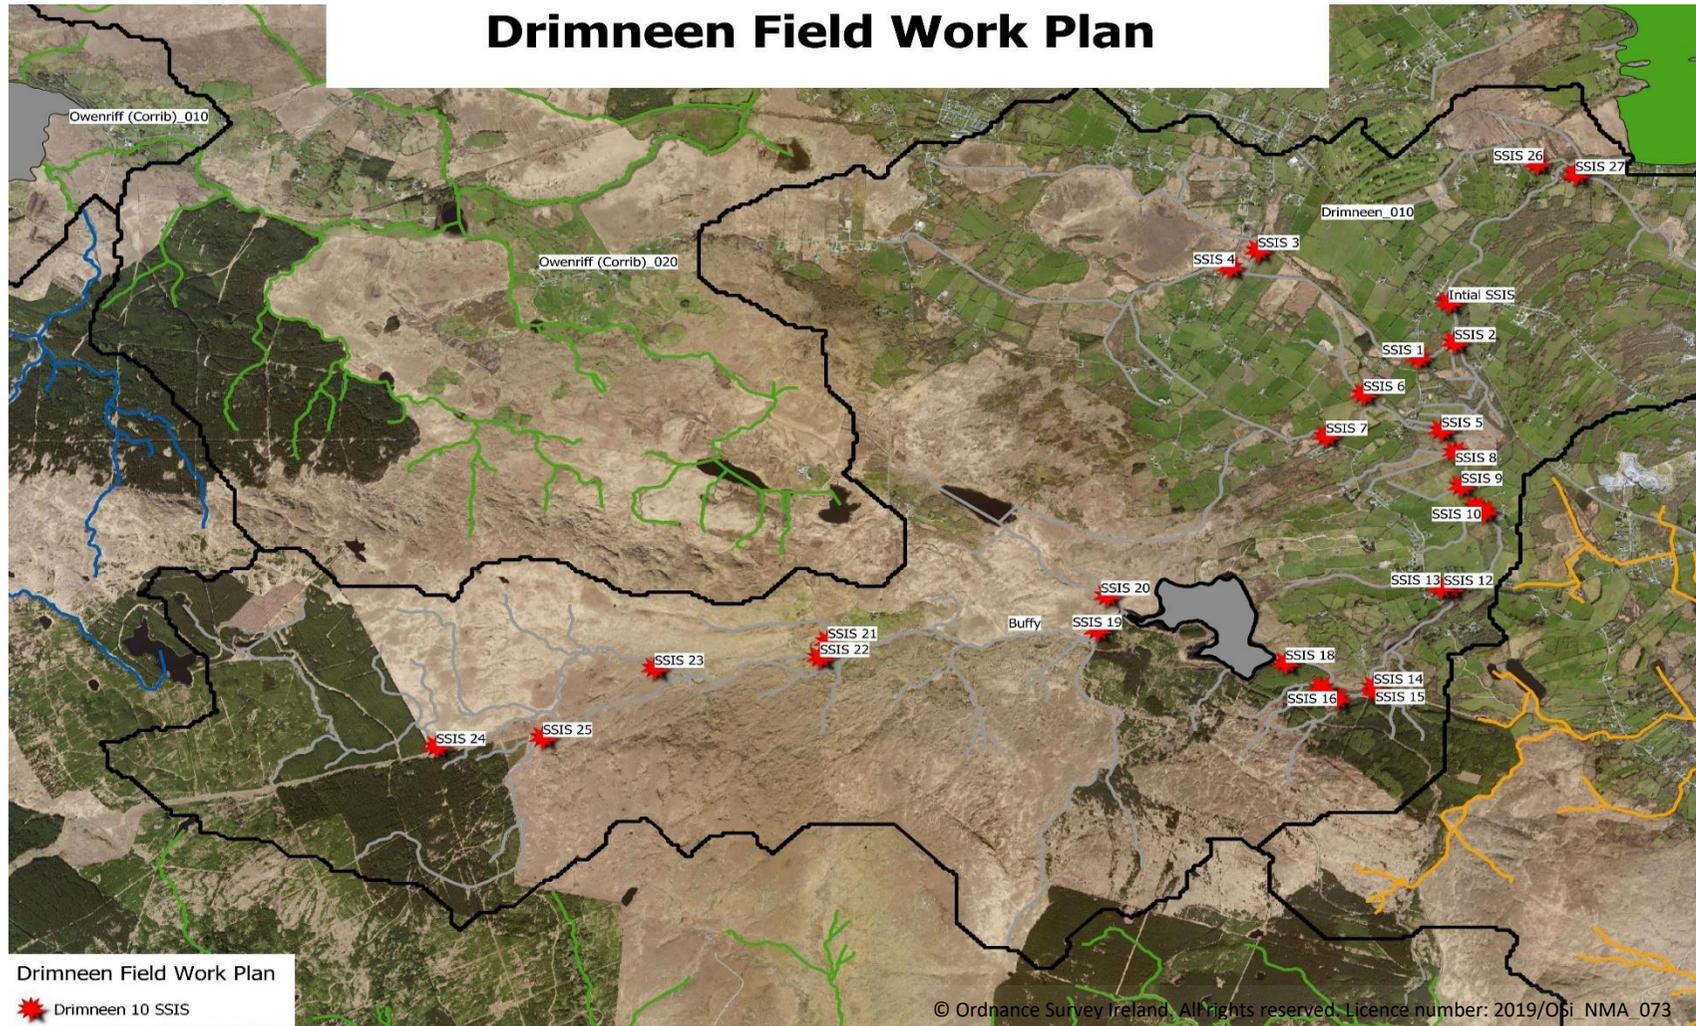
Drimneen Field Work Plan

Figure 45: Biological sampling plan for the Drimneen_010

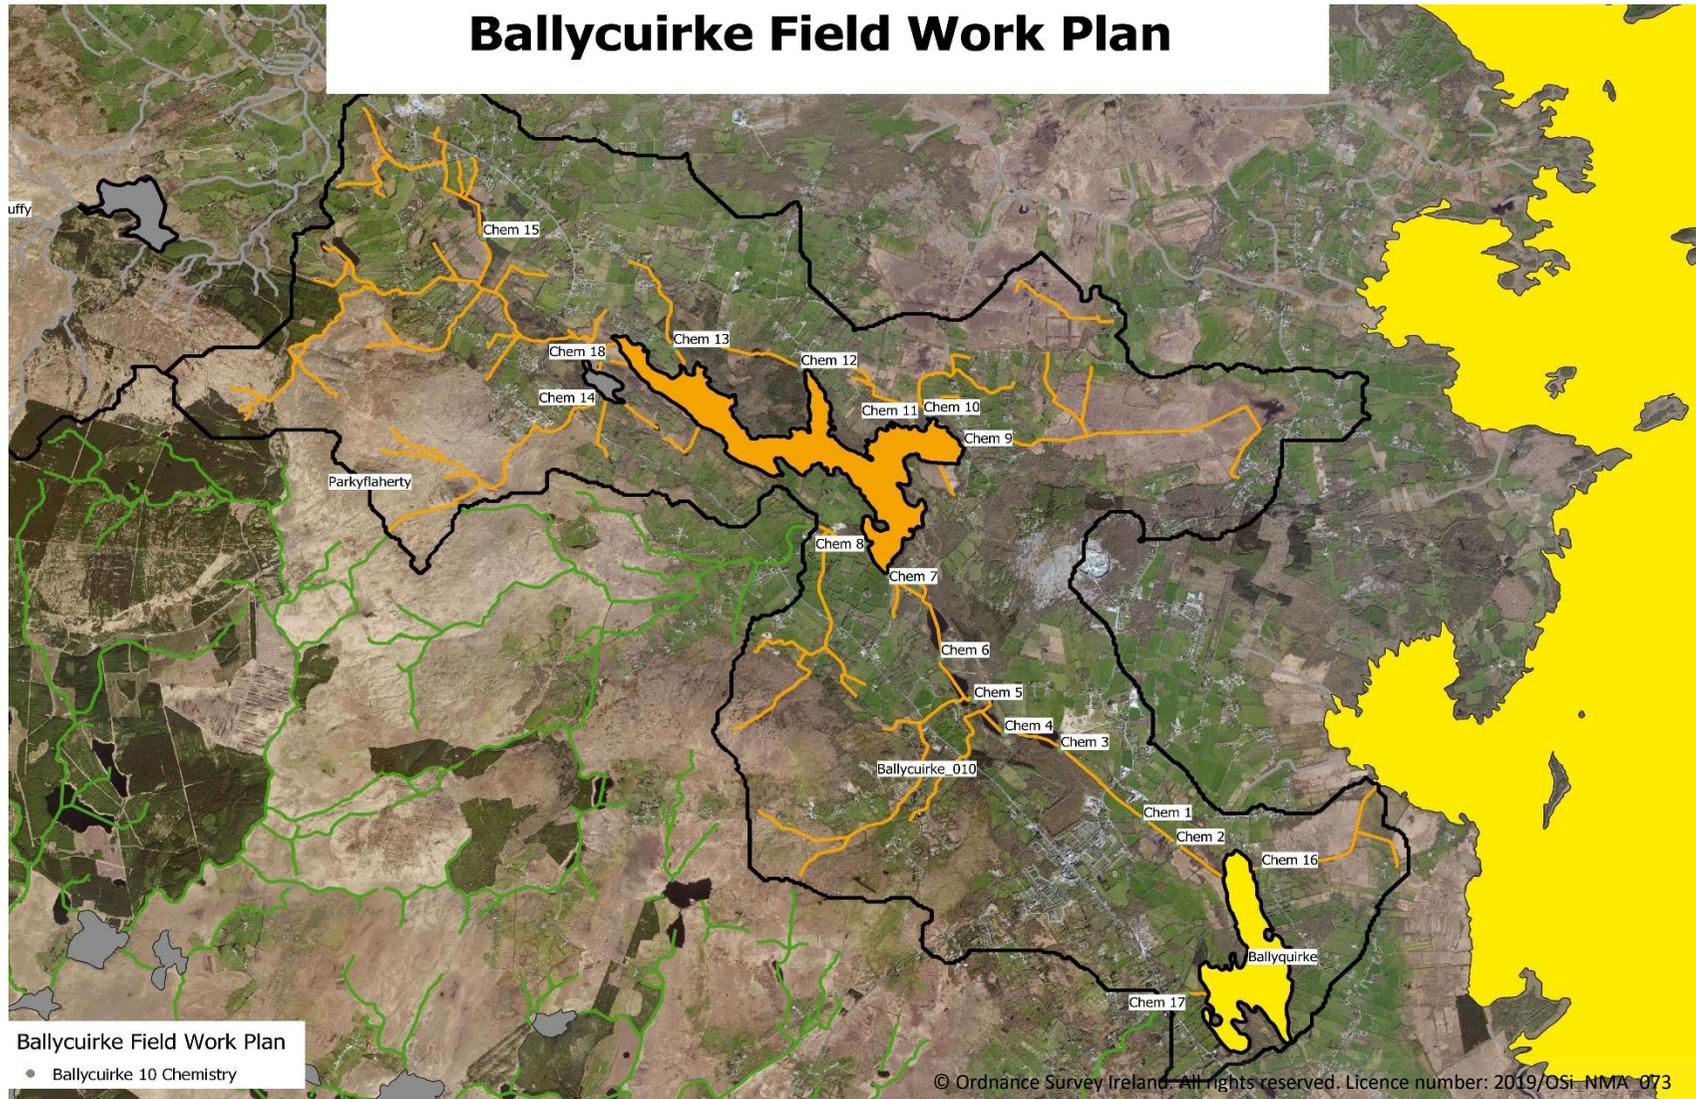
Ballycurke Field Work Plan

Figure 46: Ballycurke_010 chemistry sampling plan

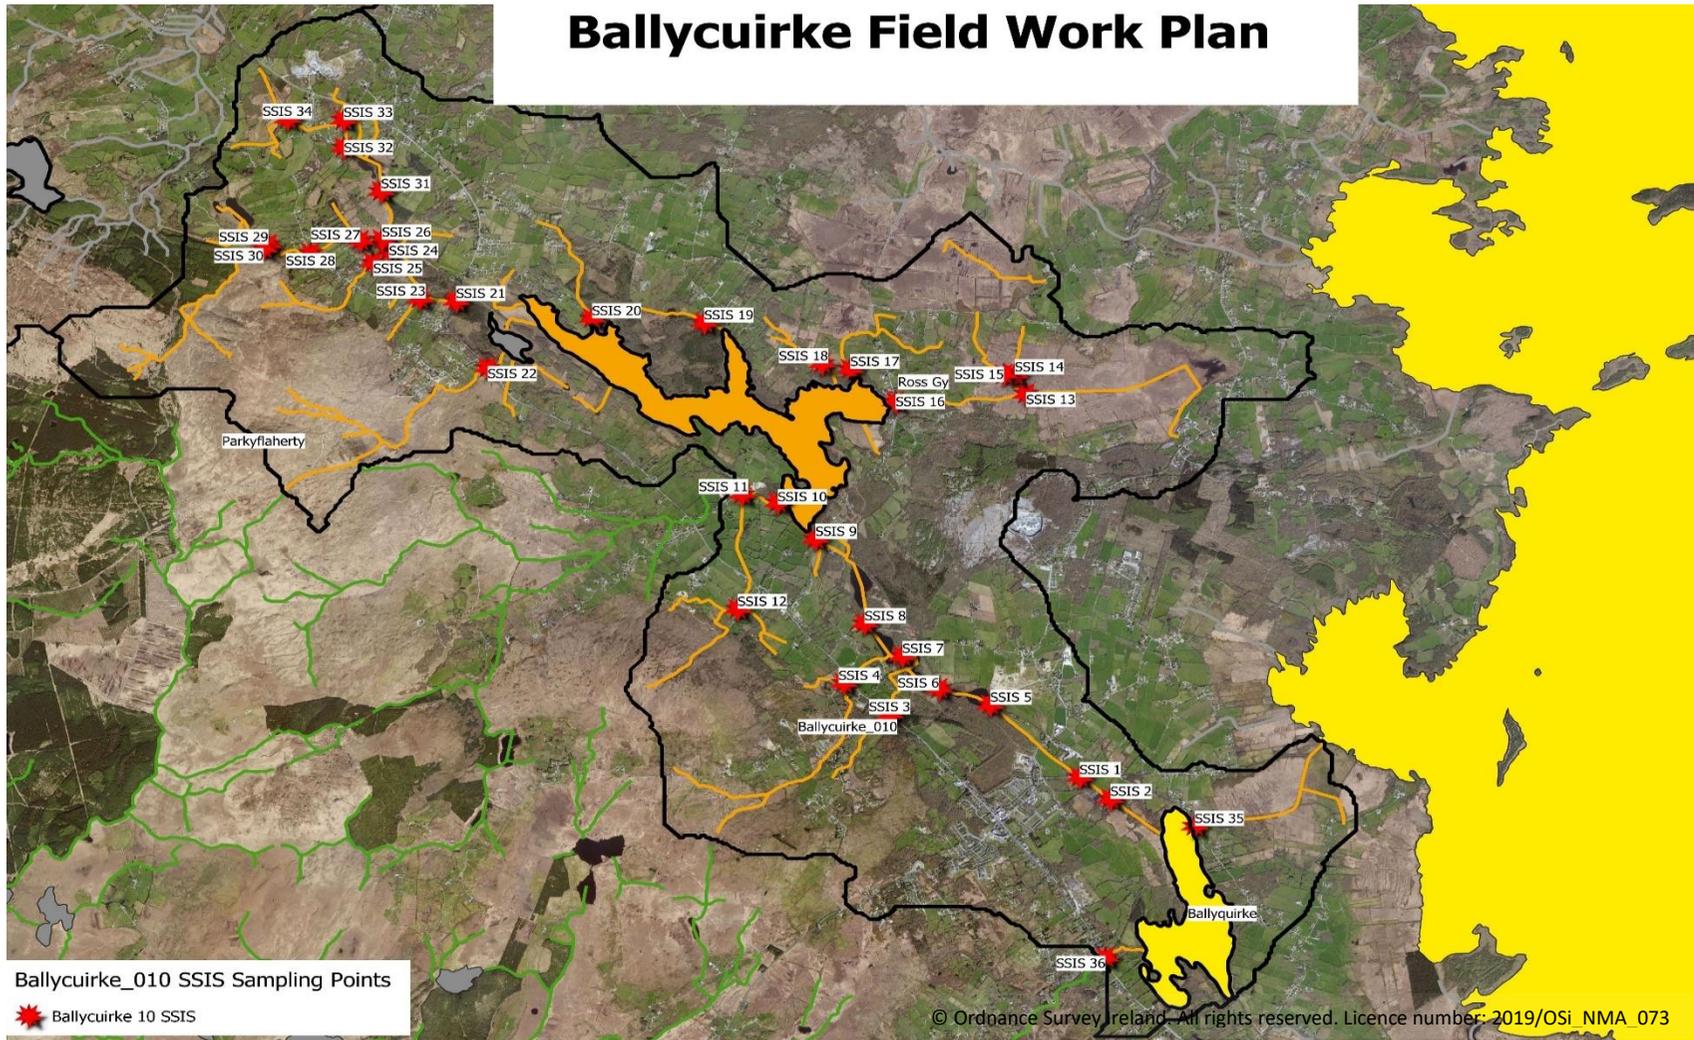
Ballycurke Field Work Plan

Figure 47: Biological sampling point for the Ballycurke_010
