Broadford Priority Area for Action

Desk Study

(AFA0030)

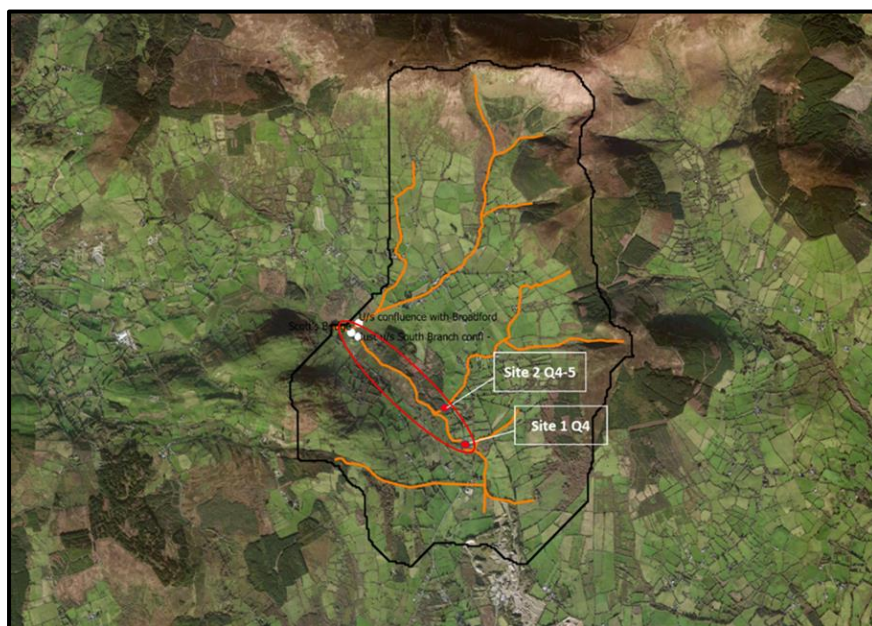
Figure 2.5: Q assessment on Broadford 10 (January 2017)

In January 2017, Clare County Council hired a consultant (Conservation Services) to carry out biological assessment at two sites upstream of the EPA WFD monitoring point at Scotts Bridge. Results indicated unpolluted conditions at both sites assessed (Q4 and Q 4/5) (see figure 2.5). This information indicates either that the significant pressure/s driving status on Broadford 10 are located within a 1km stretch upstream of Scott's Bridge (shown as a red oval in the map below) or that sediment deposition has occurred along this stretch.

In January 2017, Clare County Council hired a consultant to carry out biological assessment at two sites upstream of the EPA WFD monitoring point. Results indicated unpolluted conditions at both sites assessed (Q4 and Q 4/5). This confirms that the water quality impact on Broadford_010 is confined to a 1km stretch upstream of Scotts Bridge. This area should form the main focus of the field walks/assessments. The soils in this focus area are mainly well-drained with some peat. The land use is mainly Agriculture and Woodland. As nutrients are low, the field assessment should focus on sediment and hydromorphology.

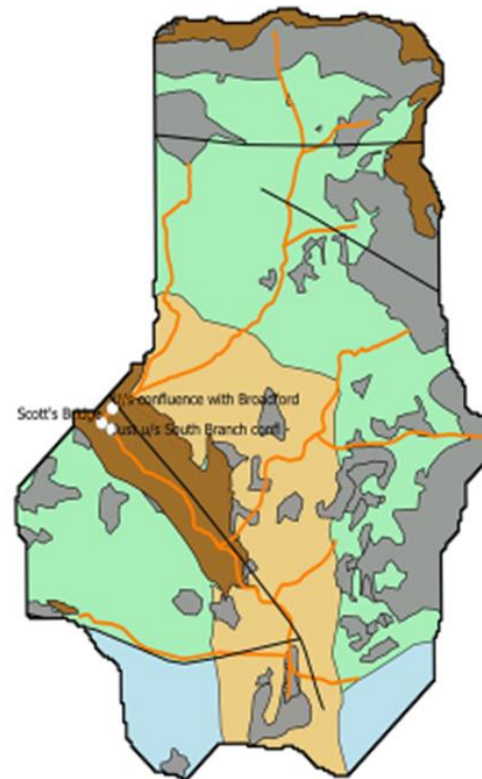
- Compartment 1**
Peat
Pathway: Overland flow of P and NH₃
- Compartment 2**
Poorly drained soil
Pathway: Overland flow of P
- Compartment 3**
Well drained soil
Poor Aquifer bedrock which is generally unproductive except for local zones.
Pathway: Shallow GW flow of N, likely P attenuation
- Compartment 4**
Well drained soil
Locally important aquifer moderately productive only in local areas
Pathway: Shallow GW flow of N, likely P attenuation
- Compartment 5**
Well drained soil
Locally Important Sand and Gravel Aquifer
Pathway: Shallow GW flow of N (Aquifer thickness 5-15m), likely P attenuation
- Fault Line:** likely enhanced GW flow

In terms of sediment sources, compartment 1 (peat) and possibly compartment 2 (poorly draining soils) are the primary focus for assessment. The impacted stretch of Broadford 10 flows mainly through compartment 1. The lands upstream of this stretch appear to be mainly well drained soils and would not be expected to be a source of sediment.

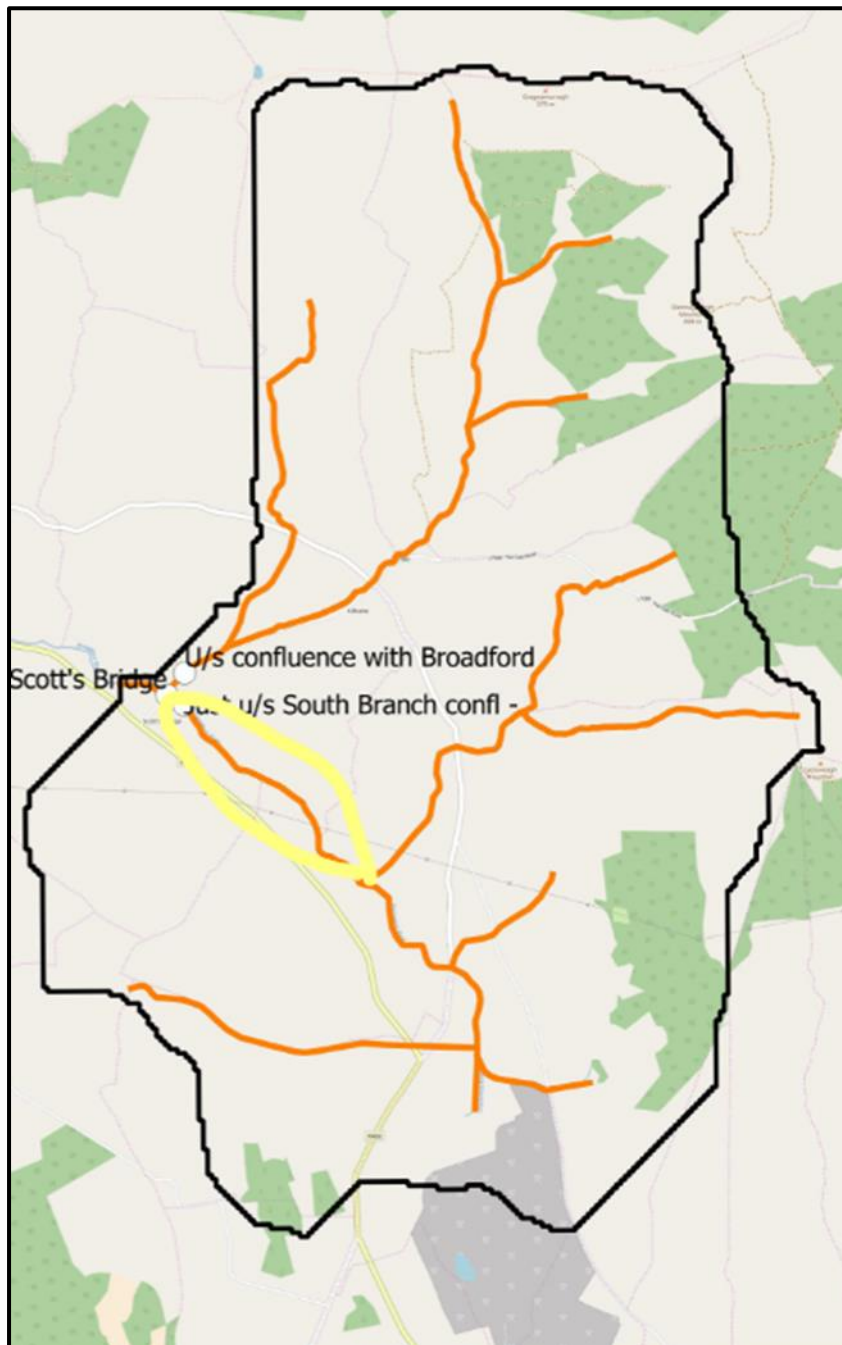
Figure 6.1 Area of focus for field investigation

Field investigations to be undertaken at location outlined in yellow below as shown in figure 6.1.

| Waterbody Name | Action | Description |
|---|---|---|
| Broadford_010 | IA5 Multiple Sources in defined rural area (1km) or waterbody or rural town | Walk along stretch of the Broadford_010 river water body between stations RS27B020300 and RS27B020500. Note point sources of sediment from land drainage. Note siltation and compete SSRS upstream and downstream of any point sources. Establish if land drainage is contributing to siltation at RS27B020500. |

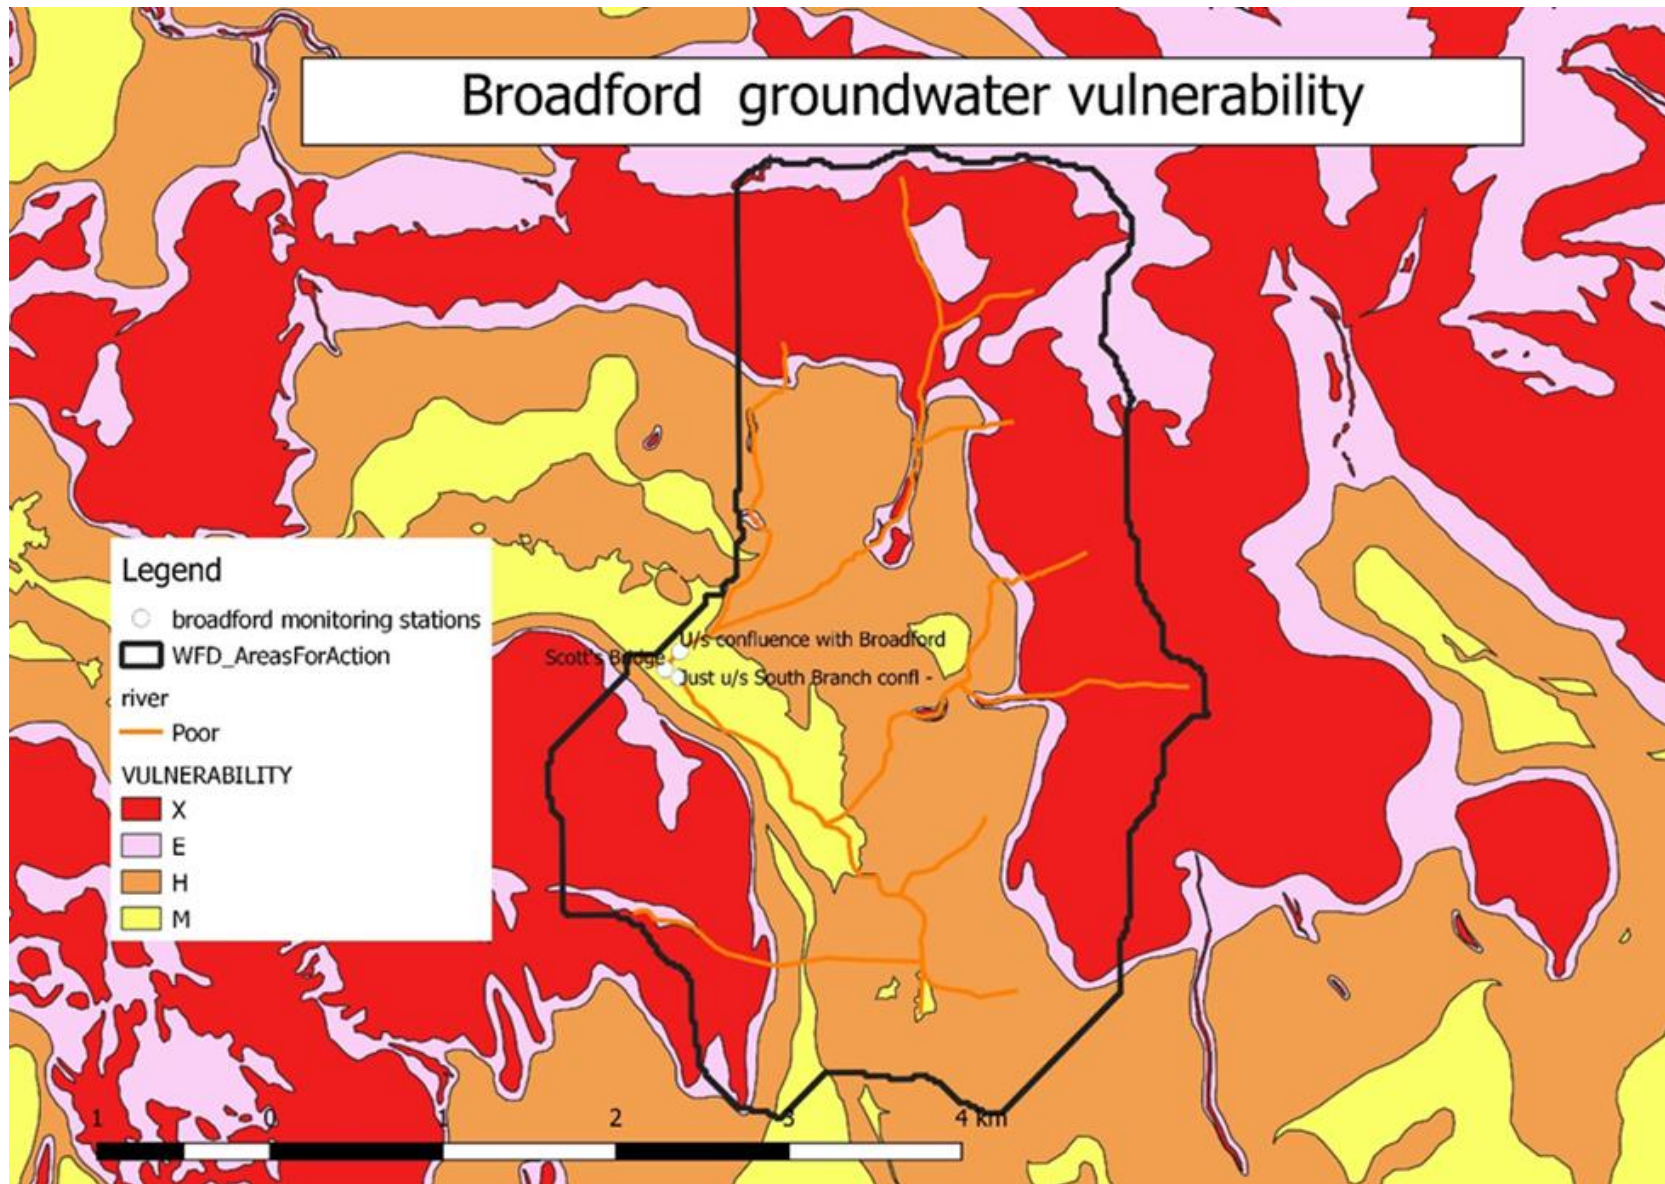
Scott's Bridge
U/s confluence with Broadford
Just u/s South Branch confl -
