Desktop Assessment

Dawros Priority Area for Action

(AFA0058)

24th October 2019

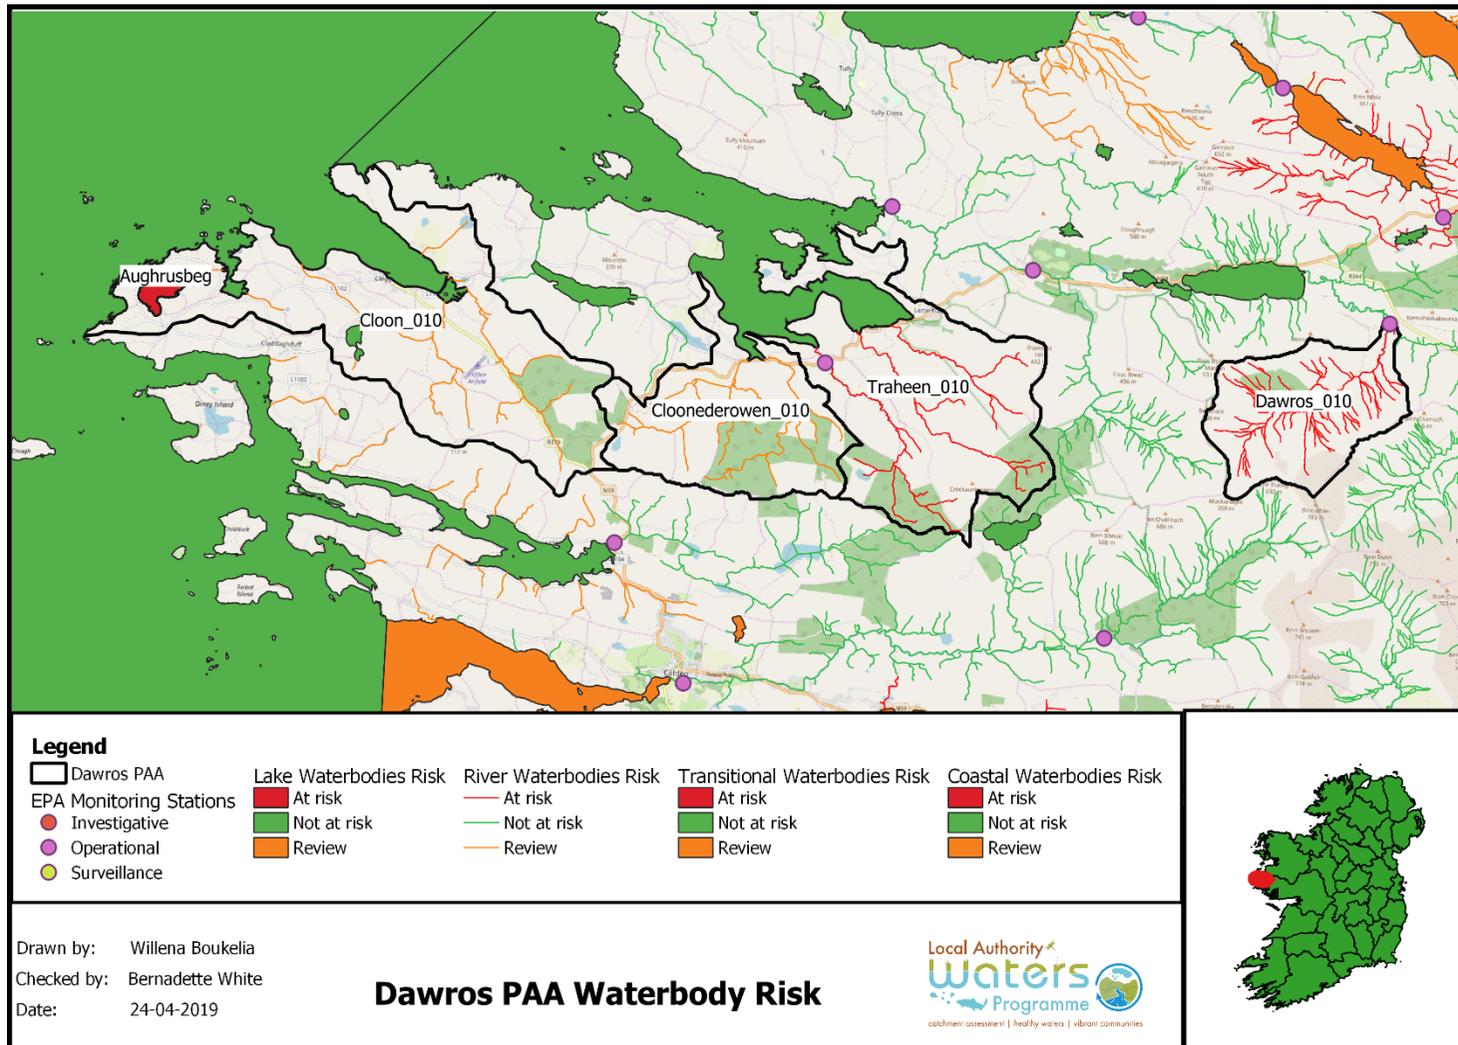
Figure 1: Dawros PAA Waterbody Risk

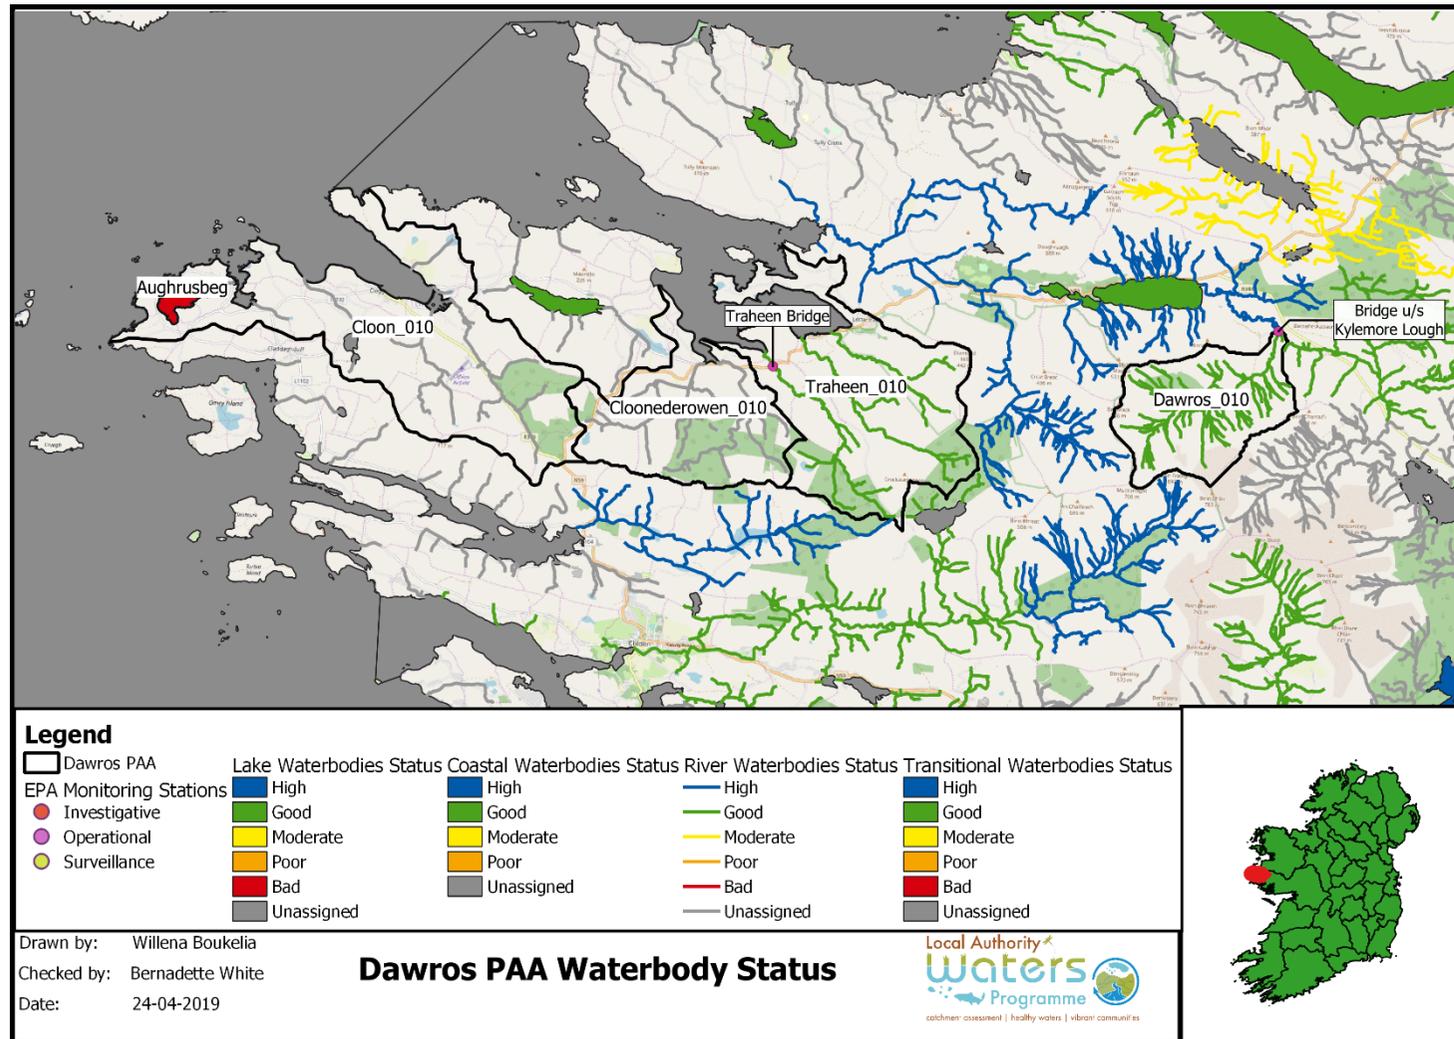
Figure 2: Dawros PAA Waterbody Status with the operational EPA monitoring sites.

The Traheen_010 currently achieved Good Ecological Status between 2013 and 2015 (**Figure 2**) and was classified *At Risk* of failing to meet its high status objective. It consists of three distinct rivers which discharge into Ballynakill Bay. Monitoring data is available from the EPA operational monitoring station at Traheen Bridge in the lower part of the Traheen River in the west of this sub-basin (**Figure 2**). The Traheen_010 was at Moderate Ecological Status in 2009 improved to Good Ecological Status in 2012 and 2015. The available information suggests that siltation or enrichment are impacting the river status from either of the significant pressures identified: overgrazing (HYMO) or waste water discharge (DWWTS), respectively.

Table 2, Table 3 and **Table 4** present water quality information for the Dawros_010, Traheen_010 and Aughrusbeg Lake waterbodies, respectively, and include the status and trends of the monitored quality elements and the significant issues that may be impacting on water quality in these waterbodies. The unassigned river waterbodies Cloonederowen_010 and Cloon_010 are not monitored and have no water quality data available. **Figure 2** shows the location of EPA monitoring stations within the PAA.

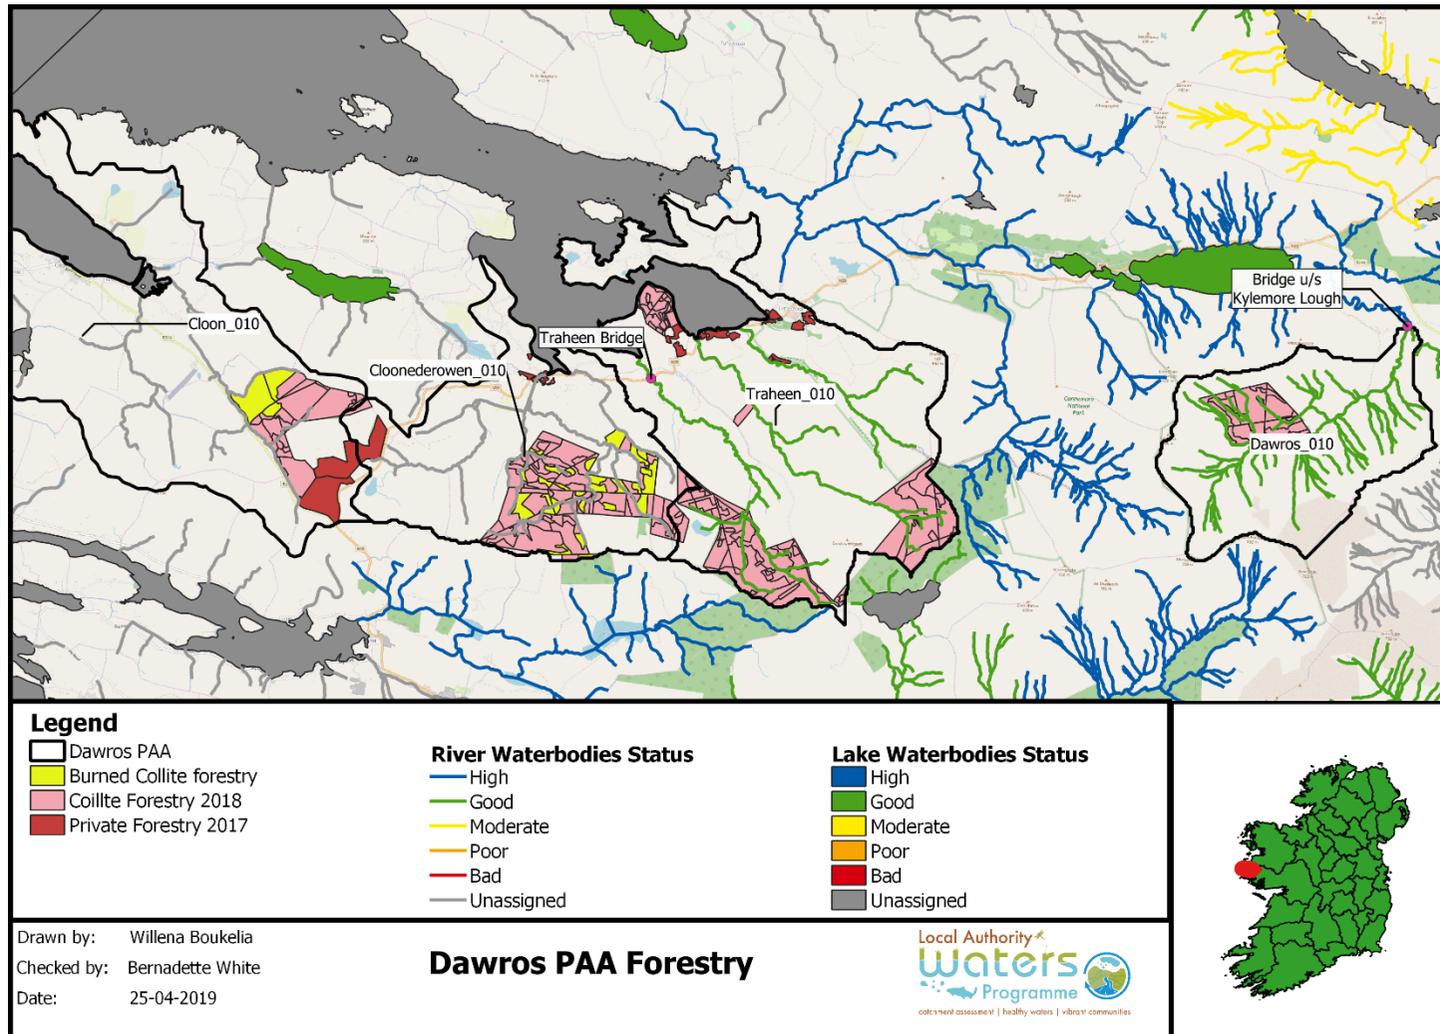
Figure 3: Collite and privately-owned forestry within the Dawros PAA

Forestry is identified as a significant pressure for the Dawros_010 river water body due to nutrient pollution and altered habitat due to morphological changes. Drainage channels associated with forestry stands can transport silt and nutrients to surface waters. Forestry across the PAA is owned largely by Collite (857.55 ha), with some small areas of privately-owned forestry (88.57ha) (**Figure 3**).

GIS datasets provided by Coillte have identified 106ha of forestry within the Cloonederowen_010 and Cloon_010 RWBs that is listed as ‘Burned’ in the land use type (Figure 3). A query has been sent to the Forest Service for more information.

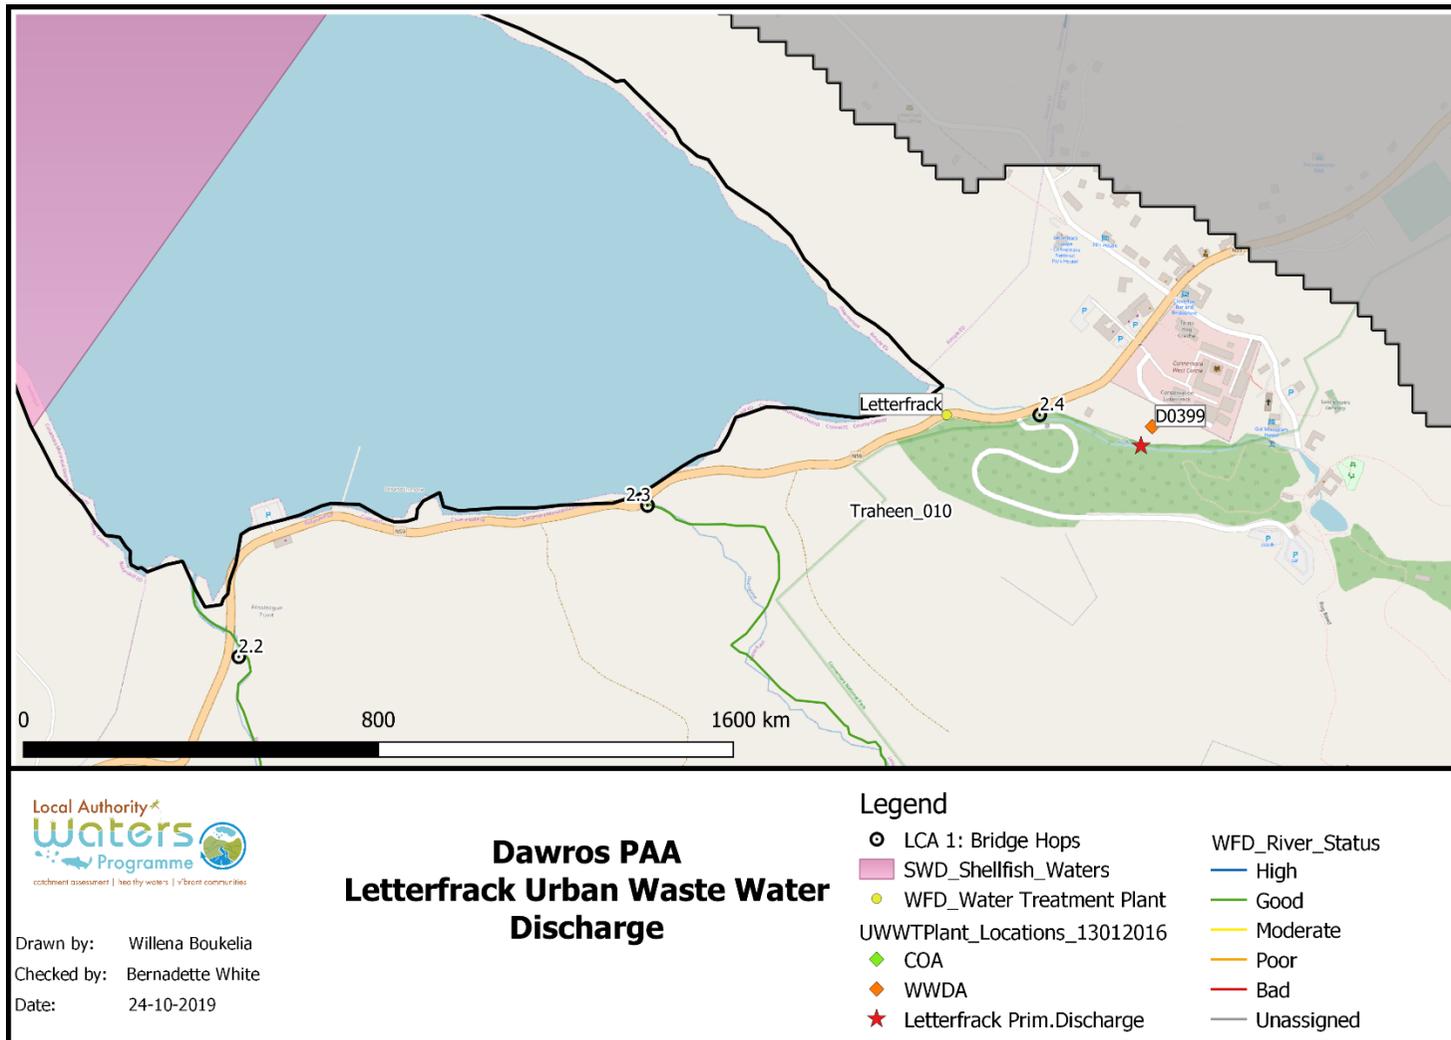
Figure 4: Context and location of Letterfrack’s UWWTP and Water Treatment Plant

Within the Traheen_010 the Letterfrack UWWTP (Certificate of Authorisation License Code: A056 1-0) supporting an agglomeration of PE 500-1,000 discharges to surface water into the most easterly tributary of this RWB. The plant currently operates at a P.E. of less than 500 and holds a Certificate of Authorisation (CoA) to discharge. The WWTP is a Package Plant with secondary treatment that discharges to reed bed on site and was a design build WWTP now operated by Galway County Council. The Plant is designed and constructed for an 800 P.E. currently operating at P.E. 221 (2017) and with a projected 2023 P.E of 232, well within its design build capacity of operation. The WWTP has been designed to the required effluent standard of 25 mg/l BOD and 35 mg/l SS. The treated effluent discharges directly to the Sruffaunboy Stream at the treatment plant site approximately 300m upstream from Ballynakill Harbour (**Figure 4**).

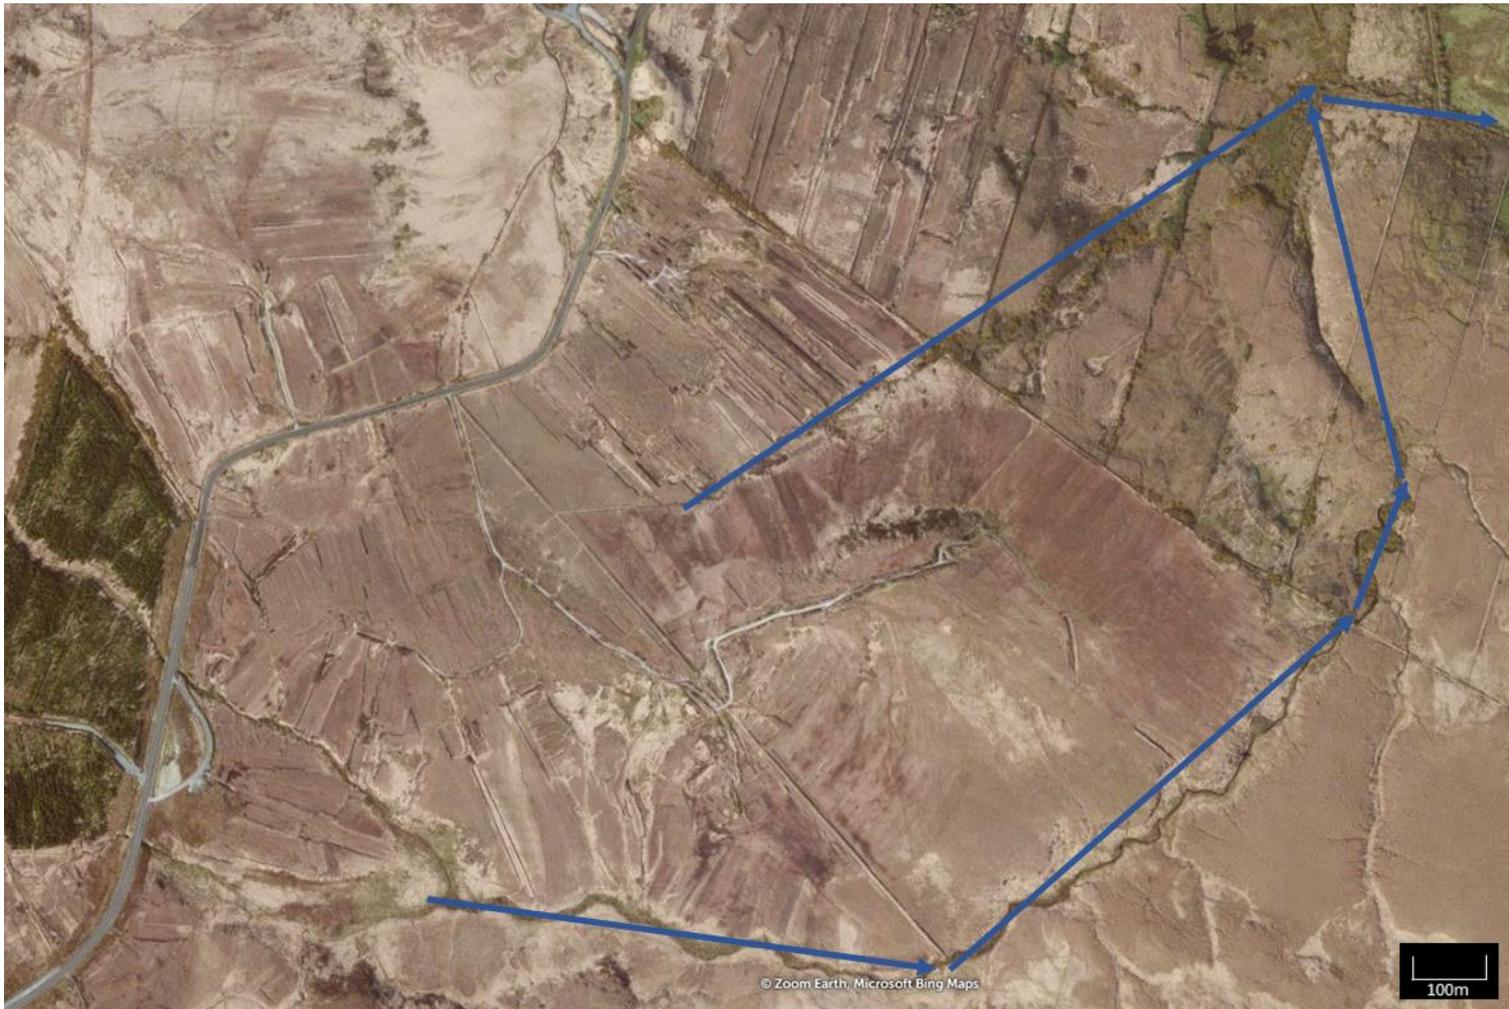
Figure 5: Aerial image illustrating extensive peat extraction within the Clonederowen_010

It is evident from aerial imagery and a catchment drive that peat cutting is very active and extensive in some areas of the PAA and may be contributing to water quality conditions. This activity occurs primarily within the Cloon_010 and Cloonederowen_010 river water bodies with tributaries criss-crossing areas of peat extraction (**Figure 5 & Figure 6**) and to a lesser extent within the Traheen_010.

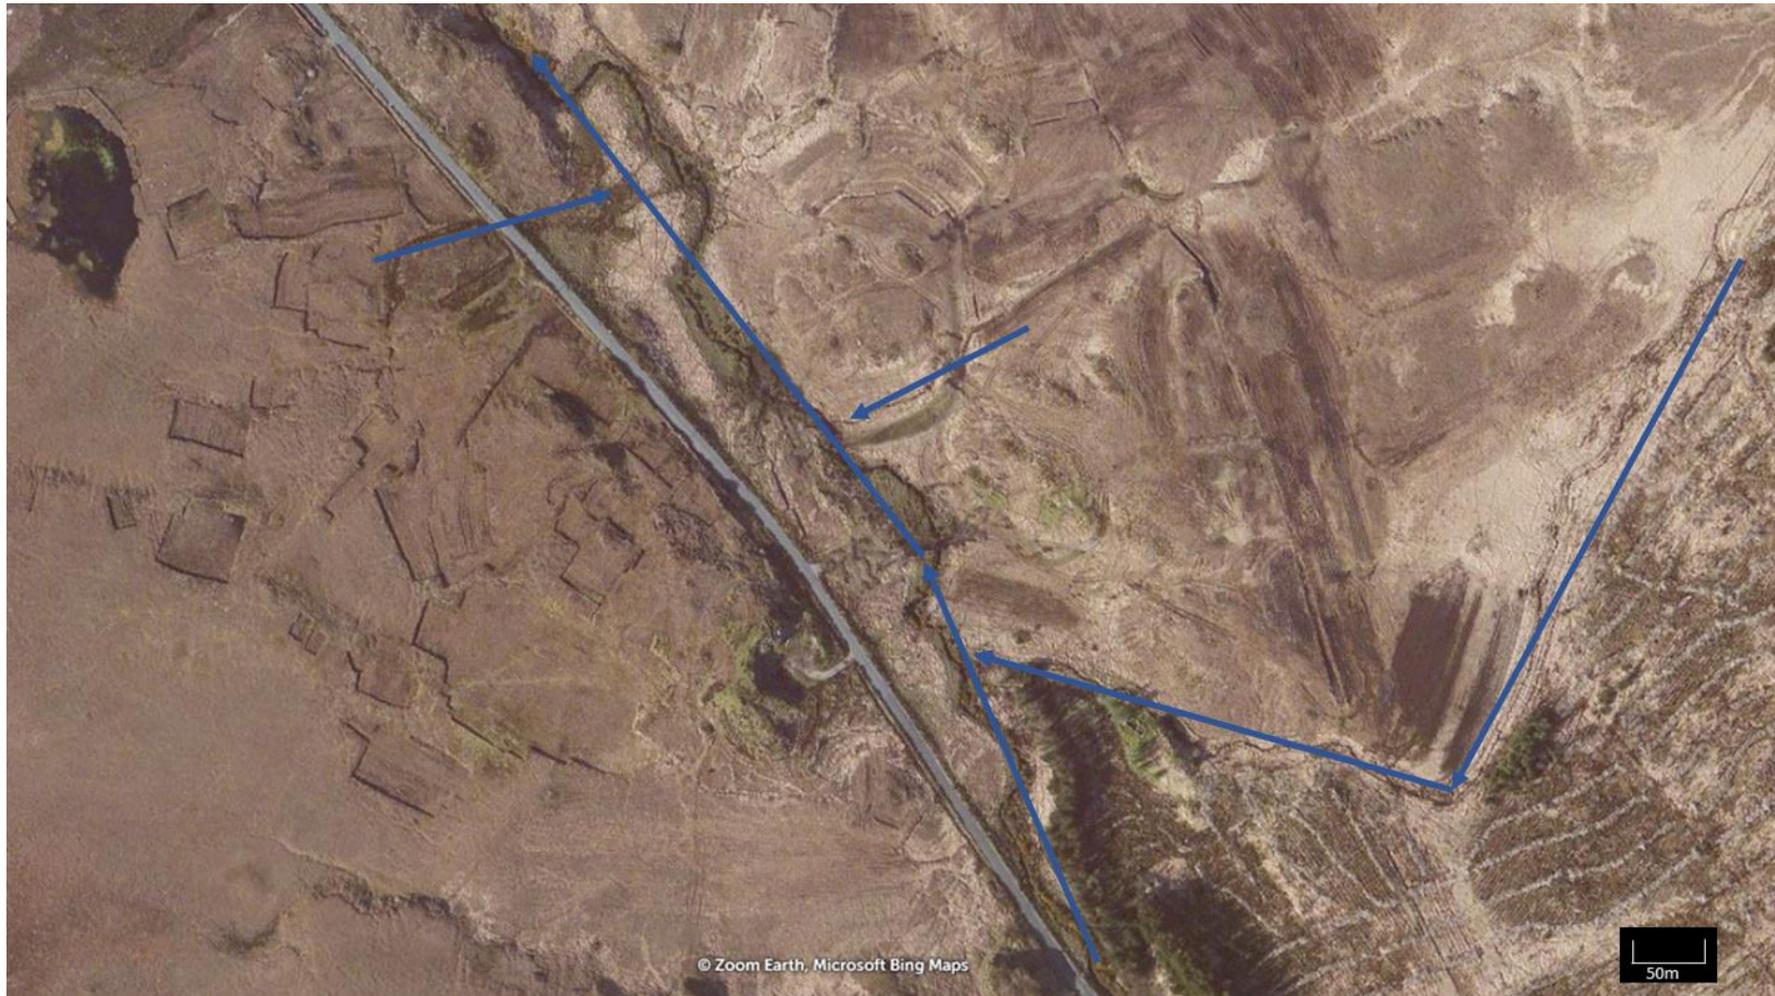
Figure 6: Aerial image of peat extraction within the Cloon_010 river water body

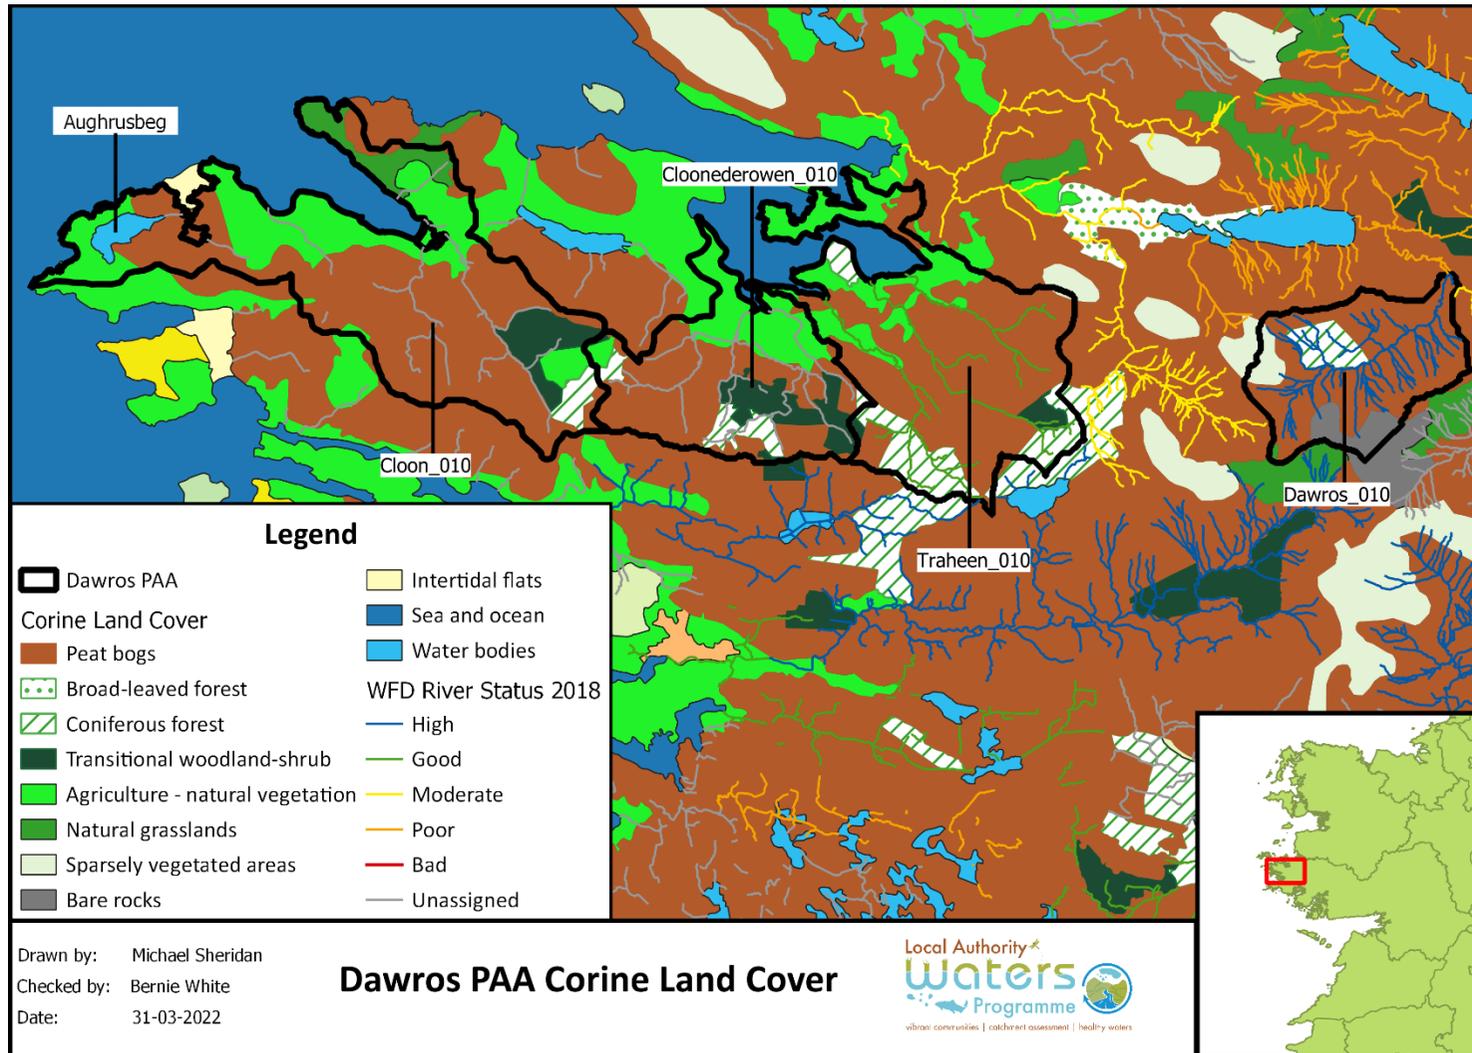
Figure 7: Corine Land Cover in Dawros PAA

The Corine Land Cover (CLC) mapping (**Figure 7**), illustrates the types of land use within the PAA. The principal land cover is peat bogs covering 58% of the area (**Table 6**) with land principally occupied by agriculture covering nearly 22%. Some agricultural areas, which are predominantly near the coast, has been due to reclamation of peatland that potentially may have resulted in the digging of drainage channels flowing directly into surface waters. There are also some substantial areas of coniferous forestry (8.5%) and transitional woodland shrub (6%) on higher ground away from the coastal areas within the PAA, particularly in the Traheen_010 and Cloonederowen_010 sub-basins. Direct pathways from forest drains to surface waters should also be considered as part of LCA in these RWBs.

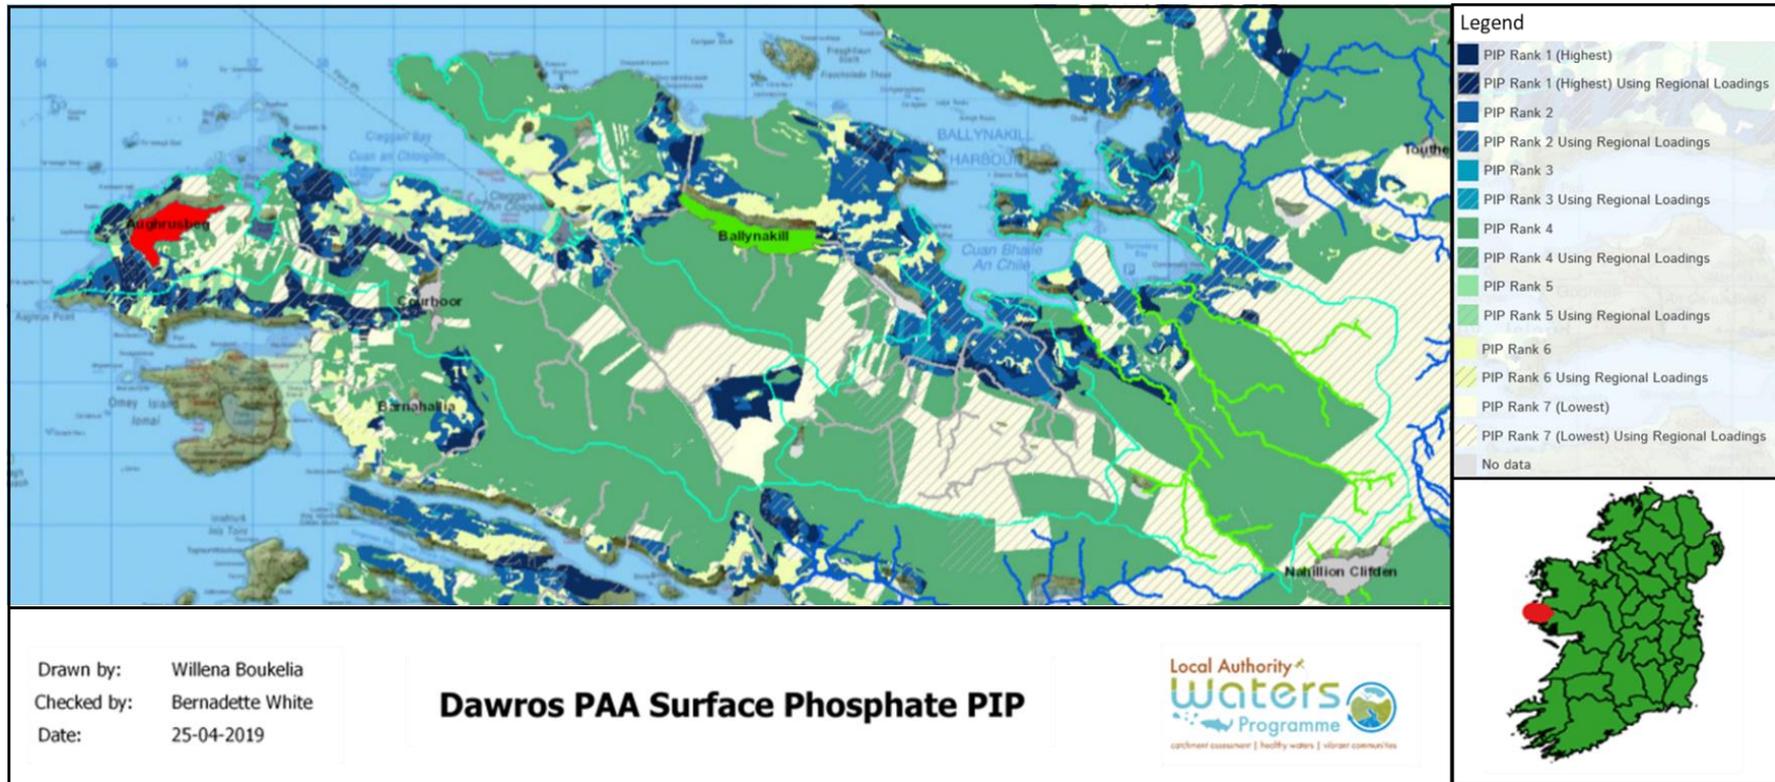
Figure 8: Surface Water Receptor Phosphate Pollution Impact Potential

Sanicose Potential Impact P Risk: very high potential impact from DSWWTSs occurs all along the high phosphate PIP area along the coast. Moreover, one very high potential impact DSWWTS is located adjacent to the Traheen_010 EPA operational monitoring station. Approximately 50 DSWWTSs around Aughrusbeg Lake are identified as a very high potential impact for phosphate.

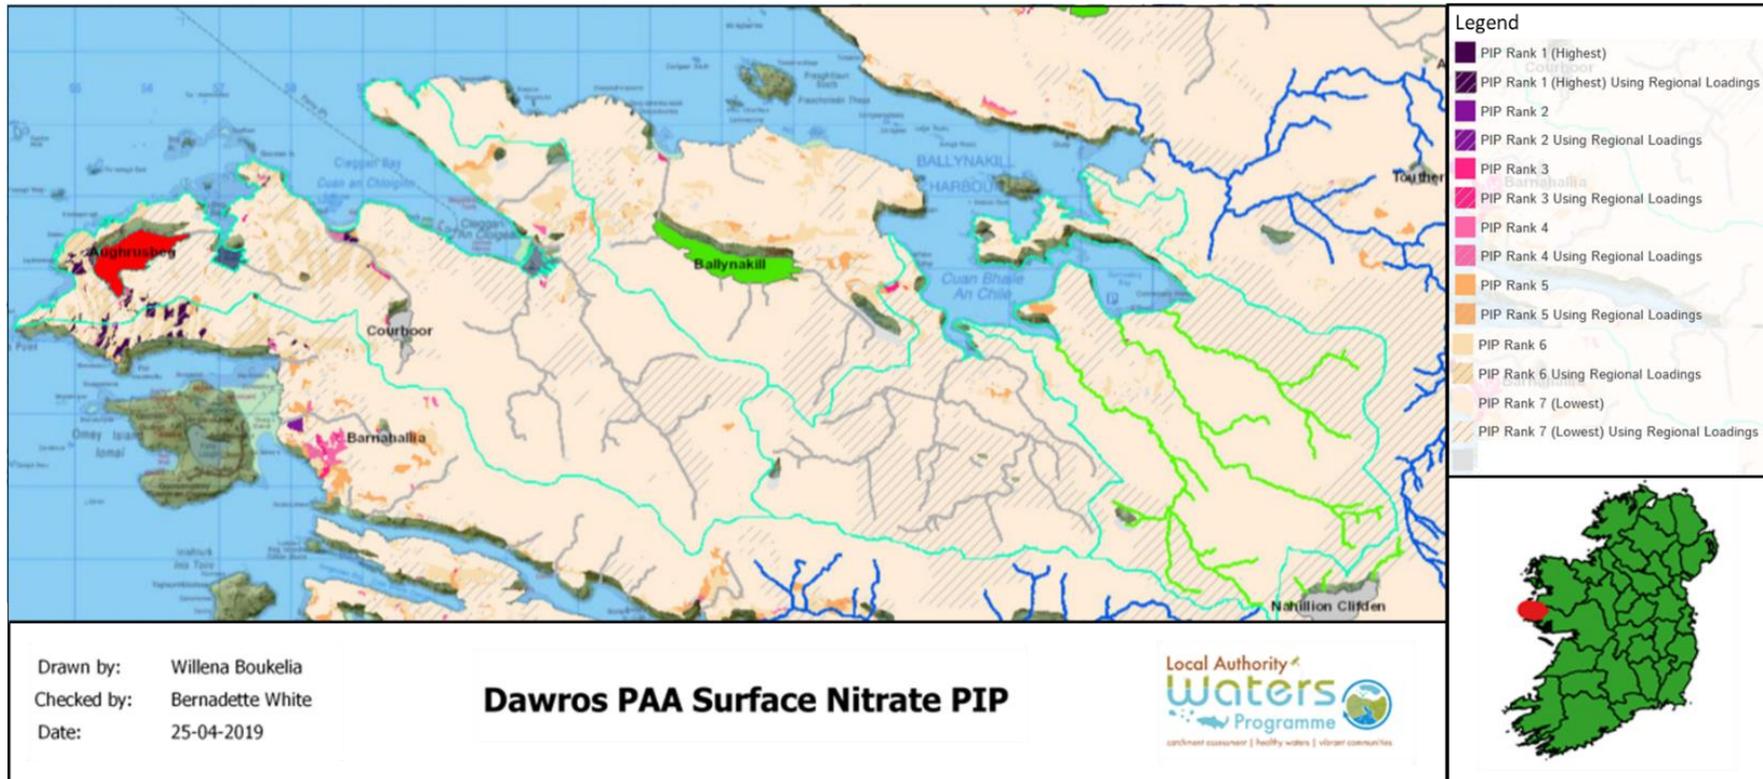
Figure 9: Surface Water Receptor Nitrate Pollution Impact Potential

Sanicose Potential Impact N Risk is high for approximately 50 OSWWTS around Aughrusbeg Lake where depth to bedrock is <3m.

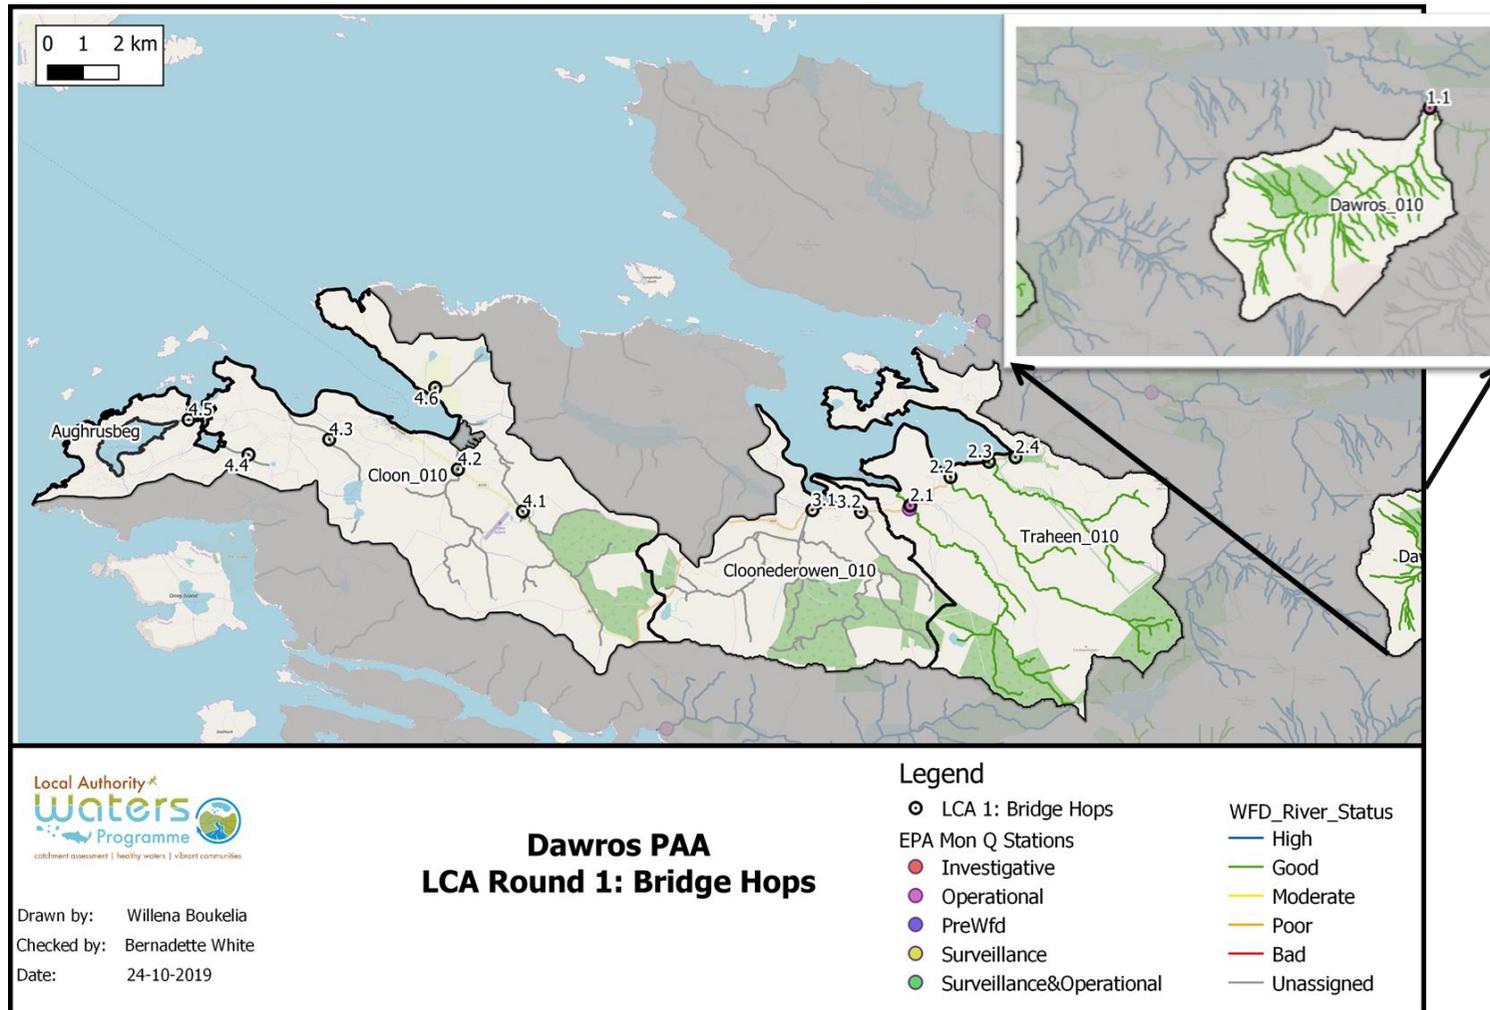
Figure 10: LCA Round one bridge hop locations

The RWB has three distinct tributaries and potentially a fourth unmapped tributary within the river subbasin that flows northerly into the coastal water body. Only the most westerly tributary is monitored by the EPA and is currently *At Risk* of failing to meet its High Status Objective. This tributary is known locally as the Traheen River. The LCA strategy will initially be as described above for Cloon_010 and Cloonederowen_010, starting at the EPA operational monitoring station at Traheen Bridge. A catchment walk upstream of Traheen Bridge will be undertaken. A total of 4 potential LCA sites have been identified of 850m in length (**Figure 10**).

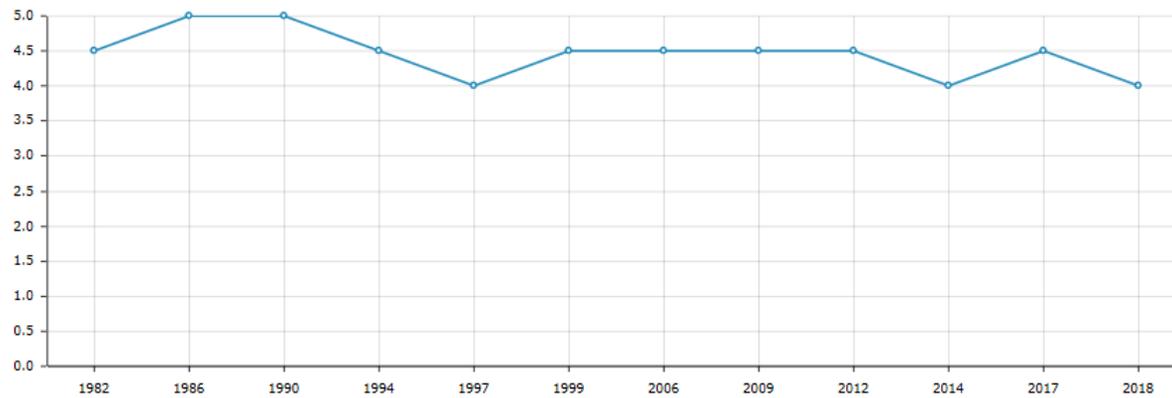
Q Value - Chart

1982	1986	1990	1994	1997	1999	2006	2009	2012	2014	2017	2018
Result	4.5	5	5	4.5	4	4.5	4.5	4.5	4.5	4	4.5	4
Classification	High	High	High	High	Good	High	High	High	High	Good	High	Good
Q-Value	4-5	5	5	4-5	4	4-5	4-5	4-5	4-5	4	4-5	4

A return to good ecological condition from the previous high quality reported in 2017 was determined for the Traheen in 2018. Quality fluctuates between high and good in this river in the most recent assessments.

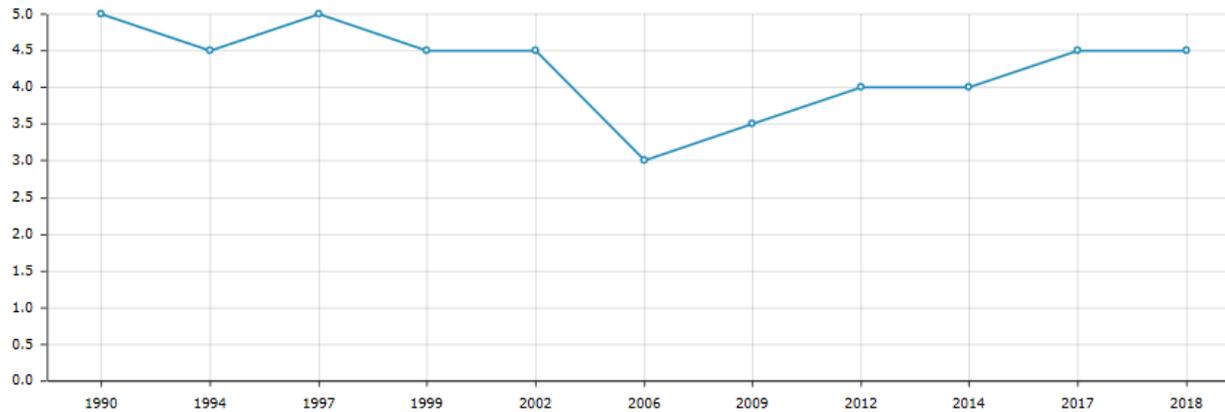
Q Value - Chart

1990	1994	1997	1999	2002	2006	2009	2012	2014	2017	2018
Result	5	4.5	5	4.5	4.5	3	3.5	4	4	4.5	4.5
Classification	High	High	High	High	High	Poor	Moderate	Good	Good	High	High
Q-Value	5	4-5	5	4-5	4-5	3	3-4	4	4	4-5	4-5

Highly satisfactory condition was noted in the headwaters of the Dawros upstream of Kylemore Lough (0020) although sensitive Perlida encountered in the 1990's remain absent from this waterbody. Station (0200) at Dawros Bridge has only seen slight improvement on the significant deterioration reported in 2017 and is still unsatisfactory in 2018.
