Lickeen System

Priority Area for Action Desk Study (AFA0104)

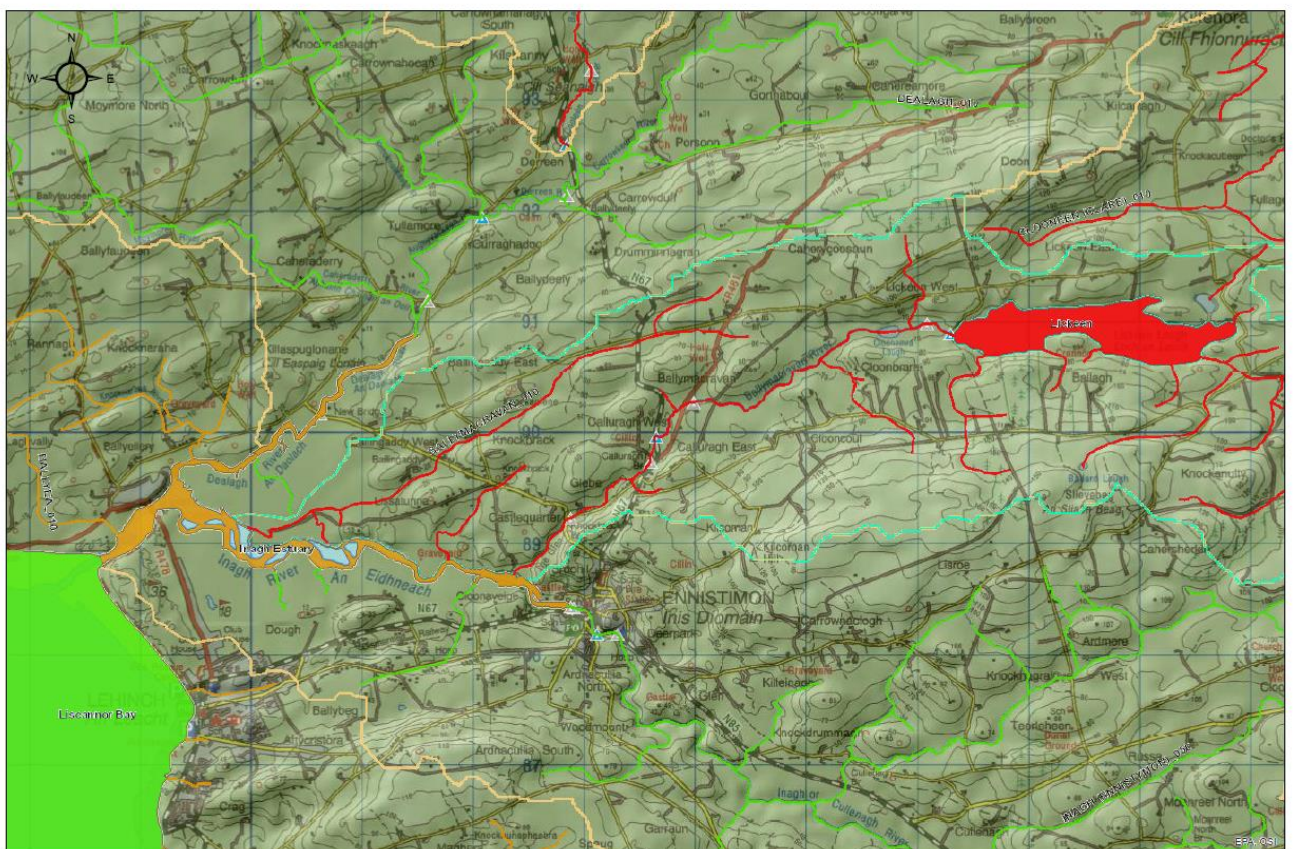
Figure 2-1: Lickeen System PAA waterbody risk map

PAA WFD Risk and Status maps are provided in Figures 2-1 and 2-2 respectively.

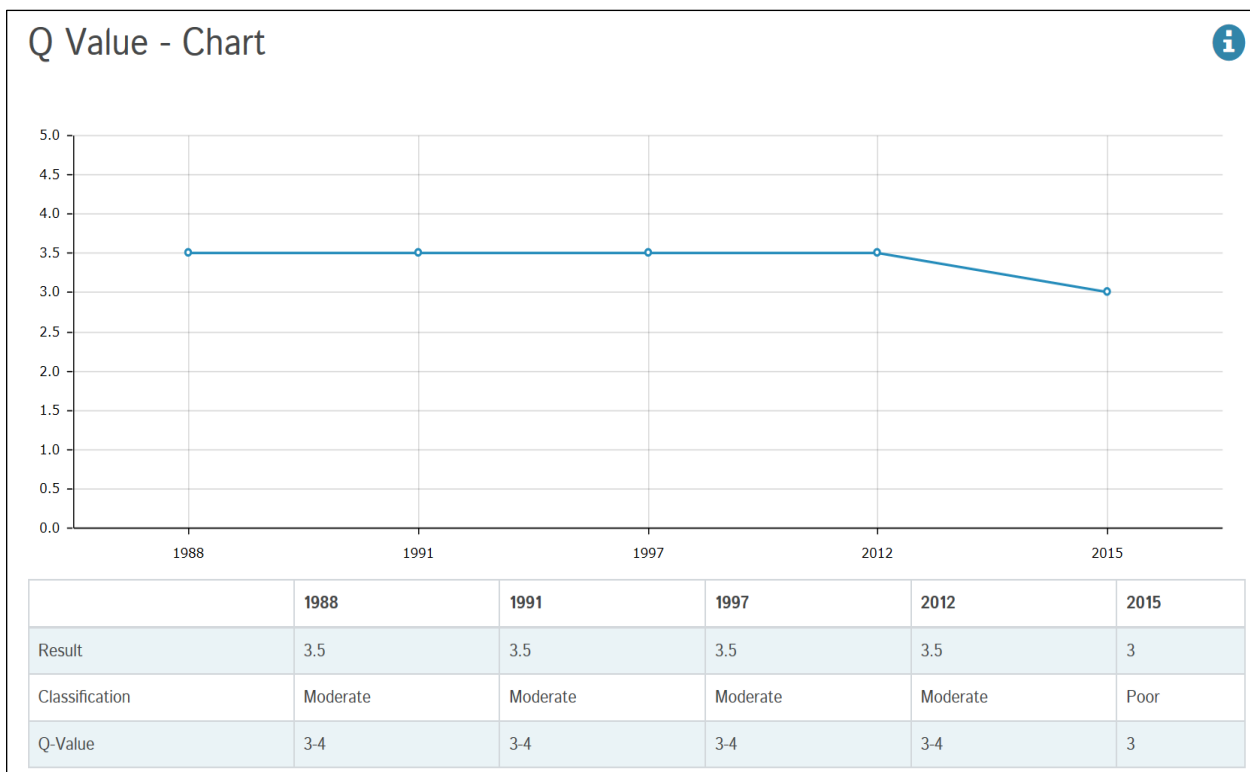
Figure 2-3: Biological monitoring results at *BALLYMACRAVAN-Br just d/s Lickeen Lough (RS28B020100)*

Q values for Ballymacravan-Br just d/s Lickeen Lough are graphed below in Figure 2.3.

The 2013-2018 Poor WFD status of Ballymacravan_010 is driven by 2015 biological monitoring results at RS28B020100, which is very close to the lake outflow (30m downstream of the outflow). The WFD app refers to a lake impoundment here which is restricting outflow in low water, but the Local Authority Area Engineer has advised that there is no physical barrier or impoundment on the lake. However, the lake is used for the Ennistymon drinking water supply and the abstraction may be potentially impacting on downstream river level, causing the river to periodically dry up at this WFD site in low flow conditions (see section on lake abstraction pressure below). The site wasn't assessed between 2000 and 2009 inclusive because the river was dry at this location during that period. It was also dry in 2018. The close proximity of this monitoring station to the lake outlet could also potentially impact on river biology here. Even when water level is adequate for assessment, this monitoring station has not been at Good status since monitoring commenced here. The suitability of '*BALLYMACRAVAN-Br just d/s Lickeen Lough*' (RS28B020100) for WFD monitoring is questionable for both of these reasons.

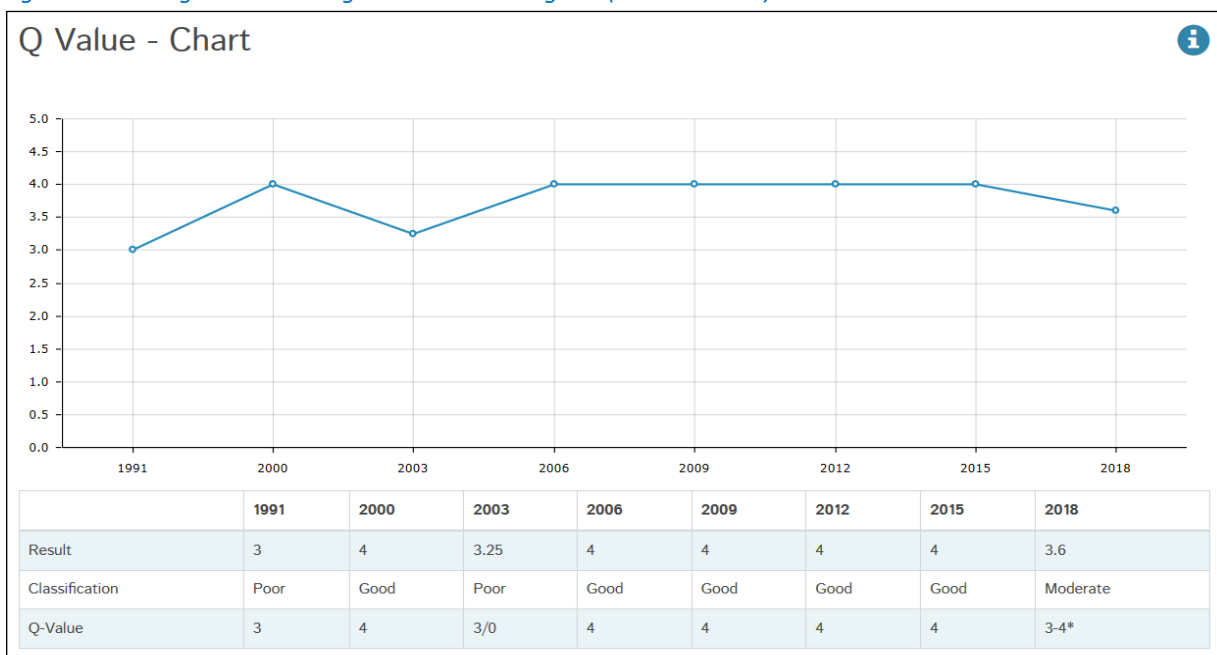
Figure 2-4: Biological monitoring results at Calluragh Br (RS28B020400)

Q values for the Calluragh Bridge monitoring station are graphed below in Figure 2.4.

As can be seen from Figure 2-4, biological status at 'Calluragh Br' (RS28B020400) was Poor with a possible toxic impact when assessed in 2003. It was consistently Good from 2006 to 2015 inclusive, dropping to Moderate (Q3-4*) in the 2018 survey. The biologists' notes for the 2018 survey state that *the river was highly coloured and turbid with extensive siltation noted on the riverbed that indicated a significant departure from the ideal 'reference condition' for such a river.* The Calluragh Bridge monitoring station is approximately 500m downstream of the outfall from the Ballymacravan water treatment plant. The local authority has advised that there is an occasional discharge of ferric sludge and sediment from the plant. This discharge in low flow conditions, could potentially impact the invertebrate community at the Calluragh bridge site. This needs to be investigated in the local catchment assessment. There is also a small residential development (5 houses) on its own system to the immediate north of the water treatment plant but if problematic, this would be more likely to cause nutrient and organic rather than sediment issues.

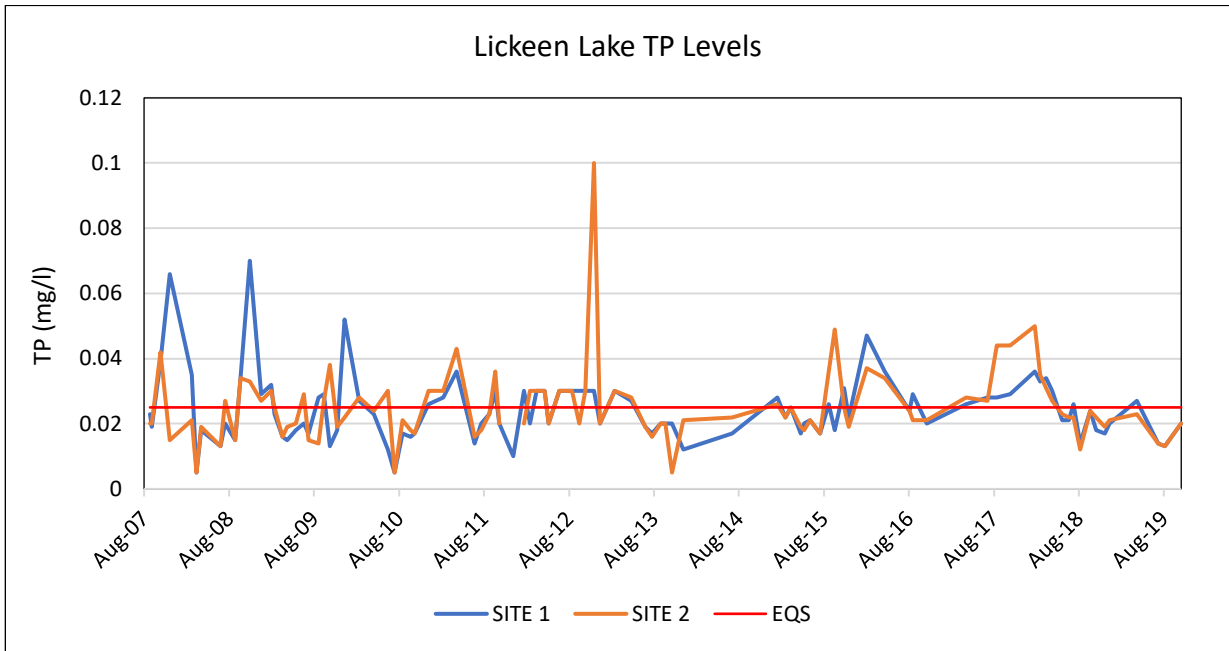
Figure 2-5: Total phosphorus levels for Lickeen Lake (Sites 1 and 2) 2007-2019

Individual total phosphorus results from 2007 to most recent available results are graphed below in Figure 2-5. Mean results from 2016 to 2019 are graphed in Figure 2-6.

As can be seen from the graphs, individual total phosphorus results have periodically exceeded the mean good status EQS of 0.025mg/l. Annual average results also periodically exceeded this standard (2007, 2012, 2016, 2017, 2018, see table 2-2 below).

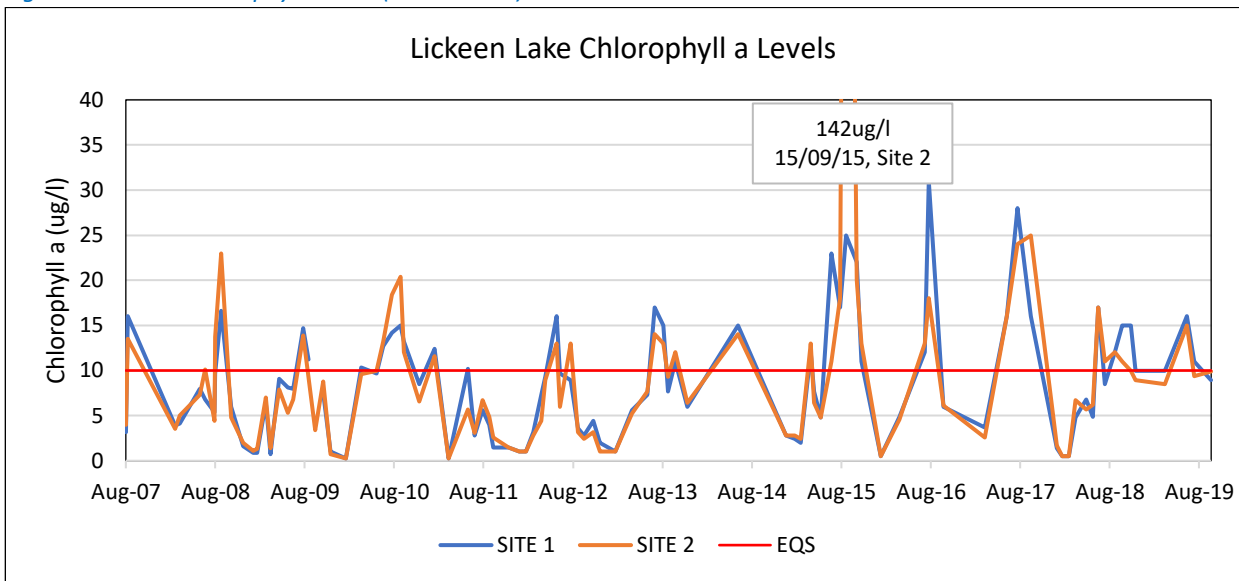
Figure 2-7: Lake Chlorophyll Levels (Site 1 and 2) 2007-2019

Lake chlorophyll levels (individual results) are graphed in Figure 2-7 below. Mean results from 2016 to 2019 are graphed in Figure 2-8.

As for total phosphorus, individual chlorophyll results periodically exceed the Mean Good Status EQS of 10ug/l.
