Big (Louth) _20 Priority Area for Action

AFA_0021 Desk Study Report Version F01

23th July 2019

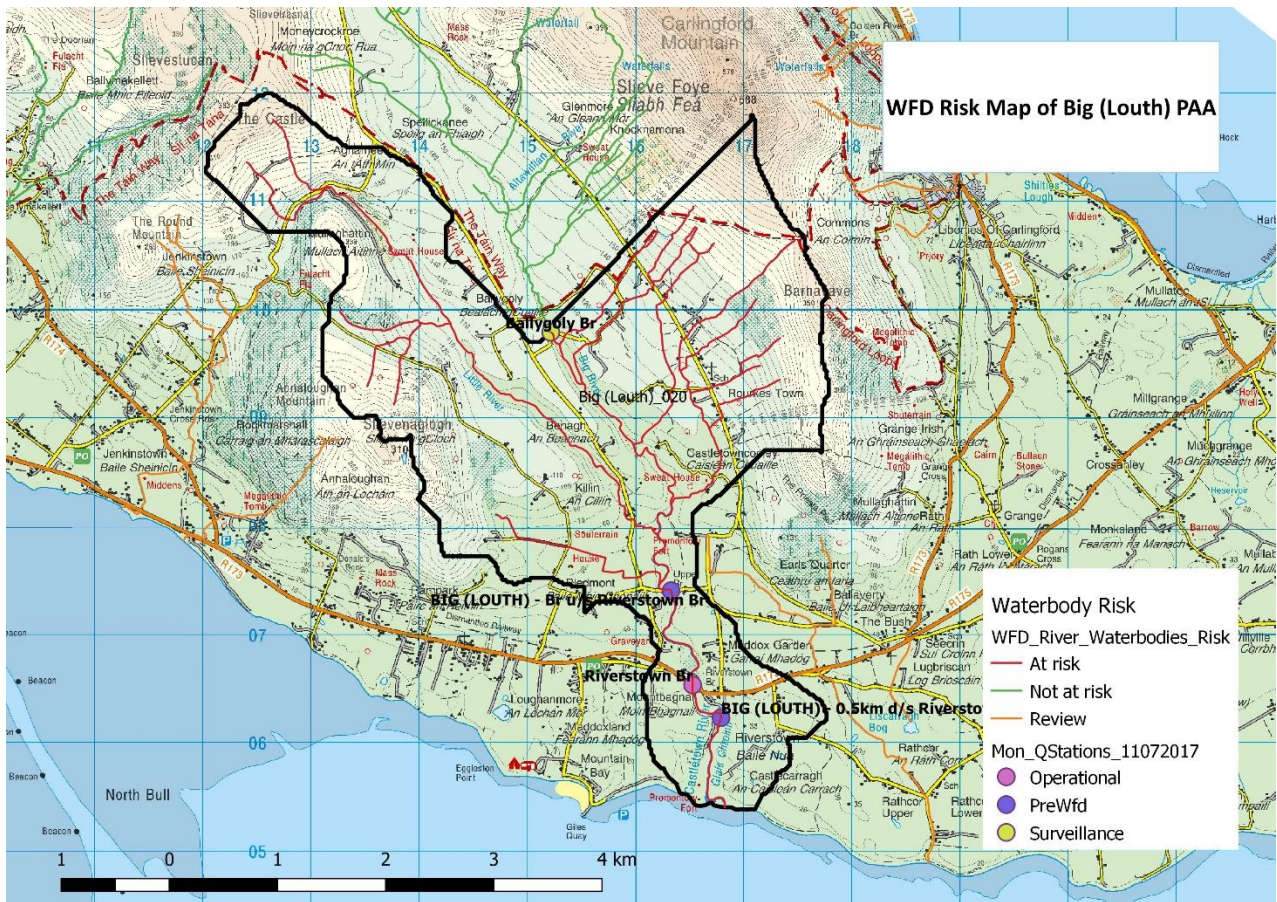
Figure 1 Water-framework Directive Risk map of the Big (Louth)_20 near Carlingford in County Louth.

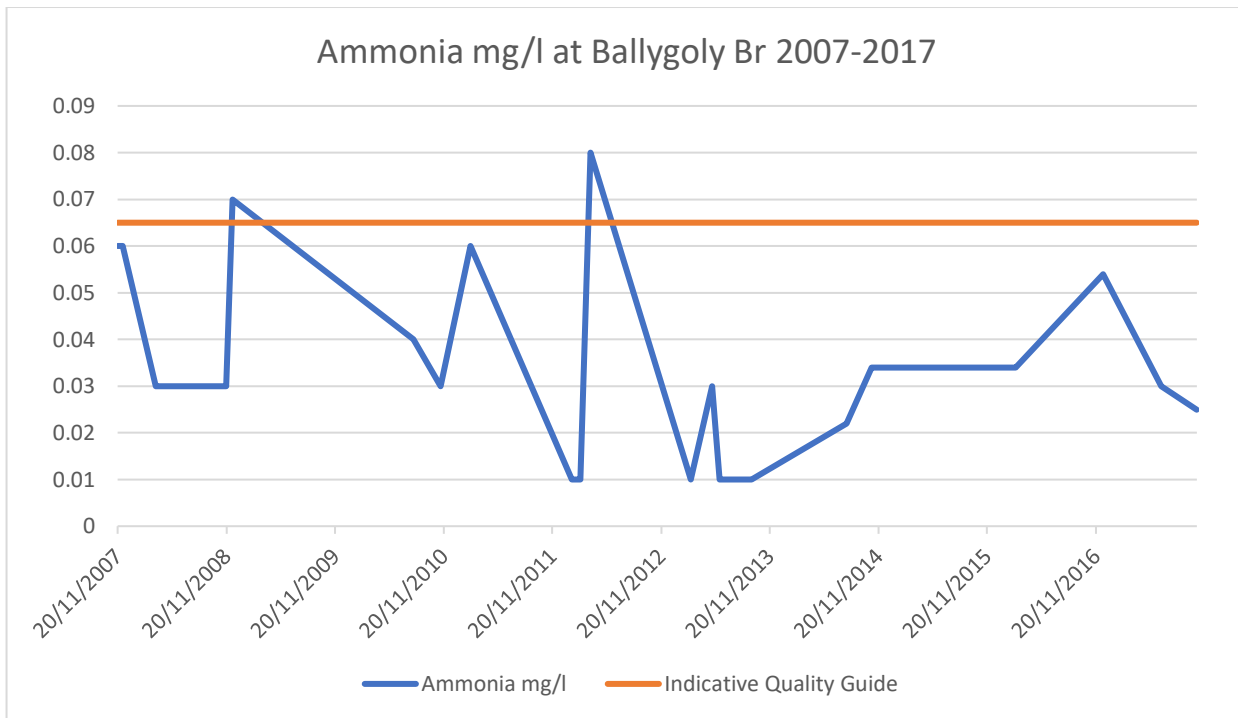
Figure 5 Ammonia levels at Ballygoly Br IE_NB_06B010100 2007-2017

- Ammonia levels at Ballygoly Br monitoring point show consistent readings below the EQ for the past number of years. There is not a Nitrate problem in Big (Louth)_10.
- Total Oxidised Nitrogen measured at Ballygoly bridge in 2016 and 2017 were below 1mg/l well below the EQS of 1.8mg/l.

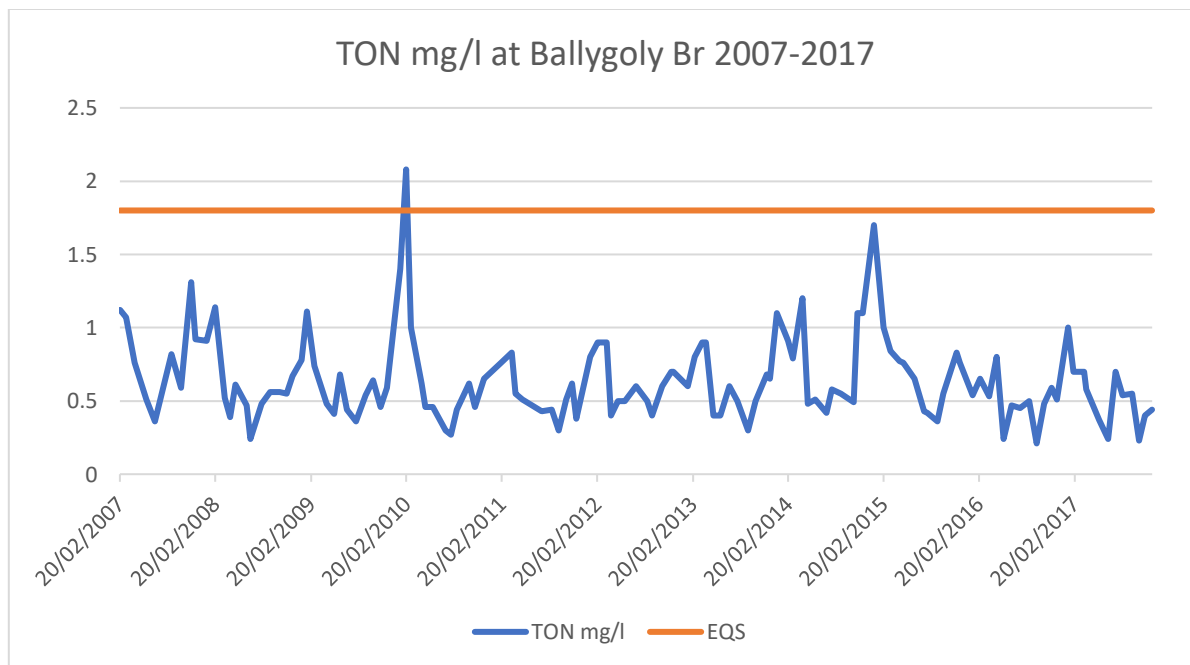
Figure 6 TON mg/l levels at Ballygoly Br IE_NB_06B010100 2007-2017

Total Oxidised Nitrogen concentrations are well within the assumed EQS of 1.8mg/l, Even though TON is trending slightly downwards the general concentrations and baseline concentrations are well below the EQS of 1.8 mg/l for TON

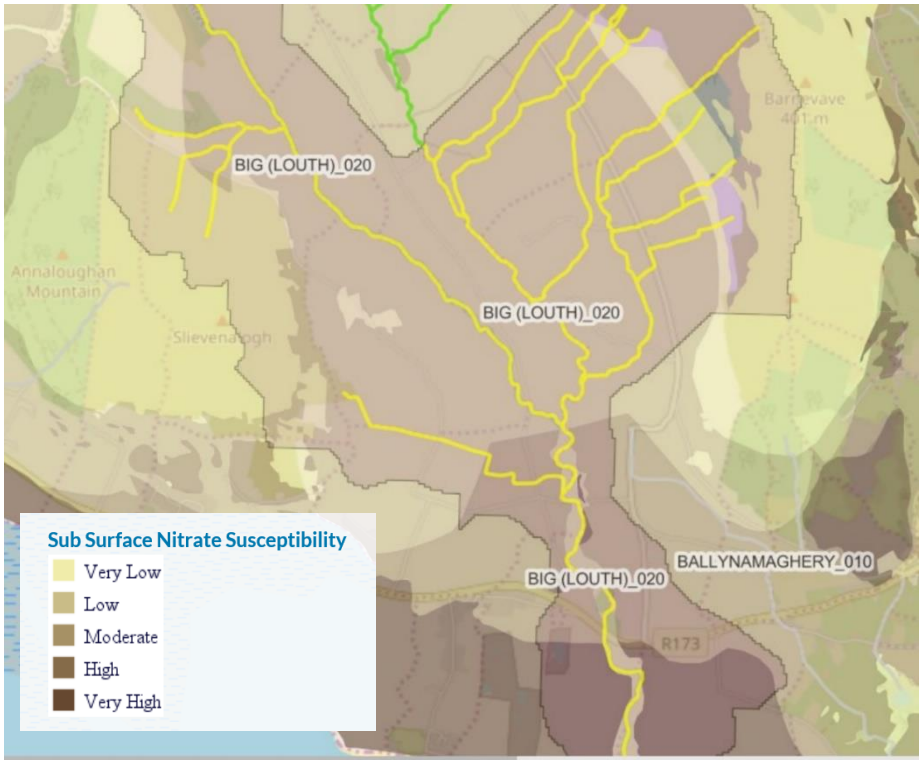
Figure 19 The Sub Surface Nitrate Susceptibility for the Big (Louth)_20 catchment in County Louth

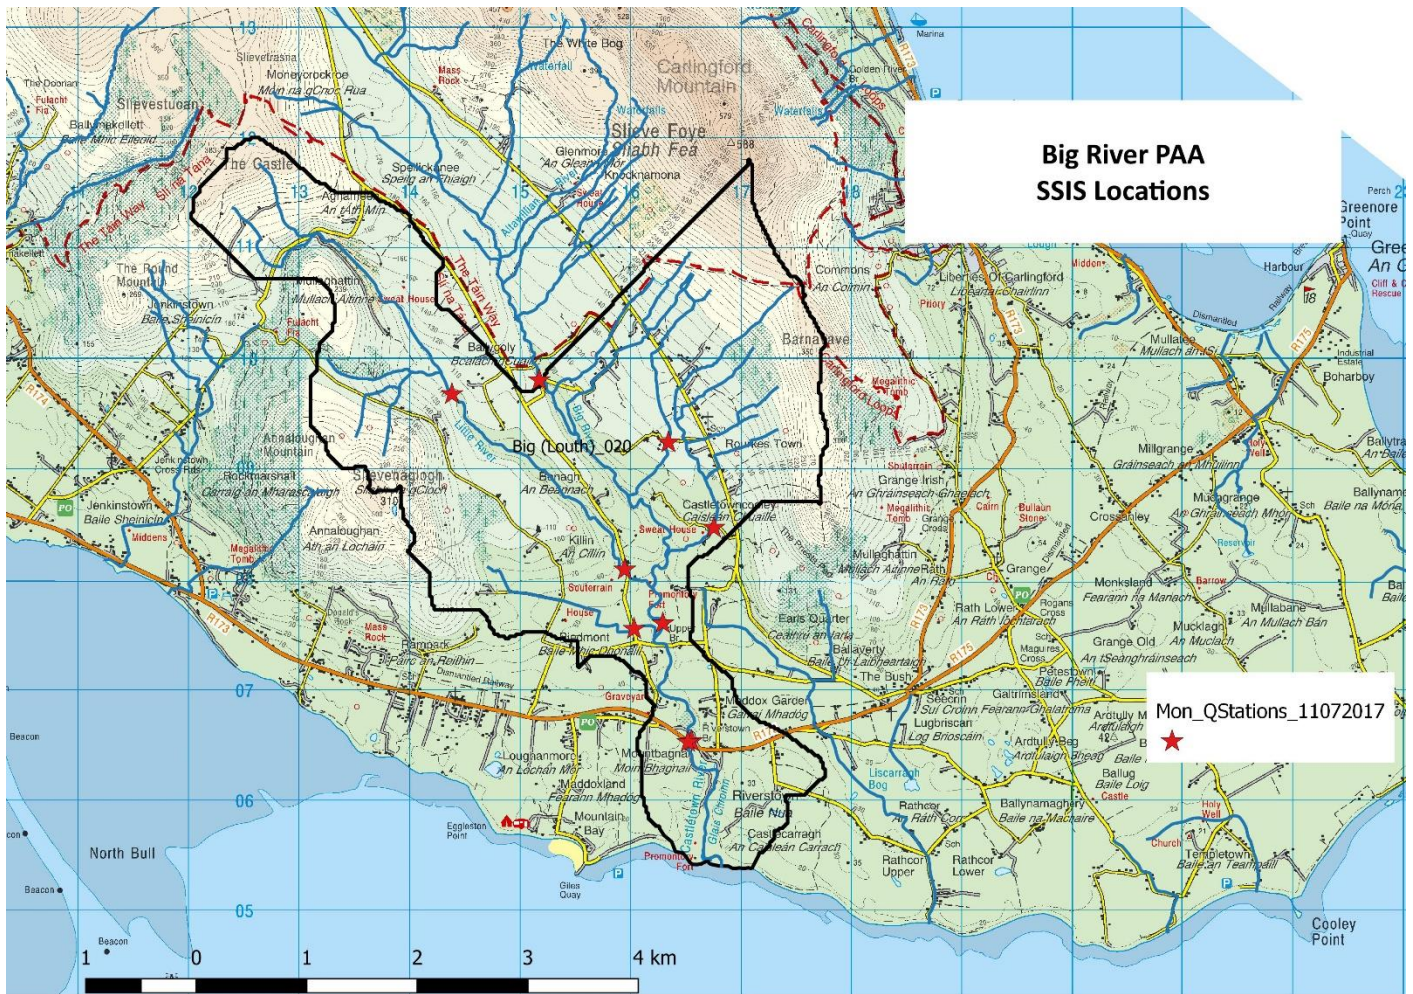
Figure 22 Planned SSIS in Big (Louth)_020

- Consultation on the desk studies LA, IFI etc
- Talk to EPA IPC licence inspectors about IPC licensed facility and request monitoring results
- Public meeting Feb 2019.
- Take 3 Water chemistry samples at the Q monitoring station in 2019
- SSIS/RA upstream and downstream of identified significant pressures
Walk 1km upstream of the monitoring point station 400
- Concentrate field work in Compartment 2 assuming the tributaries are satisfactory. Take repeated samples of conductivity/dissolved oxygen profile up the stream. Look at the pipes and discharges.
Stream walks should be designed based on sampling tributary streams prior to them meeting the main channel.
- A desk study of the abstraction regime associated with the IPC licence required
