Duff Priority Area for Action AFA0071 Desk Study Report

LAWPRO (Border Region)

AFA0071_Duff PAA

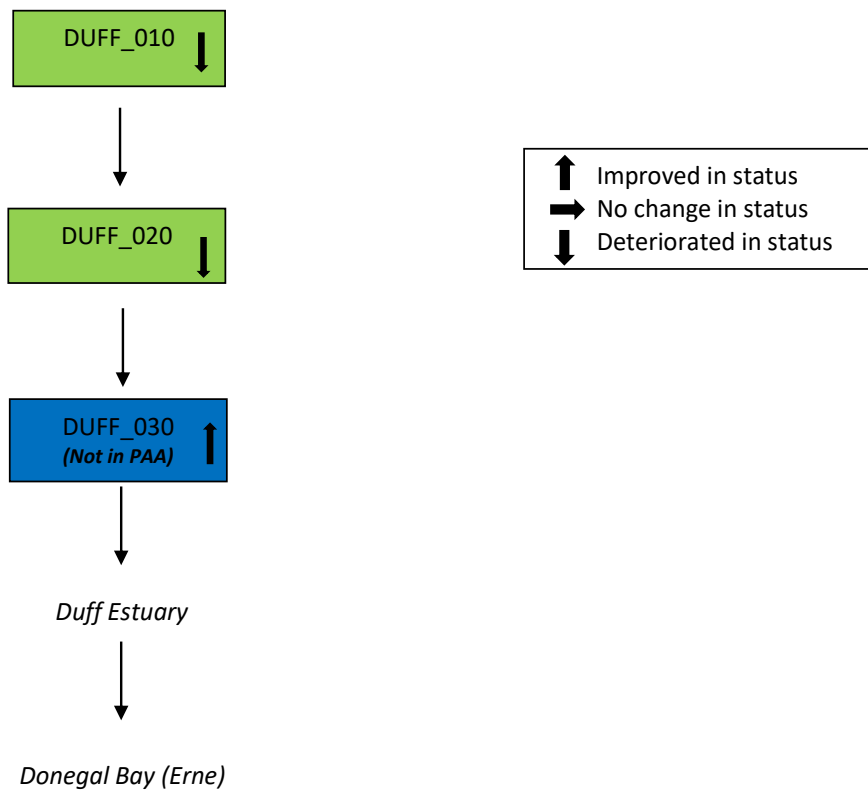
Figure 1 Flow direction of the waterbodies within the Duff PAA

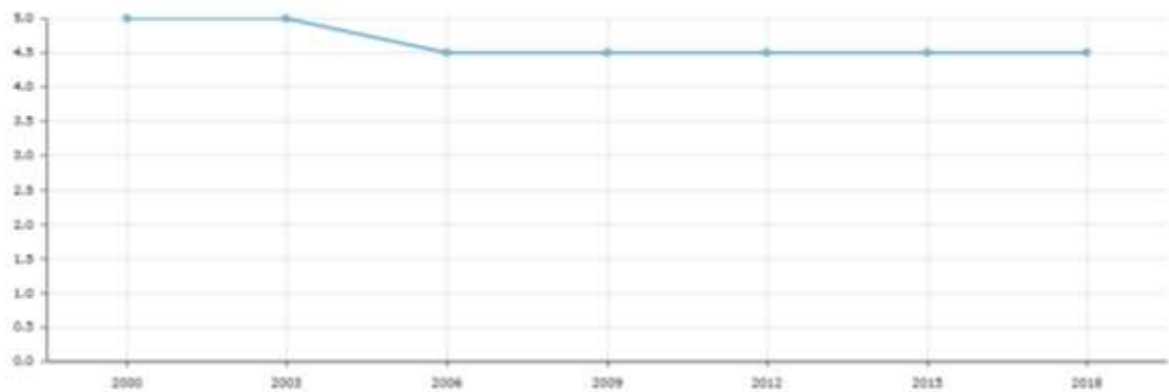
2000	2003	2006	2009	2012	2015	2018
Result	5	5	4.5	4.5	4.5	4.5	4.5
Classification	High	High	High	High	High	High	High
Q-Value	5	5	4.5	4.5	4.5	4.5	4.5

Figure 3 The biological trend and data for monitoring St. 50020 (2000 – 2018).

- The 2018 biological data at this monitoring station characterises the river in the Duff_010 as High Ecological Status (Q4-5) (Table 2, Figure 3).
- This ecological status has remained at High Status since 2000 (Table 2, Figure 3).
- Monitoring for general chemistry has only been carried out since 2016. This station is on the EPA 2019 -2021 monitoring programme for supporting chemistry monitoring.
- Based on the two monitoring data points for PO₄ and TON their concentration trends have remained the same. However, NH₃ concentrations are currently trending upwards (Table 2, Figure 4-6).
- It is important to note that none of the parameters measured (NH₃, PO₄ and TON) are exceeding their retrospective EQS (Table 2, Figure 4-6).

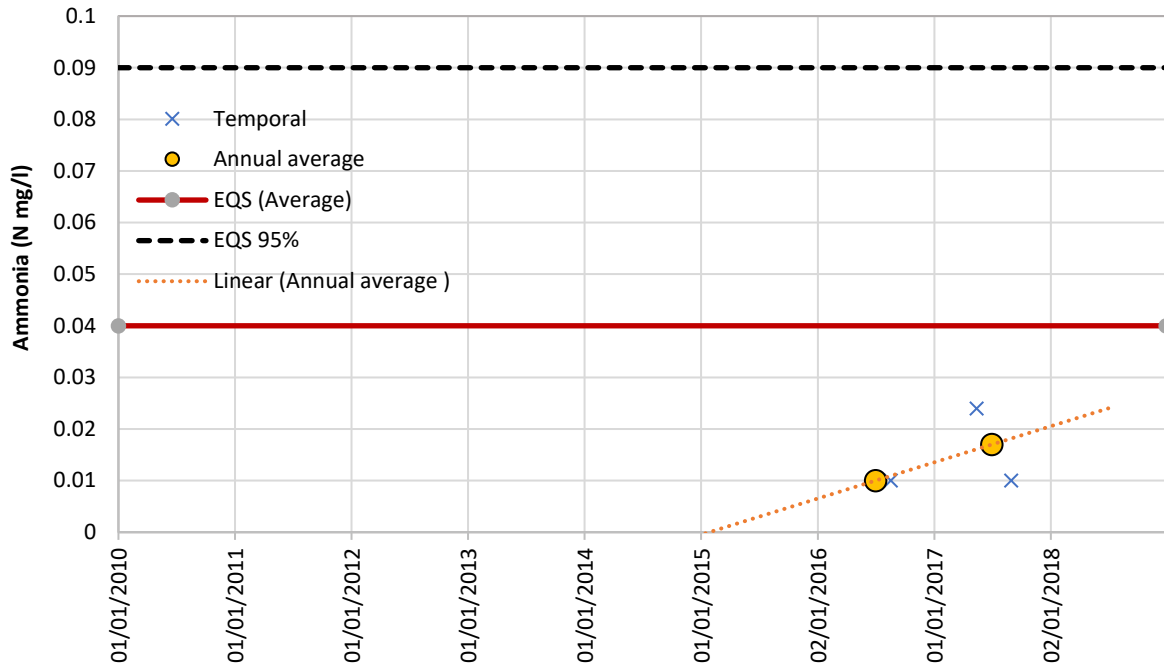
Figure 4 Ammonia (as N mg/l) trend chart for monitoring St. 50020 (2010 – 2018).

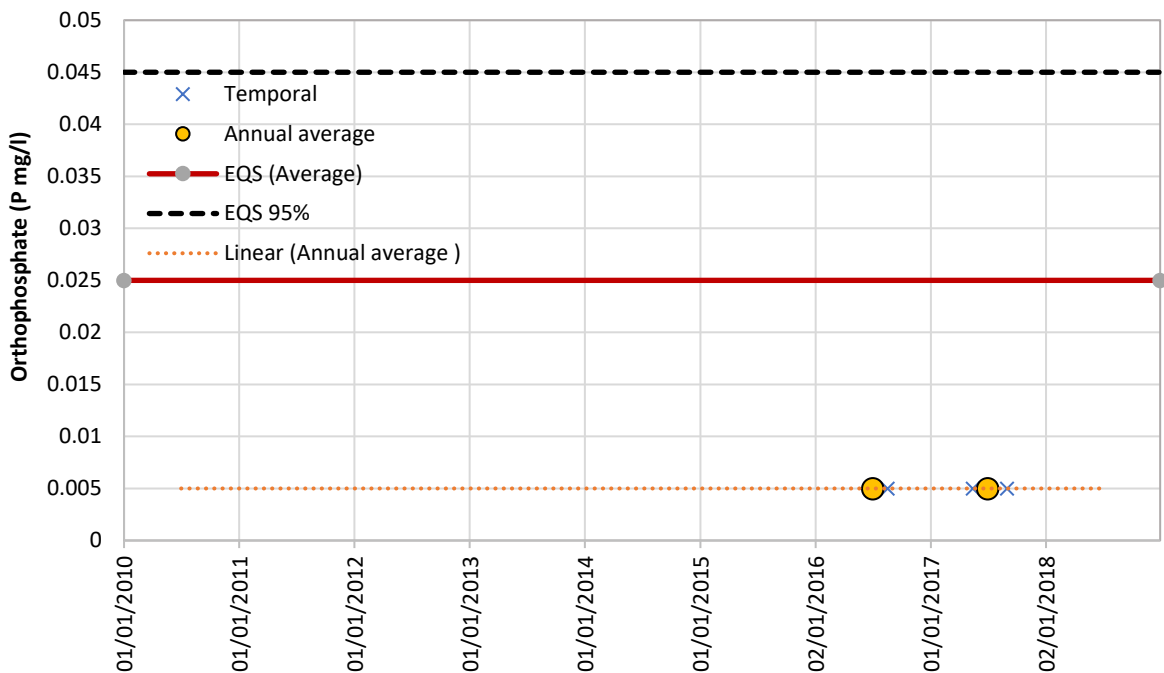
Figure 5 Ortho-Phosphate (as P mg/l) trend chart for monitoring St. 50020 (2010 – 2018).

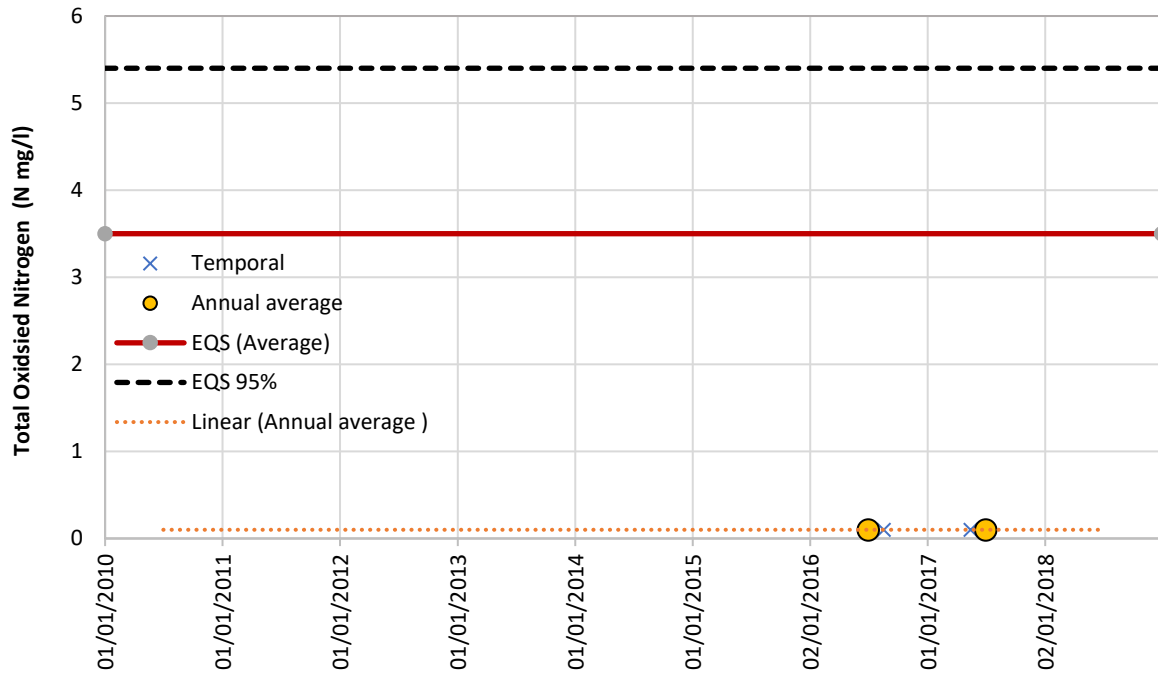
Figure 6 Total Oxidised Nitrogen (as N mg/l) trend chart for monitoring St. 50020 (2010 – 2018).

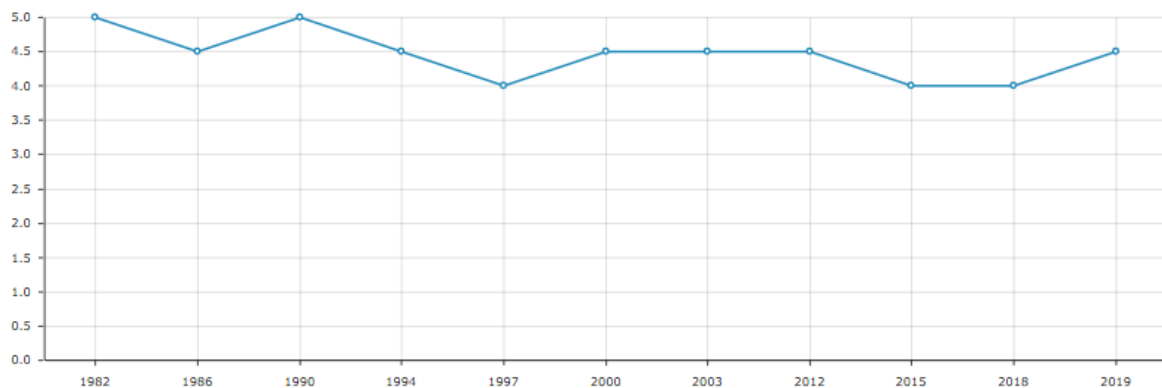
Figure 7 The biological trend and data for monitoring St. 50100 (1982 – 2019).

- The 2019 Q data at this monitoring station characterises the river at the Duff_010 and Duff_020 boundary as Q4-5. (Table 2, Figure 7).
- Invertebrate status at this site has decreased from Q4-5 in 2012 to Q4 in 2015 (Table 2, Figure 7). (Note: Invertebrates are driving status at this monitoring point in the waterbody).
- The RHAT score was high (Table 2).
- There is no further data available at this monitoring station. This monitoring station is not included on the EPA monitoring programme for supporting chemistry monitoring.

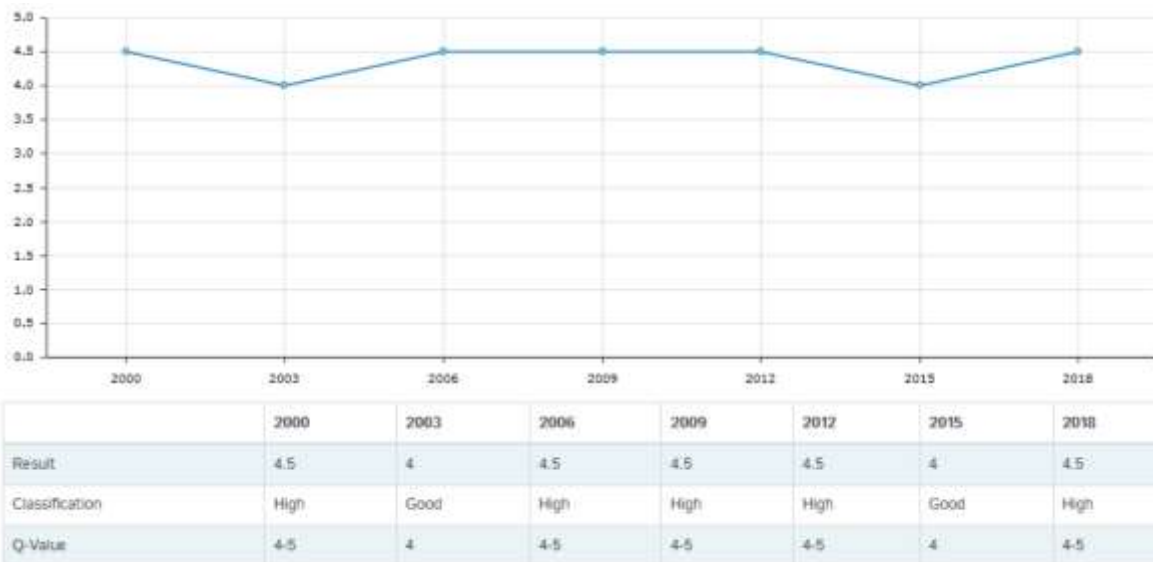
Figure 8 The biological trend and data for monitoring St. 50250 (2000 – 2018).

- The 2018 Q at this station characterises the Duff River as Q4-5 (Table 2, Figure 8).
- Invertebrate status at this site has increased from Q4 in 2015 to Q4-5 in 2018 (Table 2, Figure 8).
- This waterbody has a High Status objective.
- There is no RHAT score for this monitoring point.
- There is no further data available at this monitoring station. This monitoring station is not included on the EPA monitoring programme for supporting chemistry monitoring.

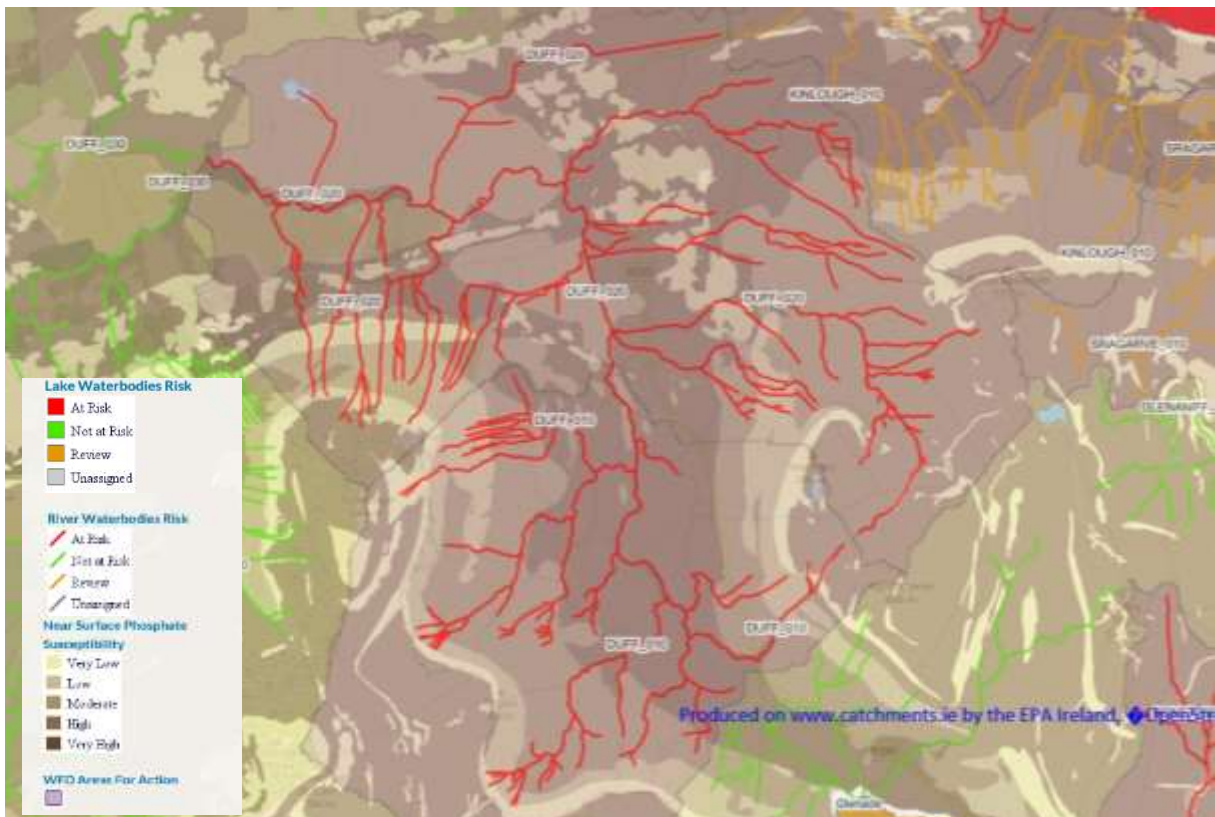
Figure 27 The near surface PO₄ susceptibility map for the Duff_010 and Duff_020 waterbodies.

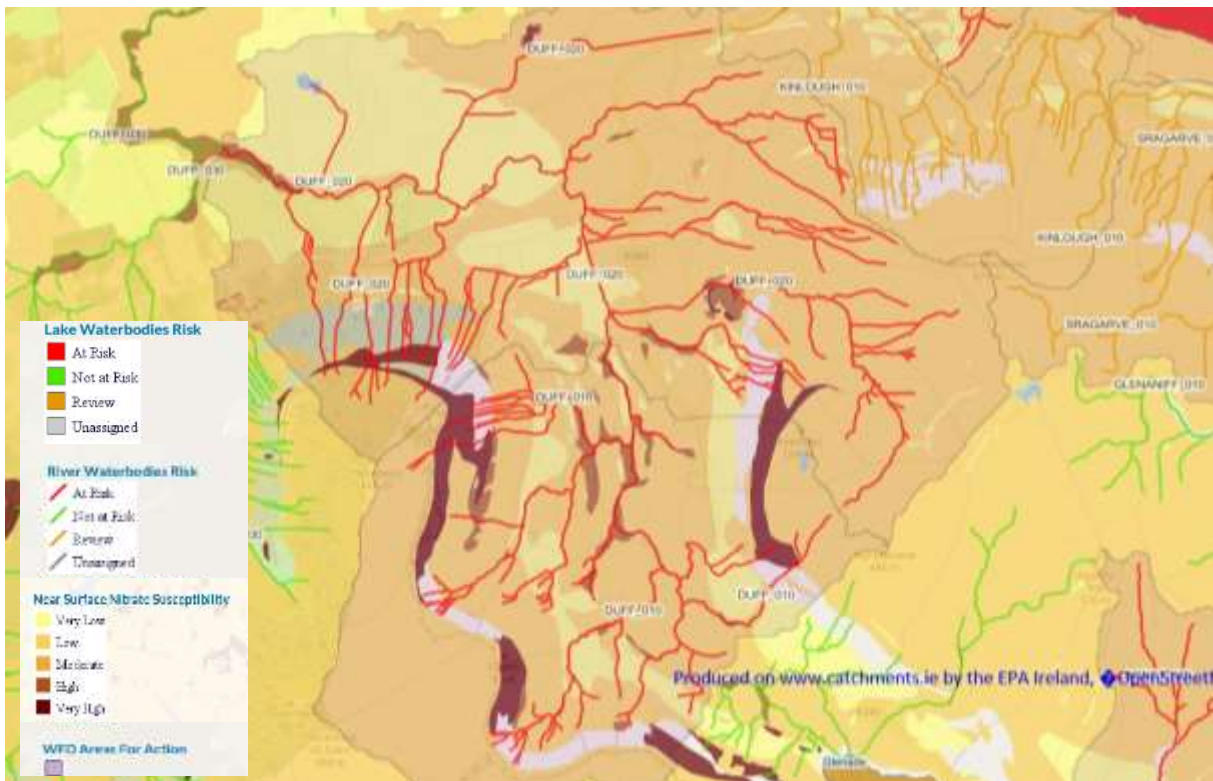
Figure 28 The near surface NO₃ susceptibility map for the Duff_010 and Duff_020 waterbodies.

NO ₃ Susceptibility (Fig. 28 & Fig 29)	Mod	Mod	Mod	Low	Mod	Low	Low	Low
PO ₄ PIP (Fig. 9 & Fig. 12)	High – V High	Low	High – V High	Low - Mod	Low	Mod - High	Low	High
NO ₃ PIP (Fig. 10, Fig. 11, Fig. 13 & Fig. 14)	Low	Mod - High	Low	Low	Mod	Low	High	Mod
Main Flow Paths	Overland, near surface flow and land drains	Near surface and groundwater flow	Overland, near surface, groundwater flow and land drains	Overland, near surface and groundwater flow and land drains	Near surface and groundwater flow	Surface, near surface flow and land drains	Surface water - groundwater interactions (Karst Features)	Surface water - groundwater interactions (Karst Features) and land drains

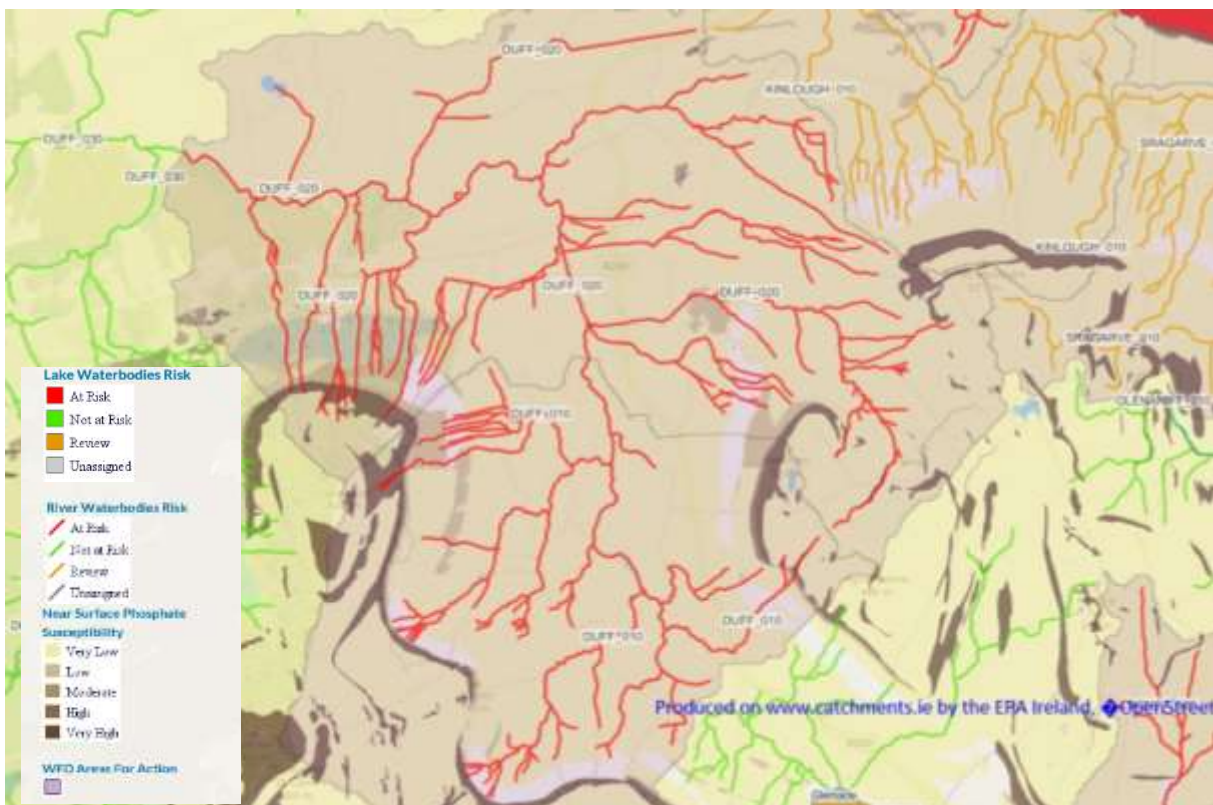
Figure 29 The sub-surface NO₃ susceptibility map for the Duff_010 and Duff_020 waterbodies.
