Lough Melvin and Drowes

Priority Area for Action

AFA0121 Desk Study Report

LAWPRO (Border Region)

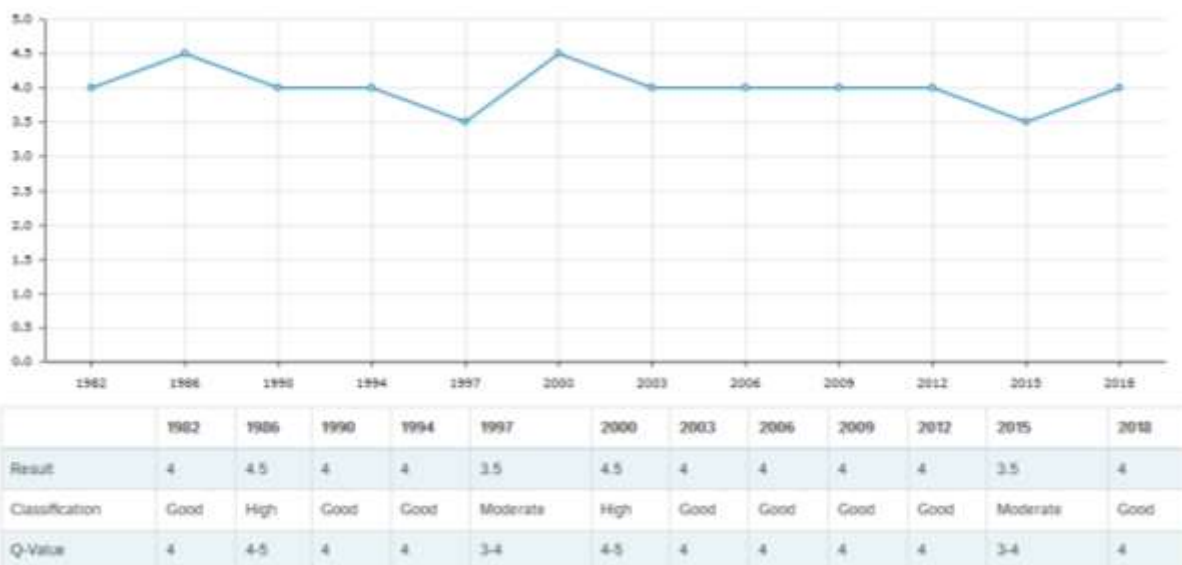
Figure 6 The biological trend and data for monitoring St. 30100 (1982 – 2018).

- The 2018 biological data characterises the river in the Drowes_010 as coming back up to Good Ecological Status (Q4) (Figure 6).
- The ecological status in the Drowes has fluctuated between High Ecological Status in 2000 to Moderate Ecological Status in 2015 (Figure 6).
- Total Oxidised Nitrogen concentrations are generally below the EQS, apart from a spike which occurred on the 9th of Aug 2016. Even though TON is trending upwards the general concentrations and baseline concentrations are well below the EQS of 1.8 mg/l for TON (Table 5, Figure 7).

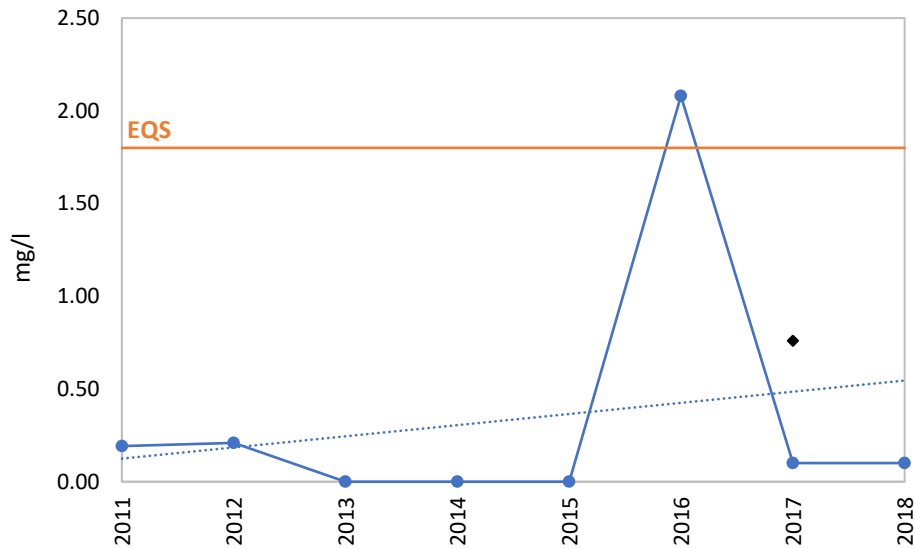
Figure 7 Total Oxidised Nitrogen (as N mg/l) trend chart for monitoring St. 30100 (2011 – 2015).

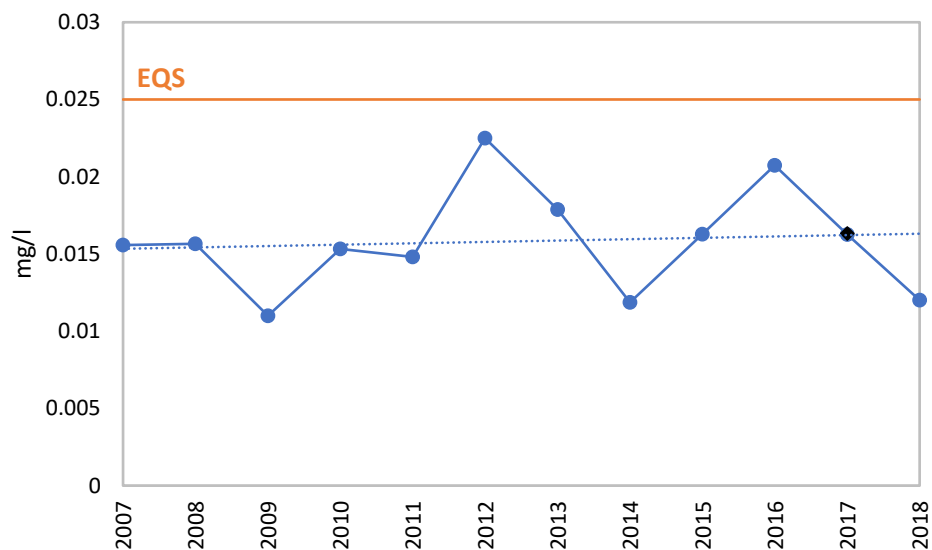
Figure 8 Total phosphorus (mg/l) trend for Site 3 in Lough Melvin (2007 – 2018).

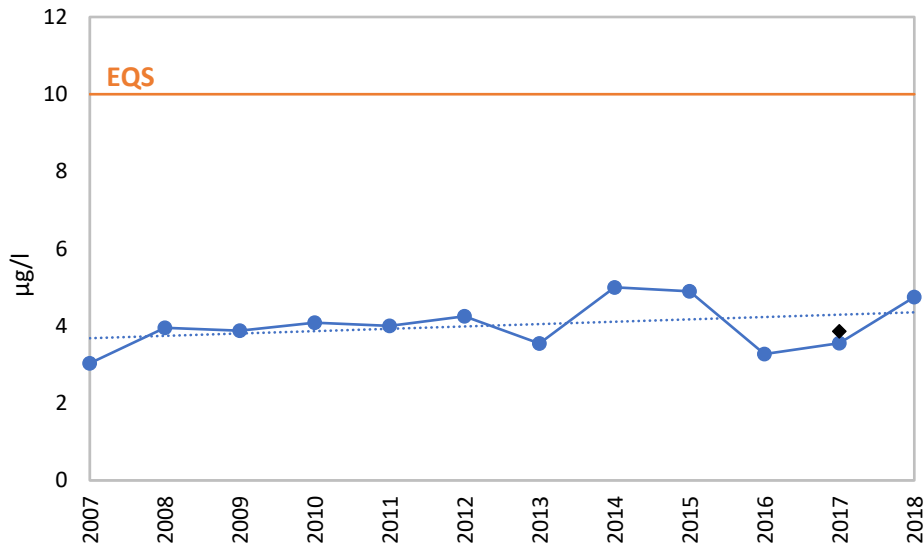
Figure 9 Chlorophyll a (µg/l) trend for Site 2 in Lough Melvin (2007 – 2018).

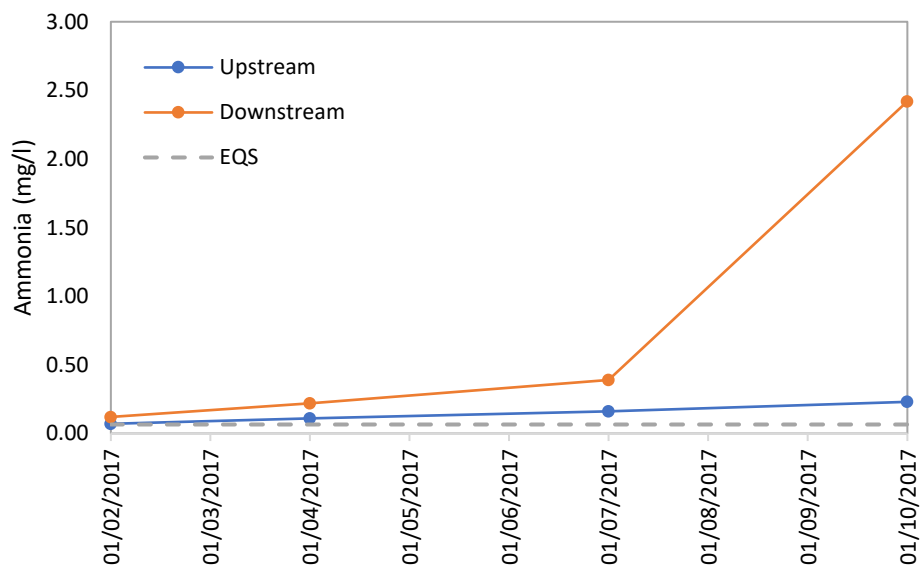
Figure 11 Ammonia concentrations at the monitoring stations upstream (St. 60090) and downstream (St. 60100) of Kinlough WWTP.

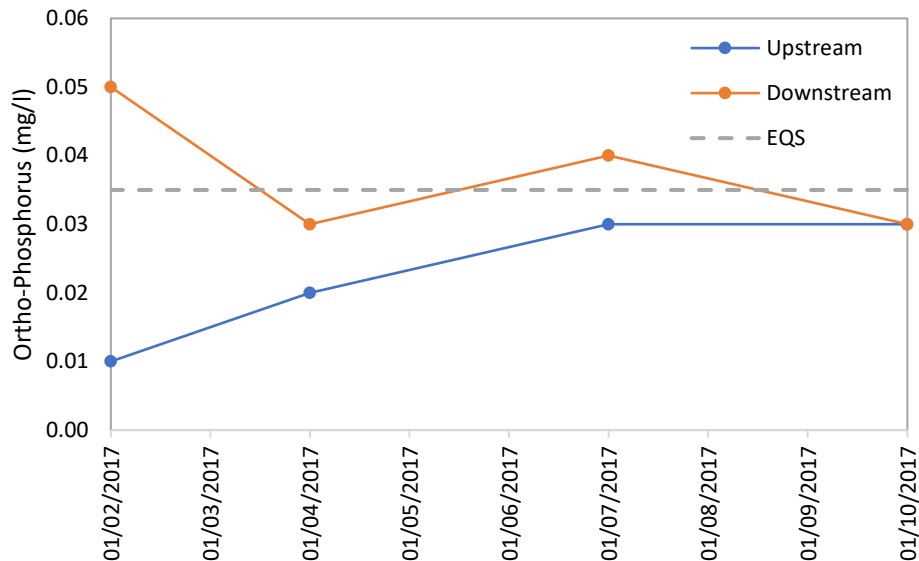
Figure 12 Ortho-Phosphorus concentrations at the monitoring stations upstream (St. 60090) and downstream (St. 60100) of Kinlough WWTP.
