Mountain Water and Emy Lough Priority Area for Action AFA0134 Desk Study Report

LAWPRO (Border Region)

Version F01

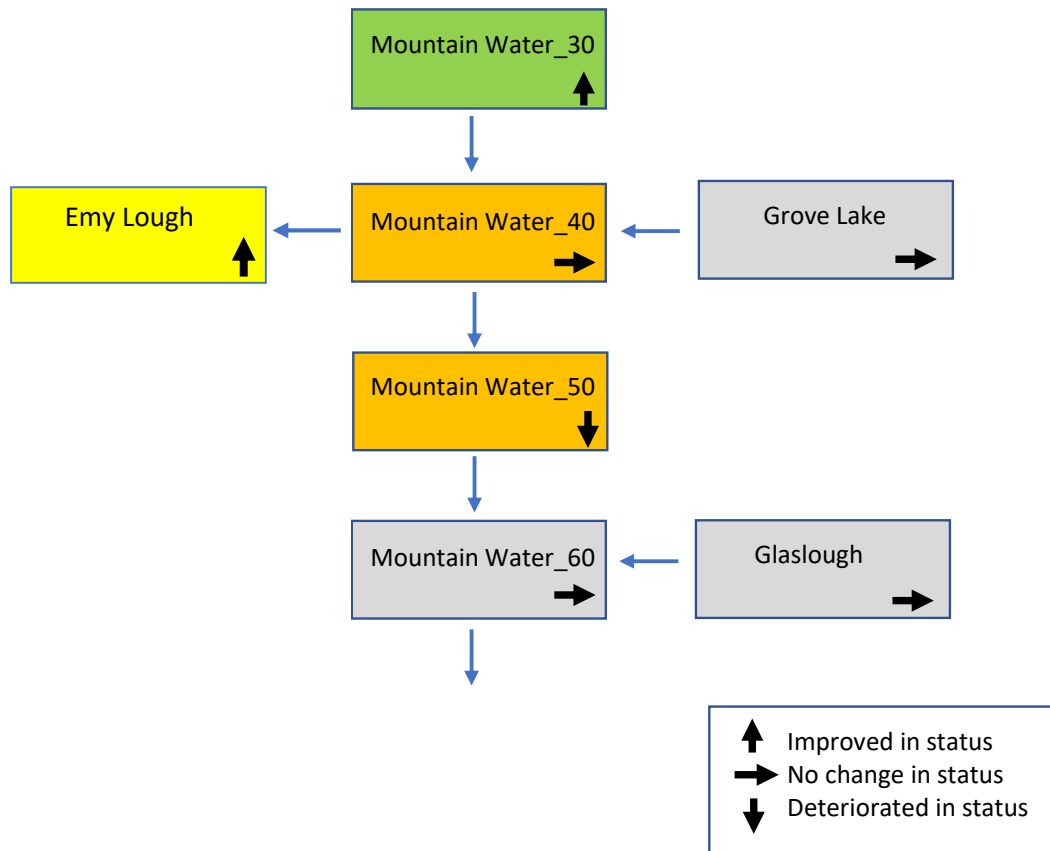
Figure 1 Flow direction of the waterbodies within the Mountain Water and Emy Lough PAA.

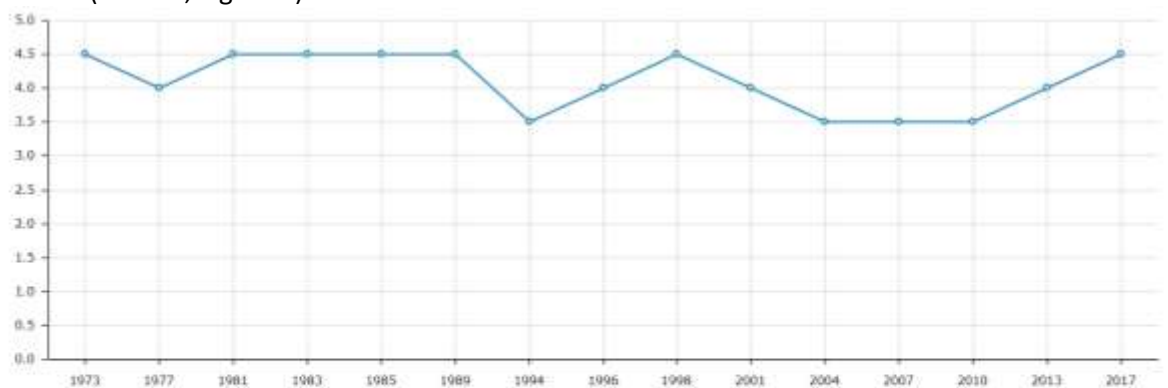
1973	1977	1981	1983	1985	1989	1994	1996	1998	2001	2004	2007	2010	2013	2017
Result	4.5	4	4.5	4.5	4.5	4.5	3.5	4	4.5	4	3.5	3.5	3.5	4	4.5
Classification	High	Good	High	High	High	High	Moderate	Good	High	Good	Moderate	Moderate	Moderate	Good	High
Q-Value	4.5	4	4.5	4.5	4.5	4.5	3.4	4	4.5	4	3.4	3.4	3.4	4	4.5

Figure 3 The biological trend and data for monitoring St. 400 (1973 – 2017).

- The 2017 biological data characterises the river in the Mountain Water_030 as High Ecological Status (Q4-5) (Figure 3).
- This ecological status has continually improved from Moderate Status in 2004 back to High Status in 2017 (Figure 3).
- The PO₄ baseline concentration (0.034 mg/l) and the average 2018 PO₄ concentration (0.033 mg/l, n = 5) is below the EQS of 0.035 mg/l for PO₄, however, the current trend for PO₄ is going upwards (Table 4, Figure 4).

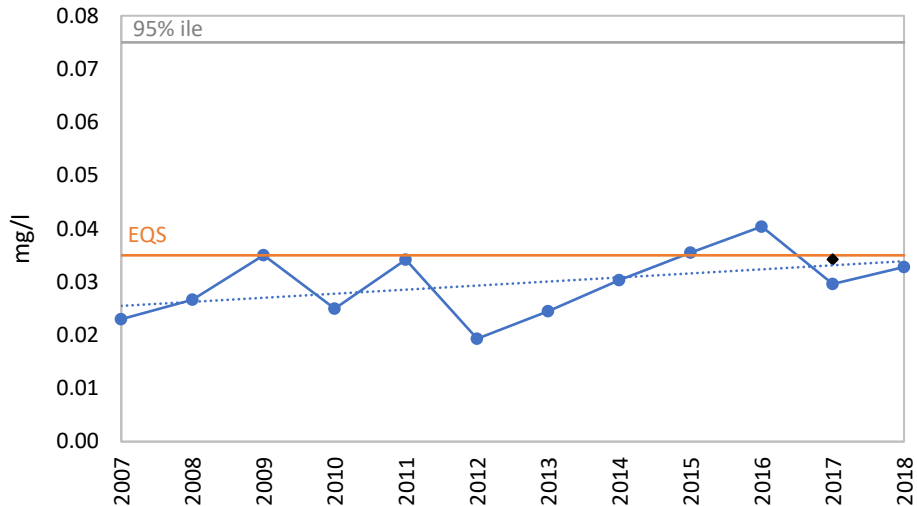
Figure 4 Ortho-Phosphate (as P mg/l) trend chart for monitoring St. 400 (2007 – 2018).

2007	2008	2009	2010	2011	2012	2013	2014	2015	2016	2017	2018
PO₄	n	10	6	6	6	6	6	6	6	5	5	5
	mg P L⁻¹	0.023	0.027	0.035	0.025	0.034	0.019	0.025	0.03	0.036	0.040	0.030

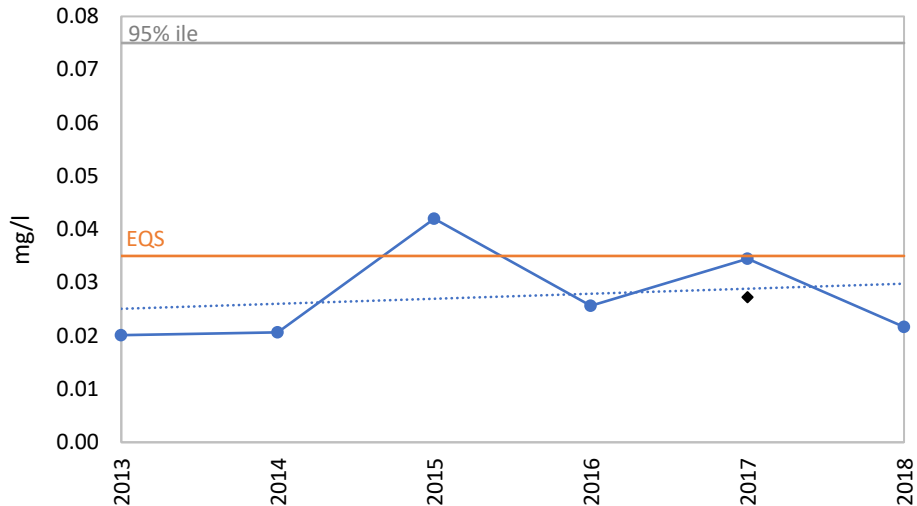
Figure 5 Ortho-Phosphate (as P mg/l) trend chart for monitoring St. 450 (2013 – 2018).

2013	2014	2015	2016	2017	2018
PO₄	n	4	4	3	6	6
	mg P L⁻¹	0.02	0.021	0.042	0.026	0.035

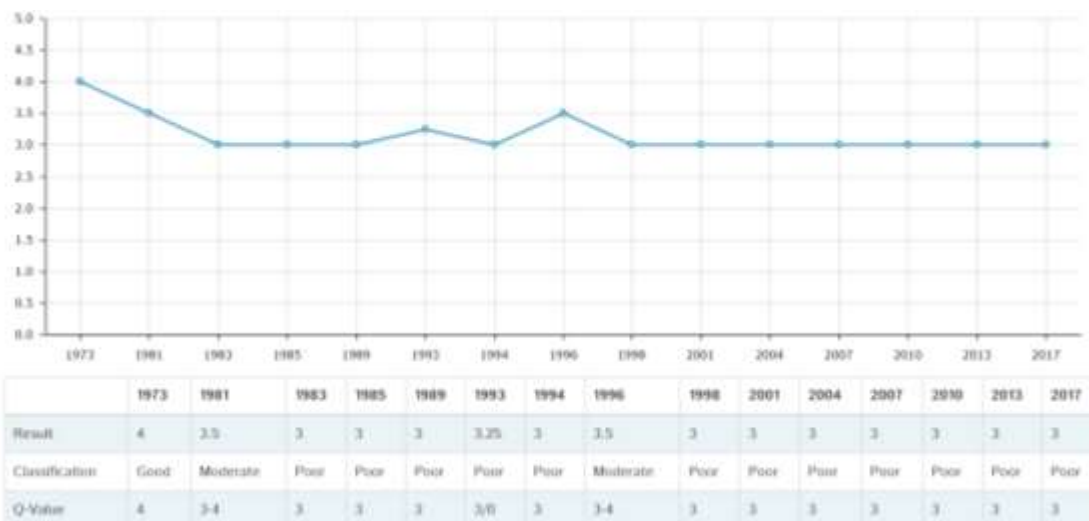
Figure 6 The biological trend and data for monitoring St. 500 (1973 – 2017).

- The 2017 biological data characterises the river in the Mountain Water_040 as Poor Ecological Status (Q3) (Figure 6).
- Ecological status at this site has not changed since 1998 (Figure 6).
- BOD concentration in 2017 and 2018 consistently fluctuated above the EQS of 1.5mg/l, ranging between 3.1 mg/l on the 19th of April 2017 and 0.5 mg/l on the 19th of April 2018.
- The NH₃ (0.072 mg/l) and PO₄ (0.038 mg/l) baseline concentrations are above the EQS of 0.065 mg/l for NH₃ and 0.035 mg/l for PO₄, however, the trends are currently going downwards (Table 6, Figure 7, Figure 8).
- The average NH₃ concentration for 2017 was 0.100 mg/l which was above the EQS, however, the average concentration decreased below the EQS in 2018 (0.055 mg/l) (Table 6, Figure 7).
- The average PO₄ concentration for both 2017 and 2018 were above the EQS (Table 6, Figure 8).

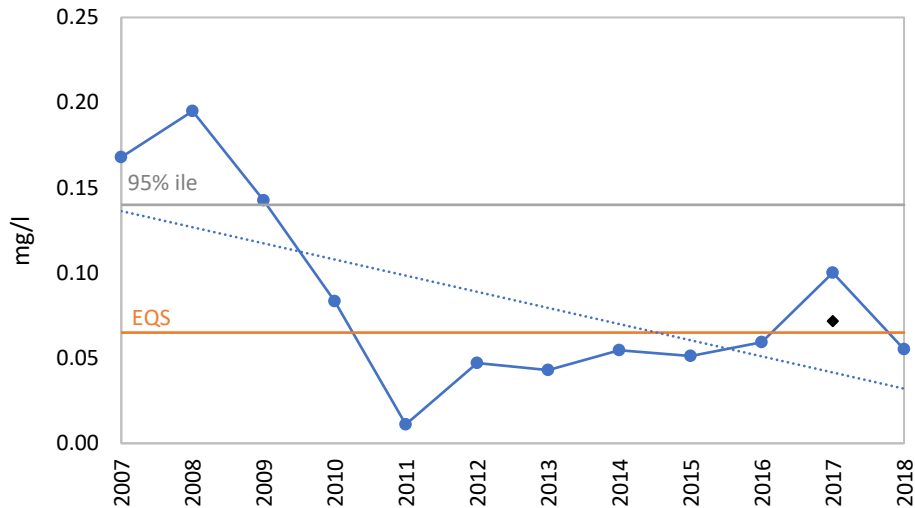
Figure 7 Ammonia (as N mg/l) trend chart for monitoring St. 500 (2007 – 2018).

2007	2008	2009	2010	2011	2012	2013	2014	2015	2016	2017	2018
NH ₃	n	10	6	6	6	6	6	13	10	10	11	11	9
	mg P L ⁻¹	0.168	0.195	0.143	0.083	0.011	0.047	0.043	0.055	0.051	0.059	0.100	0.055
PO ₄	n	10	6	6	6	6	6	13	10	10	11	11	9
	mg P L ⁻¹	0.052	0.050	0.077	0.045	0.034	0.021	0.021	0.026	0.037	0.034	0.037	0.041

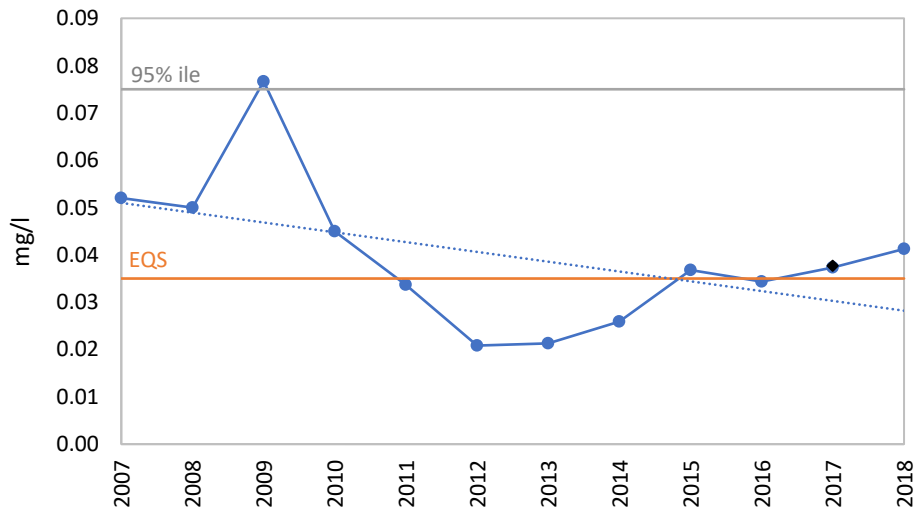
Figure 8 Ortho-Phosphate (as P mg/l) trend chart for monitoring St. 500 (2007 – 2018).

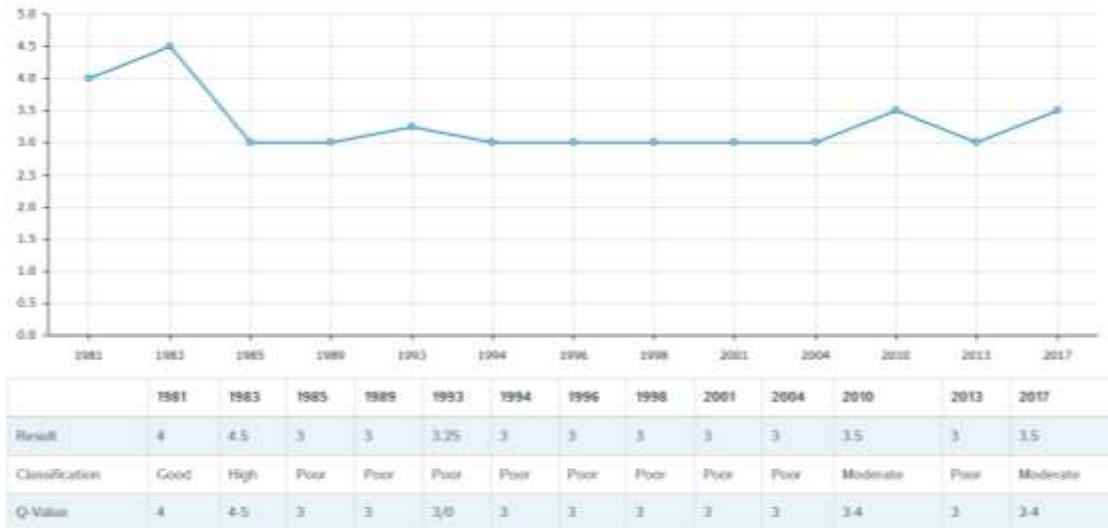
Figure 9 The biological trend and data for monitoring St. 650 (1981 – 2017).

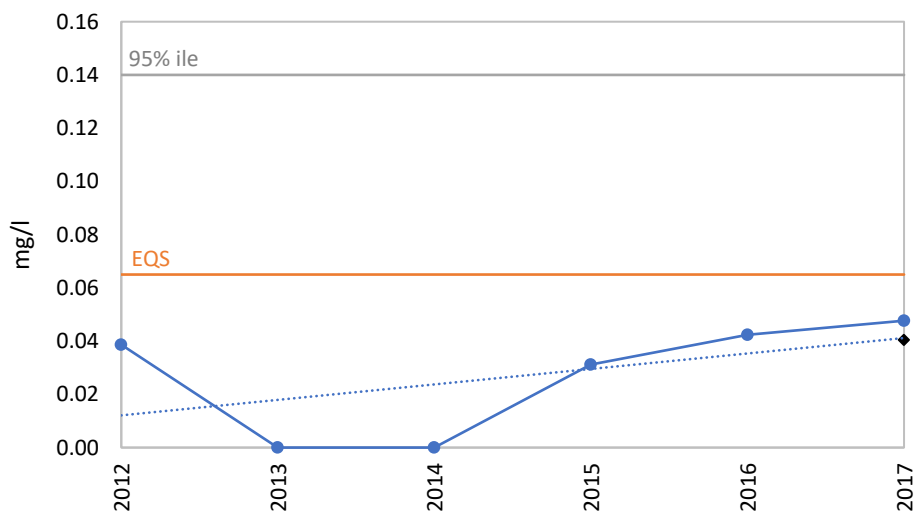
Figure 10 Ammonia (as N mg/l) trend chart for monitoring St. 650 (2012 – 2017).

- The Ammonia (0.040 mg/l) and TON baseline concentration (0.798 mg/l) and 2017 average concentration (0.048 mg/l NH₃ and 0.742 mg/l TON, n = 6) are below the EQS of 0.065 mg/l for NH₃ and 1.8 mg/l for TON, however, the trends are currently going upwards (Table 7, Figure 10, Figure 12).
- The PO₄ baseline concentration (0.050 mg/l) and the average 2017 PO₄ concentration (0.051 mg/l, n = 6) are above the PO₄ EQS of 0.035 mg/l, with the trend currently going upwards (Table 7, Figure 11).

2012	2013	2014	2015	2016	2017	2018
NH ₃	n	4			6	6	6	
	mg N L ⁻¹	0.039			0.031	0.042	0.048	
TON	n	4			6	6	6	
	mg N L ⁻¹	0.803			0.973	0.680	0.742	
PO ₄	n	4			6	6	6	
	mg P L ⁻¹	0.031			0.042	0.057	0.051

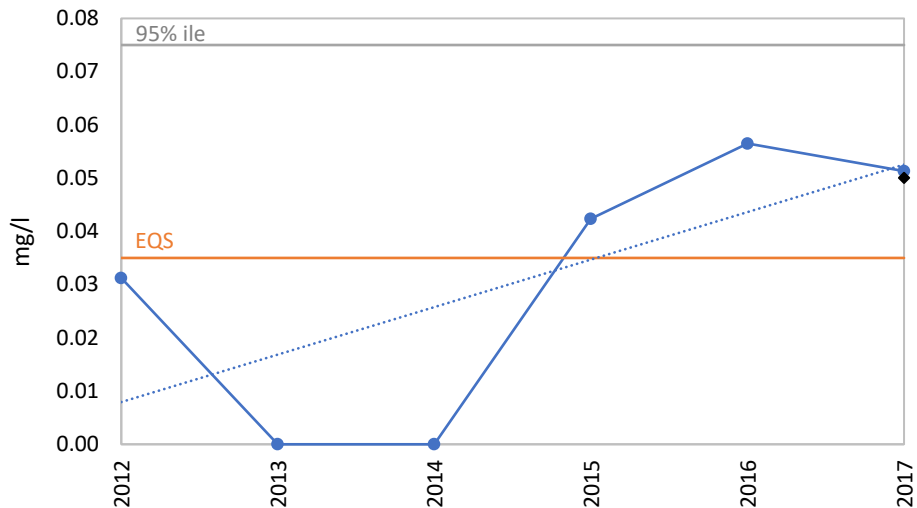
Figure 11 Ortho-Phosphate (as P mg/l) trend chart for monitoring St. 650 (2012 – 2017).

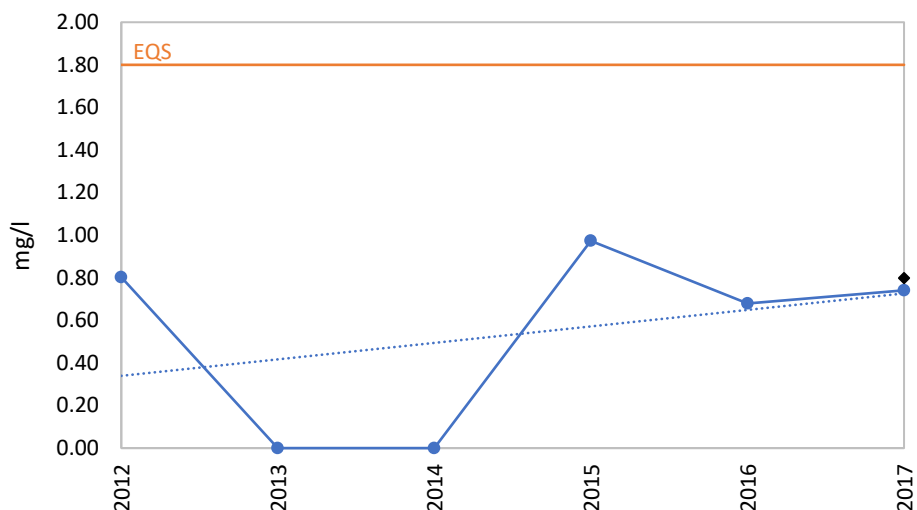
Figure 12 Total Oxidised Nitrogen (as N mg/l) trend chart for monitoring St. 650 (2012 – 2017).

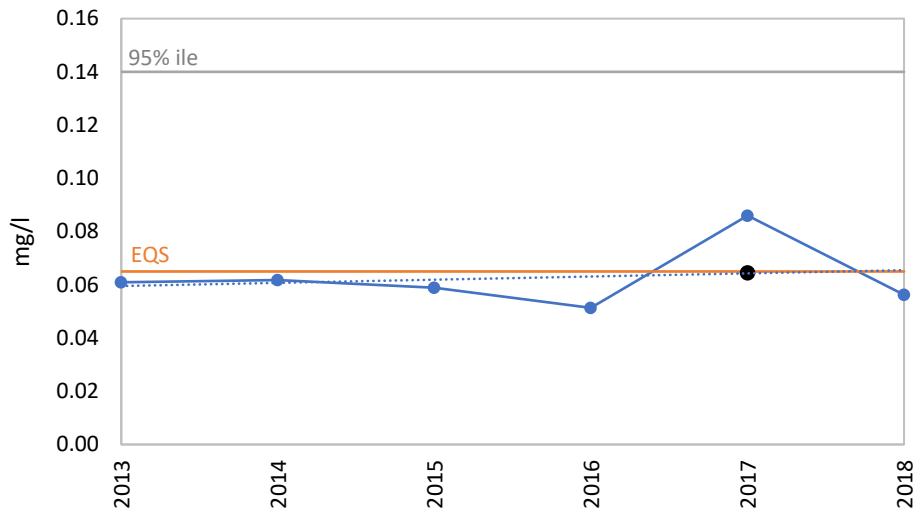
Figure 13 Ammonia (as N mg/l) trend chart for monitoring St. 670 (2013 – 2018).

2013	2014	2015	2016	2017	2018
NH₃	n	8	9	7	6	6	5
	mg P L⁻¹	0.061	0.062	0.059	0.051	0.086	0.056
PO₄	n	8	9	7	6	6	5
	mg P L⁻¹	0.020	0.052	0.030	0.049	0.082	0.029

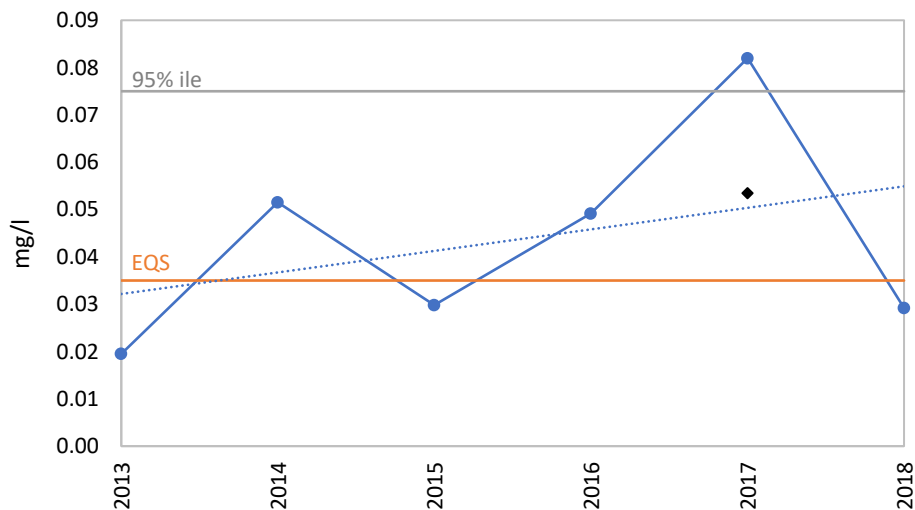
Figure 14 Ortho-Phosphate (as P mg/l) trend chart for monitoring St. 670 (2013 – 2018).

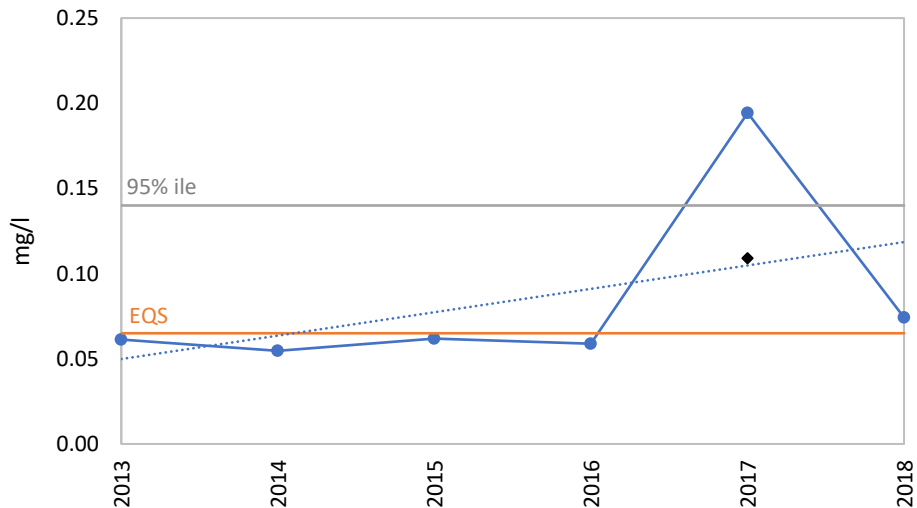
Figure 15 Ammonia-Total (as N mg/l) trend chart for the monitoring St. 680 (2013 – 2018).

2013	2014	2015	2016	2017	2018
NH ₃	n	9	9	6	6	6	5
	mg N L ⁻¹	0.061	0.055	0.062	0.059	0.194	0.074
PO ₄	n	9	9	6	6	6	5
	mg N L ⁻¹	0.036	0.051	0.033	0.057	0.119	0.039
TN	n	9	9	6	6	6	5
	mg N L ⁻¹	1.283	1.500	0.700	1.150	1.000	1.660

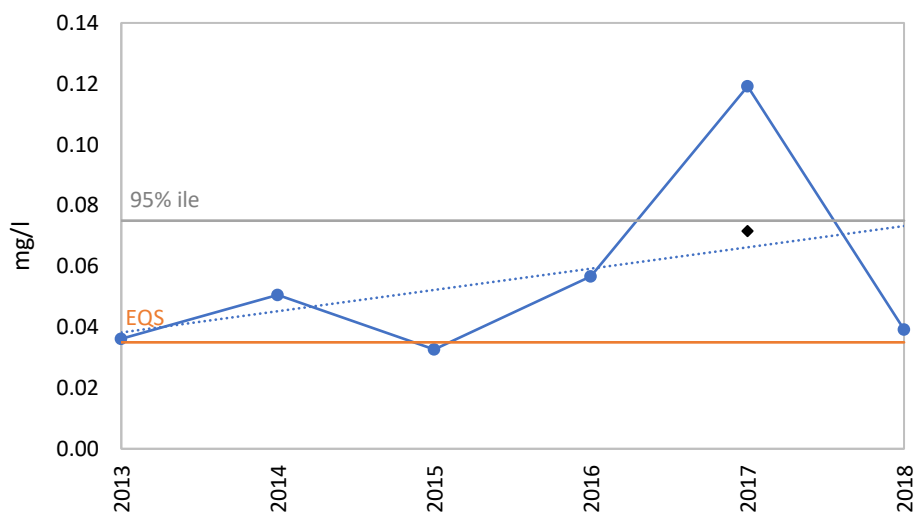
Figure 16 Ortho-Phosphate (as P mg/l) trend chart for the monitoring St. 680 (2013 – 2018).

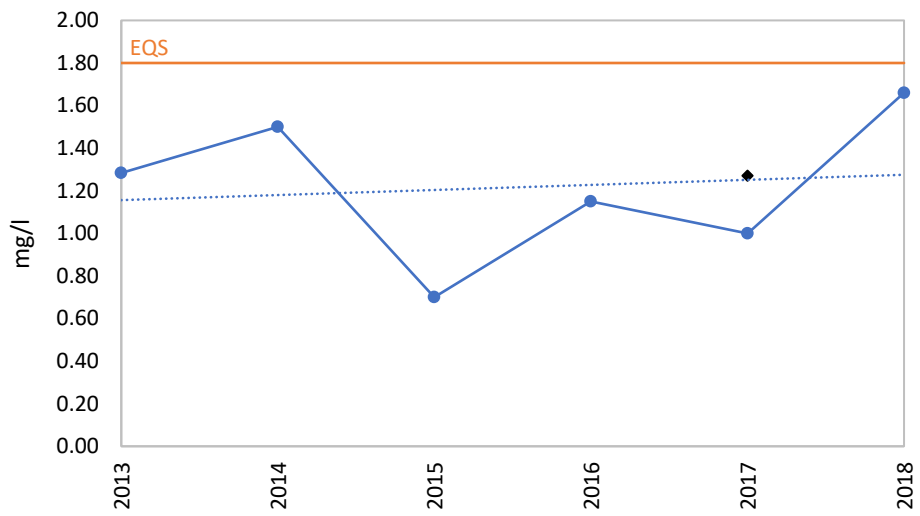
Figure 17 Total Nitrogen (as N mg/l) trend chart for the monitoring St. 680 (2013 – 2018).

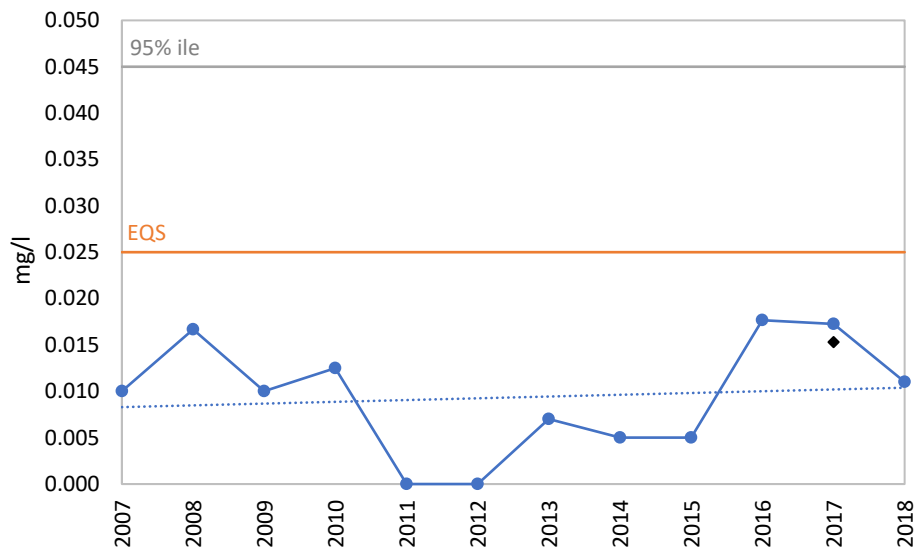
Figure 18 Total Phosphorus (mg/l) trend chart for the Midlake monitoring station St 010 (2007 – 2018).

2007	2008	2009	2010	2011	2012	2013	2014	2015	2016	2017	2018
TP												
n	1	3	4	4	0	0	4	4	4	3	4	4
mg P L⁻¹	0.010	0.017	0.010	0.013			0.007	0.005	0.005	0.018	0.017	0.011

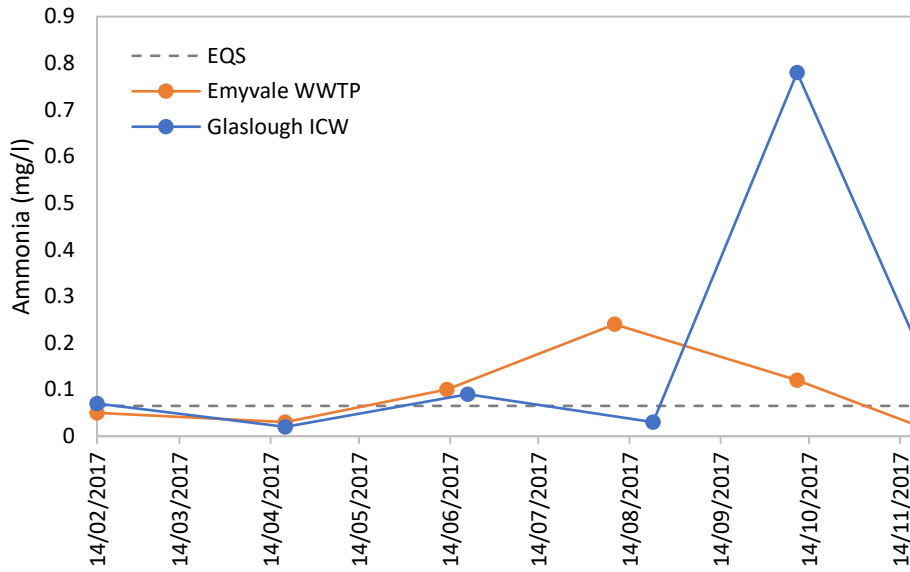
Figure 20 Ammonia concentrations at the downstream monitoring points for Emyvale WWTP (St. 500) and Glaslough ICW (St. 680).

- 644,000kgs total weight liquid sludge was removed from the WWTP in 2017, which was transferred to Monaghan WWTP.
- The following improvements were undertaken and completed in 2017:
 - Replacement of fridge and temperature sensor on both the influent and effluent composite samplers.
 - Relocate ferric dosing point to after the RBC.
- In 2017 there were seven samples found to be non-compliant with the Emission Limit Values (ELV) for both NH₃ and pH.
- On two occasions samples collected upstream from the WWTP in Emyvale were above the EQS of 0.060 mg/l NH₃ (Table 13).
- Samples for NH₃ downstream (St. 500) from the WWTP are generally higher in concentration compared to the upstream (St. 450) samples collected on the same day.
- Three of the downstream samples for NH₃ were recorded above the EQS in 2017 (Table 13, Figure 20).

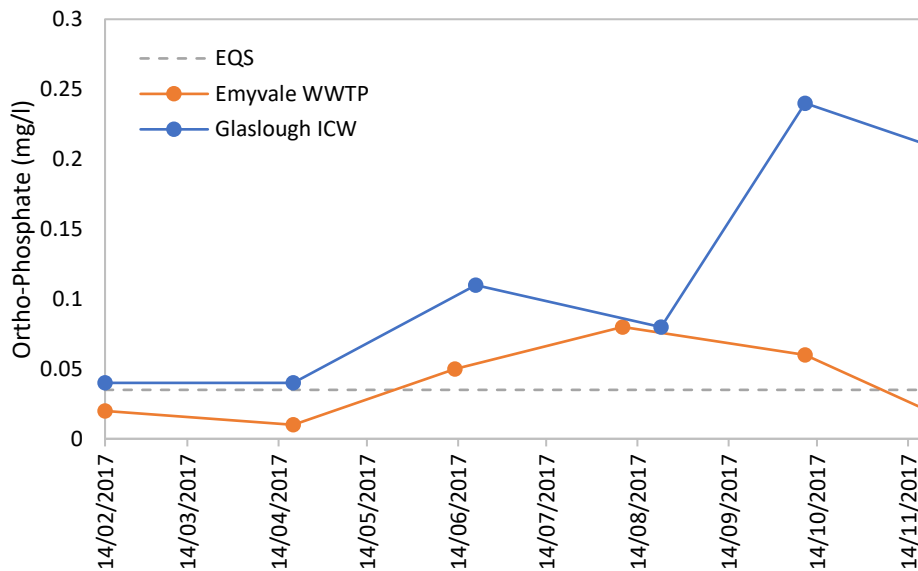
Figure 21 Ortho-Phosphate concentrations at the downstream monitoring points for Emyvale WWTP (St. 500) and Glaslough ICW (St. 680).

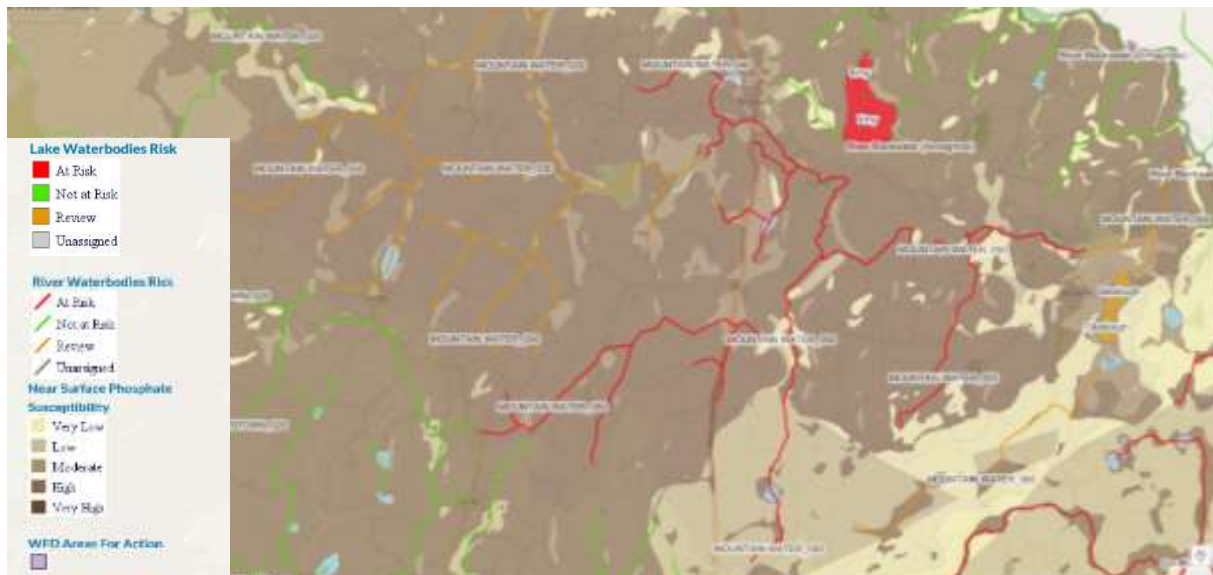
Figure 31 The near surface PO₄ susceptibility map for the Mountain Water and Emy Lough waterbodies.

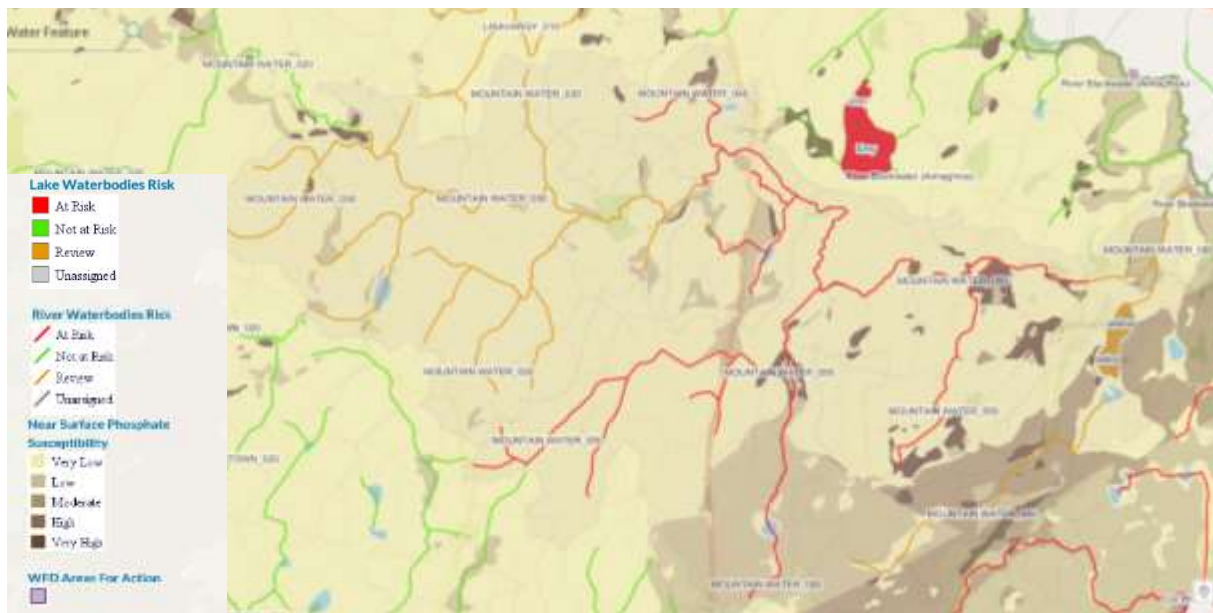
Figure 32 The sub-surface NO₃ susceptibility map for the Mountain Water and Emy Lough waterbodies.
