## Templeport PAA Deskstudy

AFA0171 Desk Study Report Version F01

## Templeport Priority Area for Action Desk Study Report

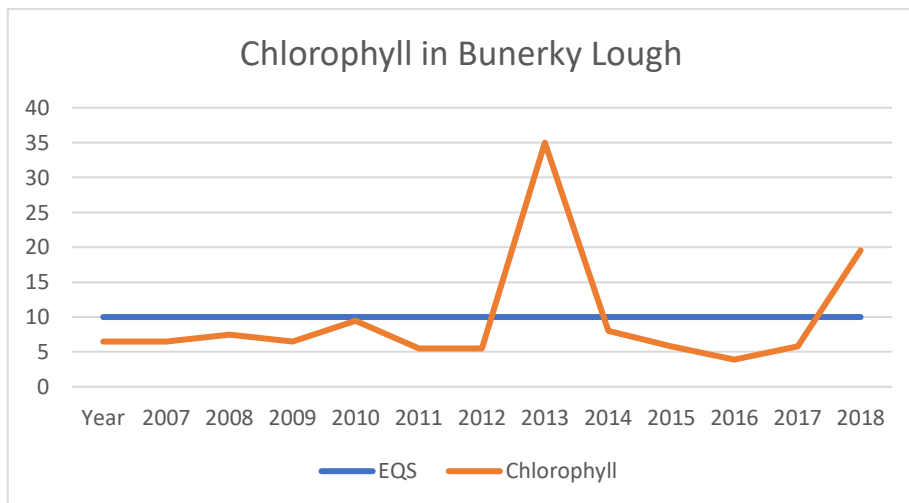
**Figure 8** Chlorophyll µg/l for Bunerky lake from 2007 to 2018

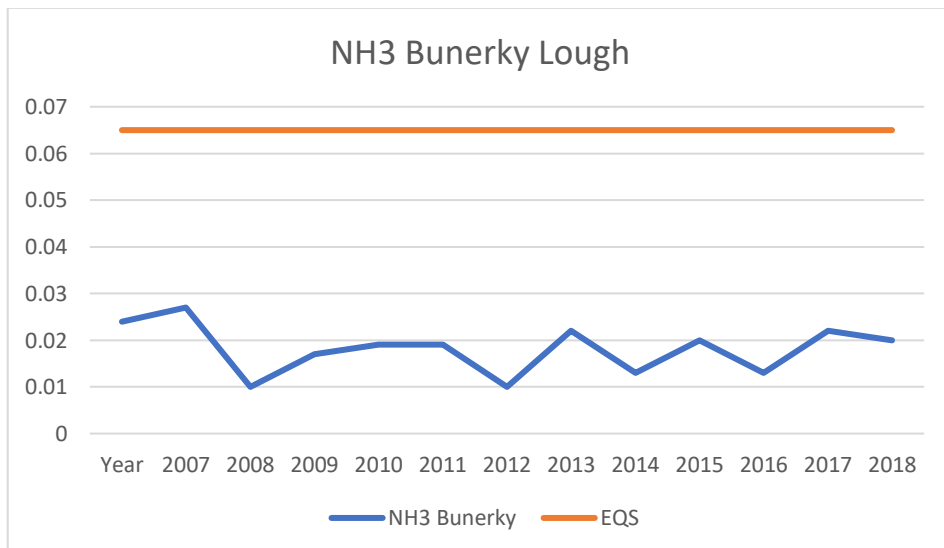
**Figure 9** Ammonia in mg/l for Bunerky lake from 2007 to 2018

Total phosphorus and ammonia levels in Bunerky Lake are trending upwards. The environmental quality standard for Total phosphorus in lakes is  $\leq 0.025$  mg/l for Good status. In 2018 the average Total Phosphorus results was 0.026mg/l and in 2019 it was 0.027mg/l which is just above the EQS. The chlorophyll levels for 2018 and 2019 respectively were 5.8mg/l and 19.5mg/l. The Indicative quality lower threshold for chlorophyll is 10mg/l so the chlorophyll in 2019 was elevated. The plant community is perhaps better than expected given the levels of chlorophyll and this may be due to the filtering action of the zebra mussels. Bunerky Lough has a population of zebra mussels (*Dreissena polymorpha*) which is an invasive alien species. Zebra mussels thrive in calcium and nutrient rich conditions. They filter algae from the water reducing chlorophyll levels. This can cause water clarity to increase depending on the size of the zebra mussel population. This can lead to changes in the macrophyte community. Zebra mussels cannot be controlled or eradicated from a lake at present.

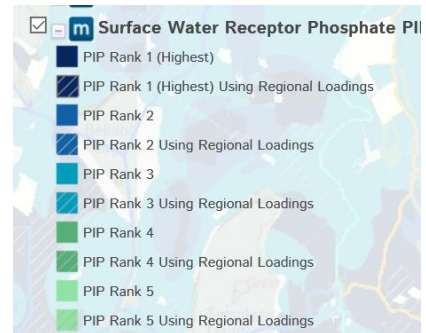
**Figure 11** Surface water receptor phosphate Pollution Impact Potential Map for Templeport PAA

- Agriculture has been identified as a significant pressure in this waterbody with nutrient pollution from pasture identified as a source.
- There is potential in the Bunerky Lake catchment for loss of phosphate to the waterbodies as there are areas of Rank 3 and 5 PIP on the river flowing into the lake. (Fig 11)

- There are some areas susceptible to phosphorous loss as illustrated in the Surface Water Receptor Phosphate PIP maps (Figure 11) with the dark blue area indicating the most susceptible areas located at the lower reaches of the catchment close to the monitoring point in purple.
- Further up the catchment there are areas of Rank 3 which is also potentially susceptible to Phosphate loss.
