Yellow (Ballinamore) PAA

AFA0189 Desk Study F01

Yellow(Ballinamore)_010 Priority Area for Action Desk Study Report

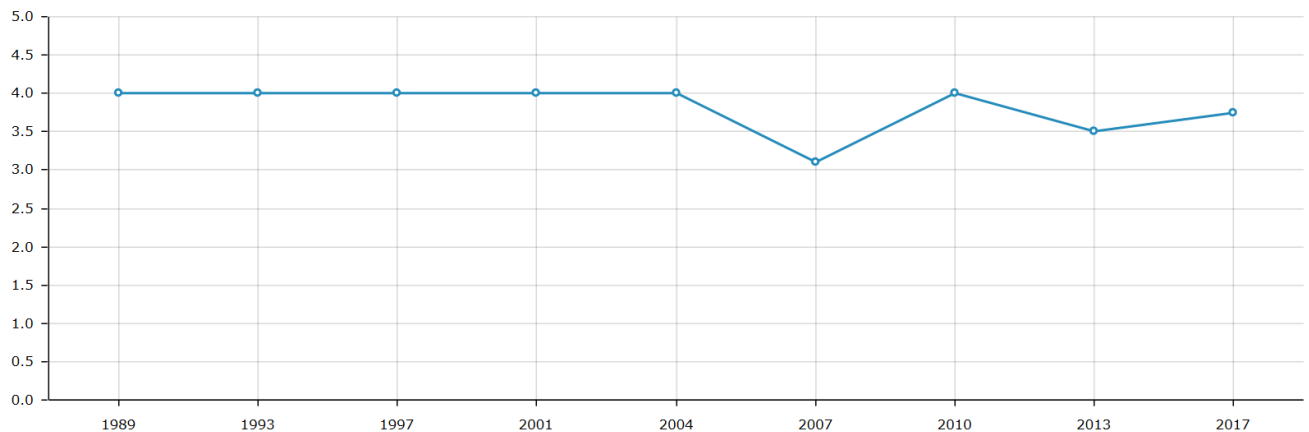
1989	1993	1997	2001	2004	2007	2010	2013	2017
Result	4	4	4	4	4	3.1	4	3.5	3.75
Classification	Good	Good	Good	Good	Good	Poor	Good	Moderate	Moderate
Q-Value	4	4	4	4	4	3*	4	3-4	3-4/0

Figure 4 The biological trend and data for Stralongford RS36YO10050 monitoring point.

This monitoring station does not have any chemistry monitoring data. The Q in 2010 was Q4, in 2013 had dropped to Q3-4 and in 2017 was Q3-4/0 meaning there was some toxic event having occurred which affected the invertebrates. Siltation was noted during biological sampling in 2007.

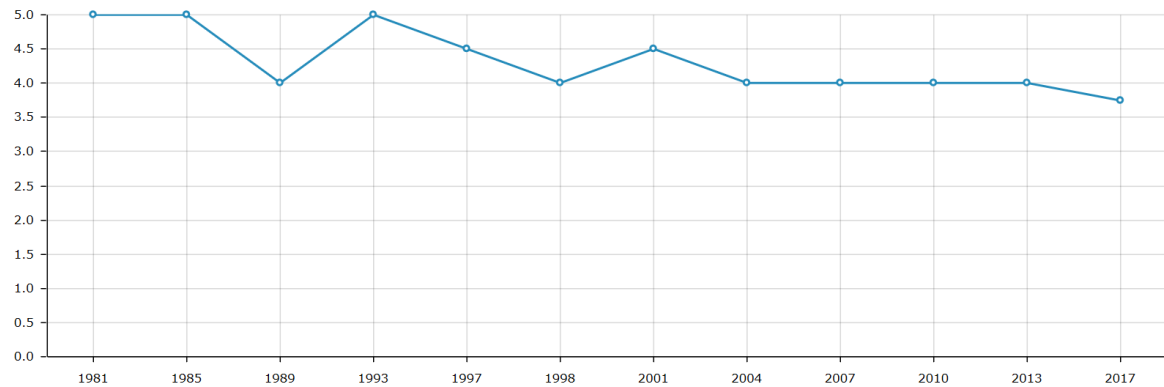
1981	1985	1989	1993	1997	1998	2001	2004	2007	2010	2013	2017
Result	5	5	4	5	4.5	4	4.5	4	4	4	4	3.75
Classification	High	High	Good	High	High	Good	High	Good	Good	Good	Good	Moderate
Q-Value	5	5	4	5	4-5	4	4-5	4	4	4	4	3-4/0

Figure 5 The biological trend and data for Mill Bridge SE of Greaghglass RS36YO10200 monitoring point.

This monitoring station does not have any chemistry monitoring data. The Q in 2010 was Q4, in 2013 it remained good as Q4 and in 2017 dropped to Q3-4/0 meaning there was some toxic event having occurred which affected the invertebrates, as the monitoring station above this one is also impacted the area of toxicity is likely to be above Stralongford RS36YO10050 monitoring point.

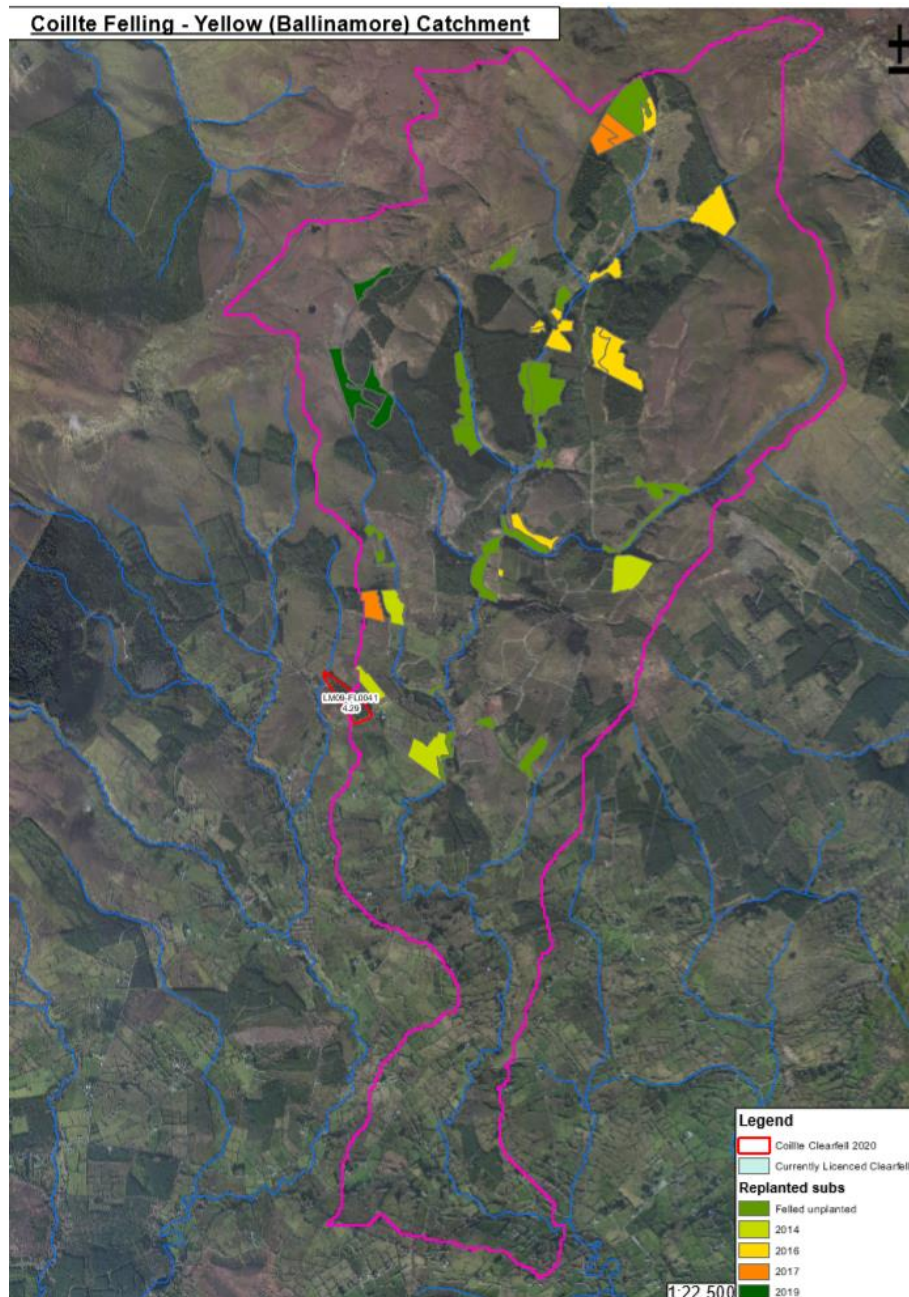
Figure 7 Coillte felling map in Yellow (Ballinamore)_10

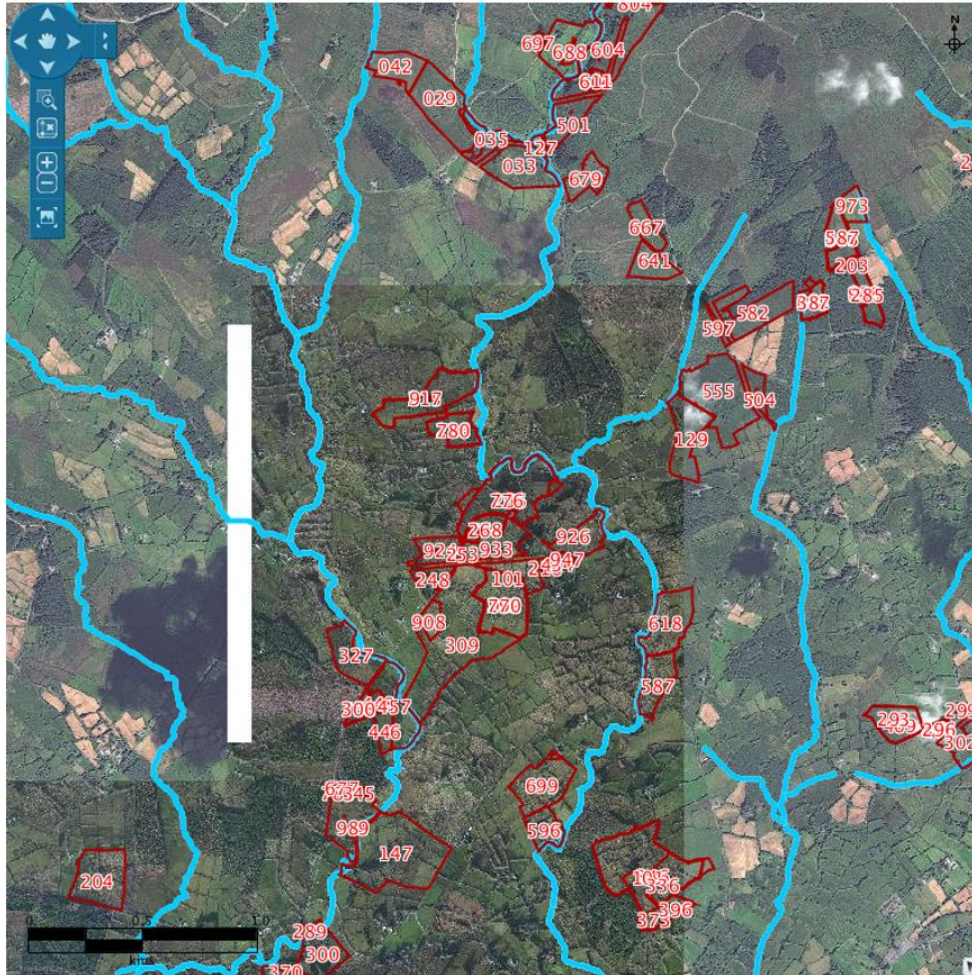
Figure 10 Licences granted for afforestation in Yellow (Ballinamore)_10

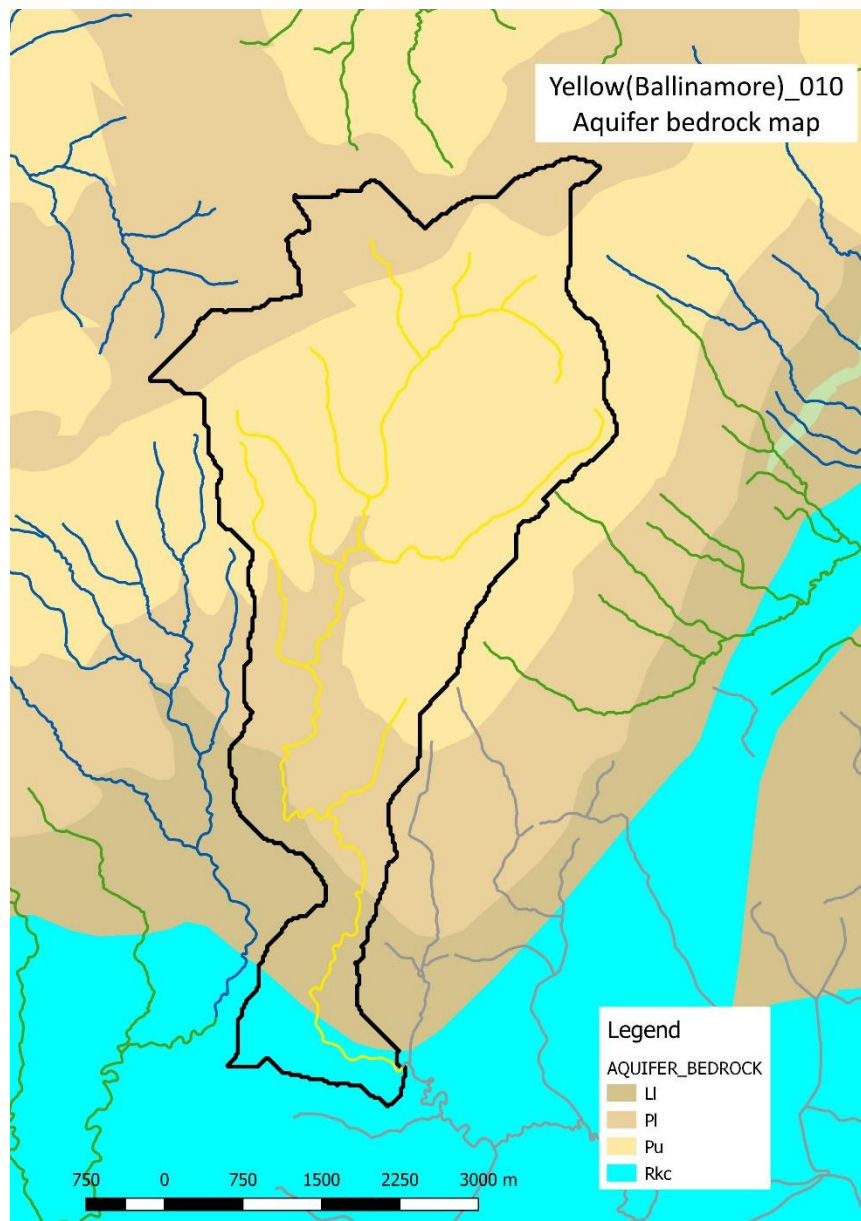
Figure 13 The aquifer bedrock for the *Yellow (Ballinamore)_010 PAA*.

There are 4 aquifer categories in the Yellow PAA:

Moderately Productive only in Local Zones (LI)

Generally Unproductive except for Local Zones (PI)

Karstified bedrock (Rk)

Generally Unproductive (Pu)

The aquifer above Stralongford Bridge monitoring point is a Poor Aquifer and generally unproductive. Soils here are peat and poorly drained. Subsoils are blanket peat and Shale and sandstones till.

The aquifer at the monitoring point at Mill Bridge is a Regionally important aquifer- Karstified but this is only for a short distance above the monitoring point. A Locally Important Aquifer is the main aquifer within the 1km upstream of Mill Bridge.
