Lough Allen Priority Area for Action Desk Study

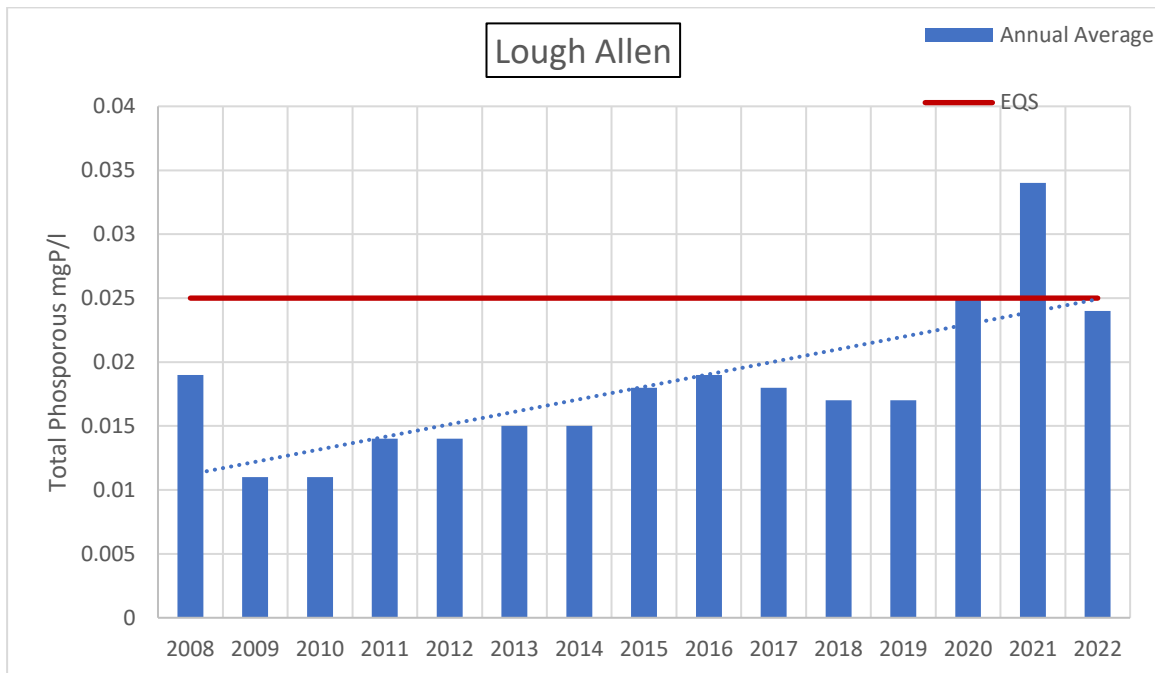
Figure 5 Total Phosphorous annual average trend for Lough Allen (all sites combined).

- A notable jump in the lakes overall annual average TP occurred from 2020-2022. The TP issue at Site 7 worsened while breaches of the EQS were also noted at Site 1, Site 2, Site 5 and Site 6. Excepting Site 7, Site 6 tended to have higher concentrations of TP, followed by Site 1, see Figure 6. Site 6 is in the southern section of the lake, just north of Inisfale Island, where the lake narrows before flowing into the Shannon (Upper)_040 outlet. Site 1 is in the northwest of the lake near the Owengar River inflow which transported sediment to the lake from the June 2020 landslide initiating in the Diffagher_010.

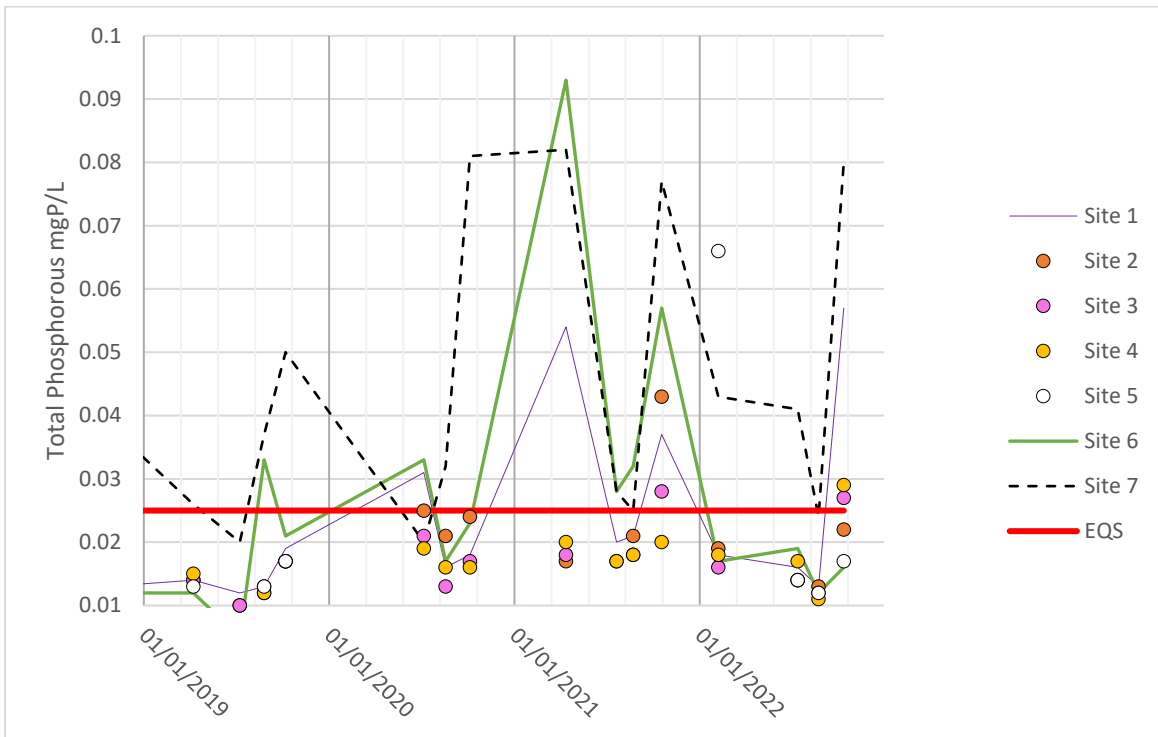
Figure 6 Total Phosphorous temporal data for Lough Allen Sites 1-7 from 2019-2022.

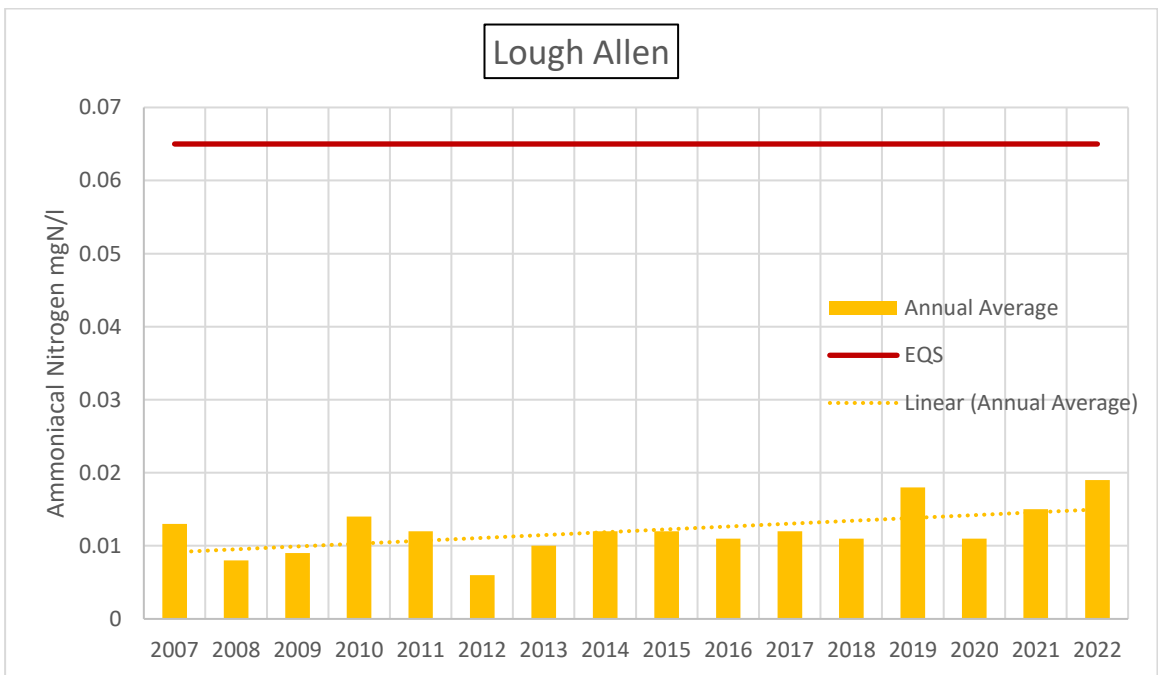
Figure 7 Ammonia annual average trend for Lough Allen (all sites combined).

- Data available from 2007-2022 for ammonia and from 2008-2022 for chlorophyll_a show annual averages for Lough Allen as a whole (all sites combined) are below their respective Ecological Quality Standards (EQS), shown in Figure 6 & 7 below. Data available from 2008-2022 for total phosphorus (TP) show an upward trend in annual average concentrations over time, with the EQS of 0.025mg/l P being met in 2020 and the threshold being breached in 2021, with an annual average of 0.034 mg/l N, see Table 3 above and Figure 5 below. It should be noted that 2020 and 2021 are the years no data is available for site 5, so the annual average is over 6 sites rather than 7.

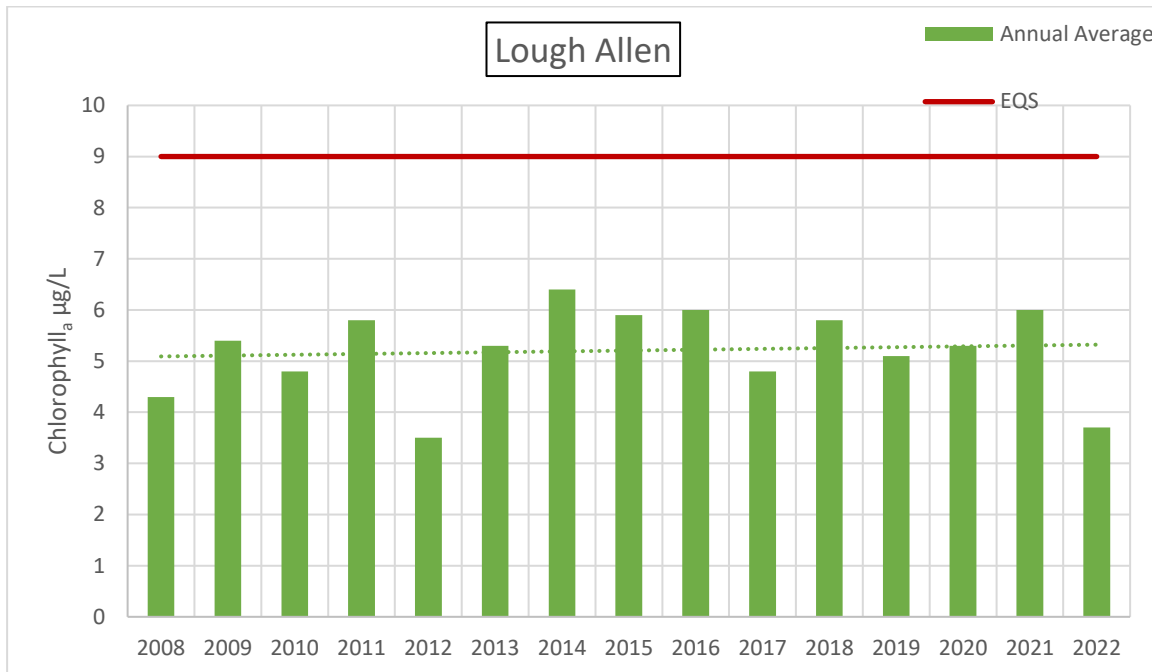
Figure 8 Chlorophyll_a annual average trend for Lough Allen (all sites combined).

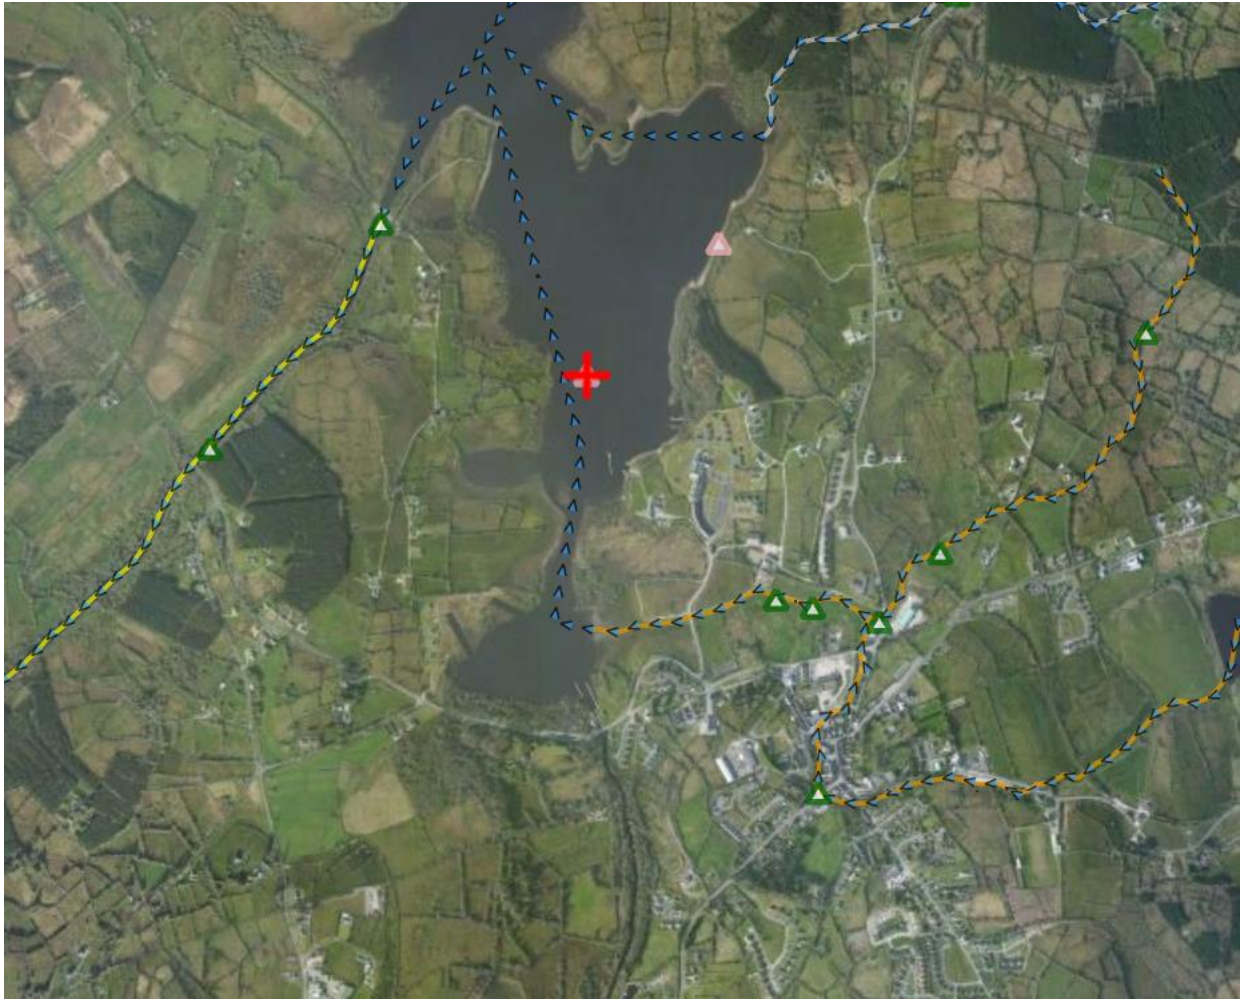
Figure 9 Taken from EPA Maps, showing the southern section of Lough Allen near Drumshanbo, Site 7 is highlighted with a red cross and river flow direction is shown for the Drunshanbo Stream_010 flowing in from the east coloured orange for Poor Ecological Status.

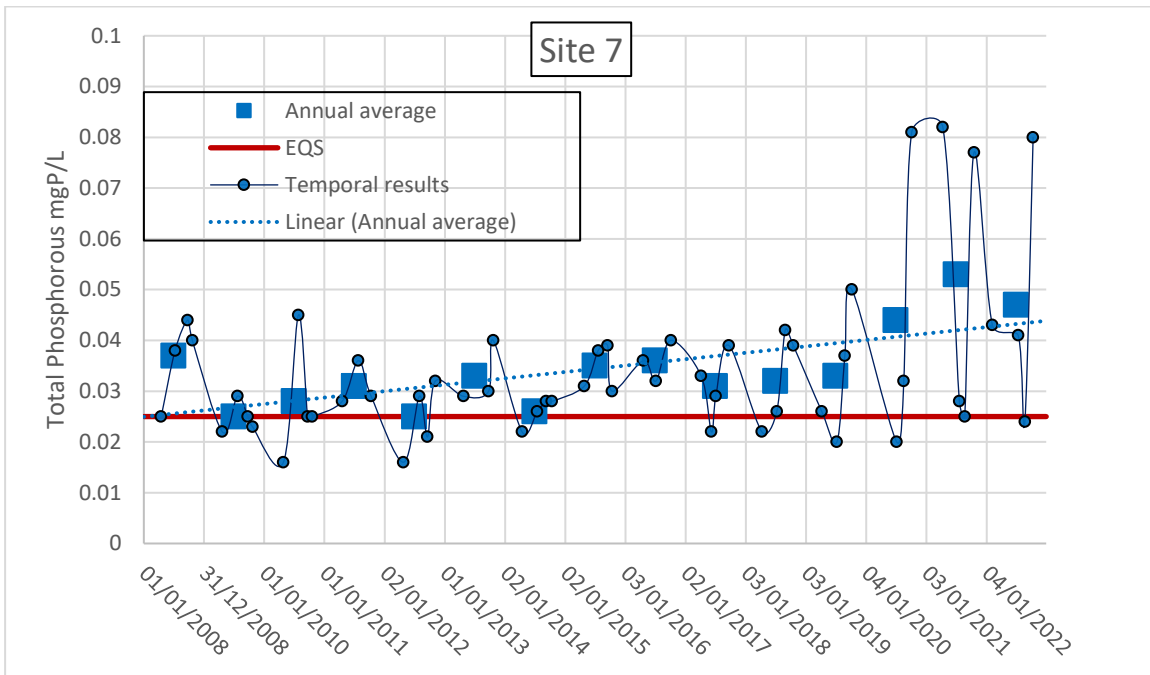
Figure 10 Total Phosphorous trend for Site 7 (LS260155a30000070) on Lough Allen.

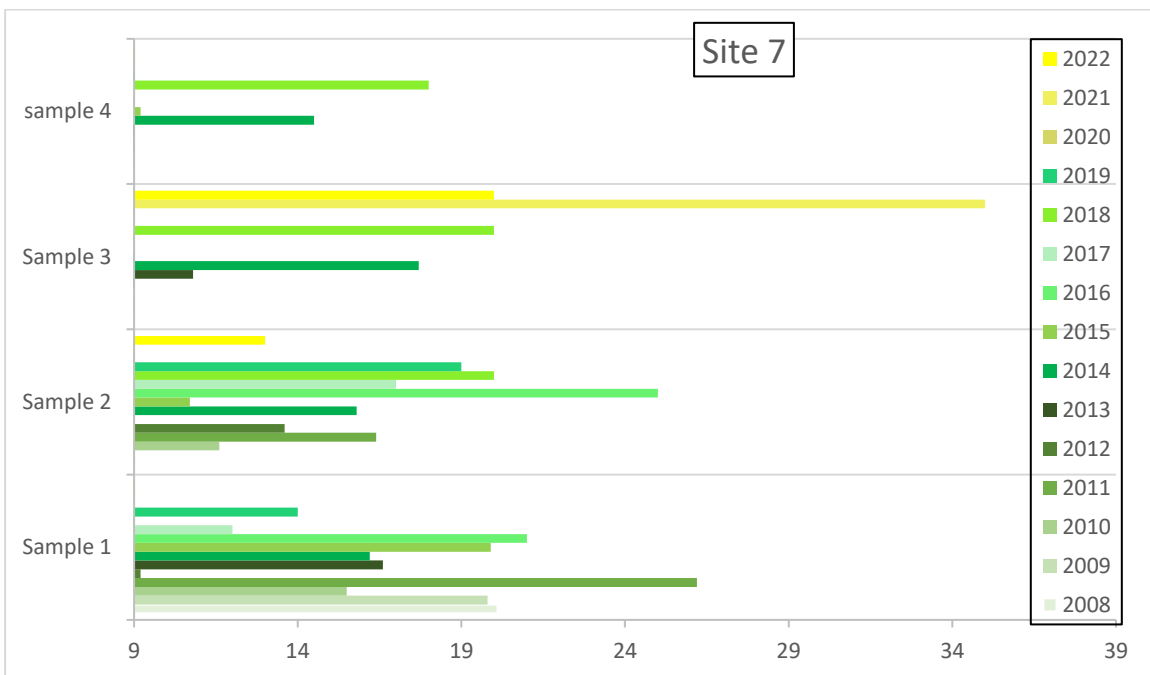
Figure 11 Chlorophyll-a results above 9µg/L by time of year sampled at Site 7 (LS260155a30000070) on Lough Allen.

Figure 11 shows that chlorophyll_a spikes at Site 7 tend to be in the first two samples of the year, typically April and July, except for 2014 and 2018 when concentrations were high throughout the growing season, including into September and October. Ireland saw drought conditions throughout the summer of 2018 and late summer drought conditions in 2014 which may account for this extended period of high concentrations of chlorophyll_a in these years. In 2021 and 2022 sample 3 of the year had spikes in chlorophyll_a concentrations, both samples were taken in late August. In 2021 this followed a hot July with both thundery and dry spells and a drier August with above average temperatures also, in 2022 this followed a drier than average and very hot July and August⁶. The available data (Fig. 12) shows no obvious, consistent relationship between TP and chlorophyll_a. Nov-Mar TP concentrations, which are unavailable in this dataset, may provide greater explanation of why and when chlorophyll_a concentrations are at their highest, otherwise, patterns of phosphorous release from the lake bed sediment may be interfering with generally expected seasonal patterns.

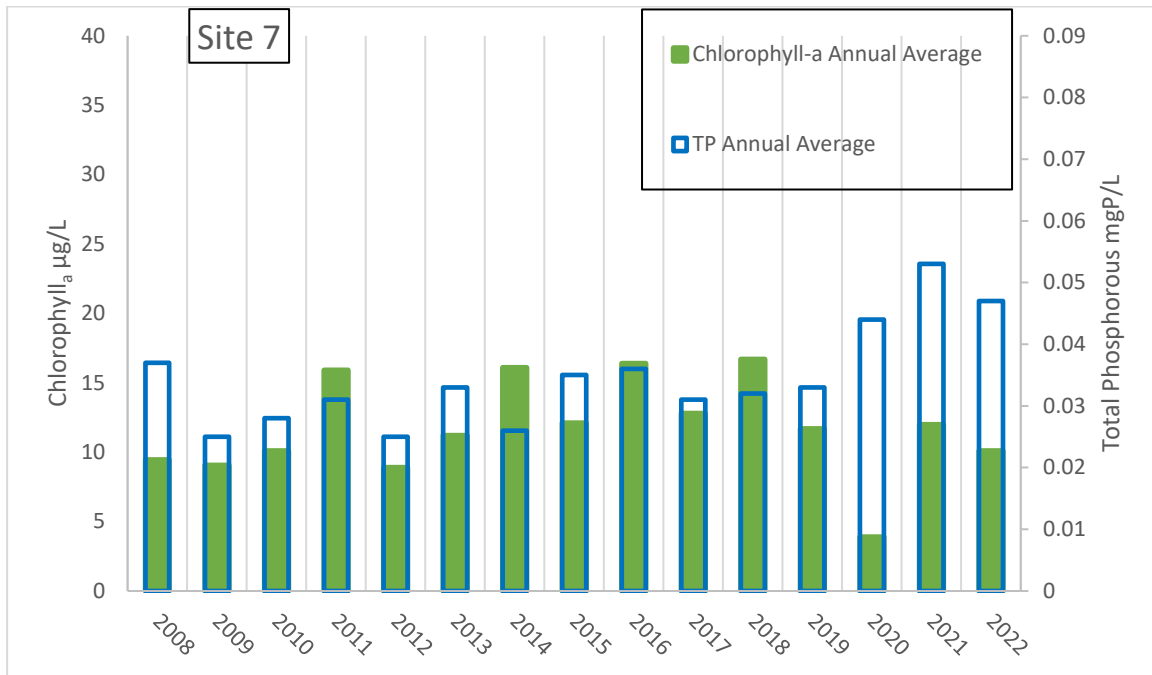
Figure 12 Relationship between total phosphorous and chlorophyll-a for Site 7 (LS260155a30000070) on Lough Allen.

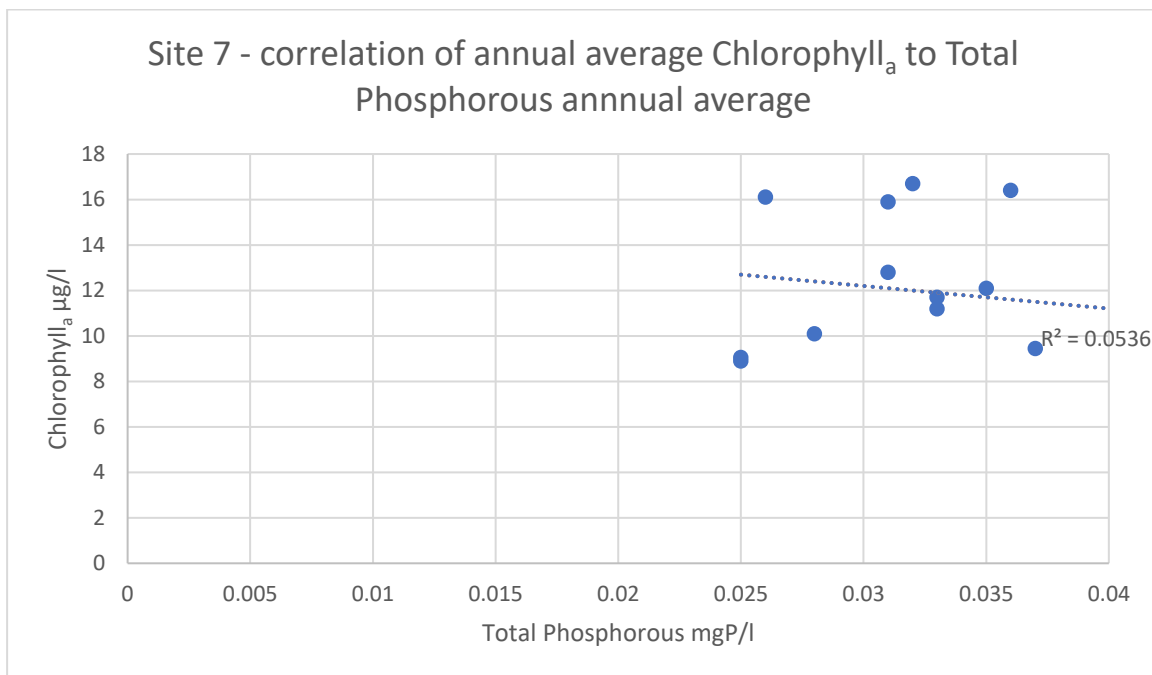
Figure 13 Correlation between annual average concentrations of Chlorophyll_a and Total Phosphorous at Site 7 on Lough Allen is very weak.

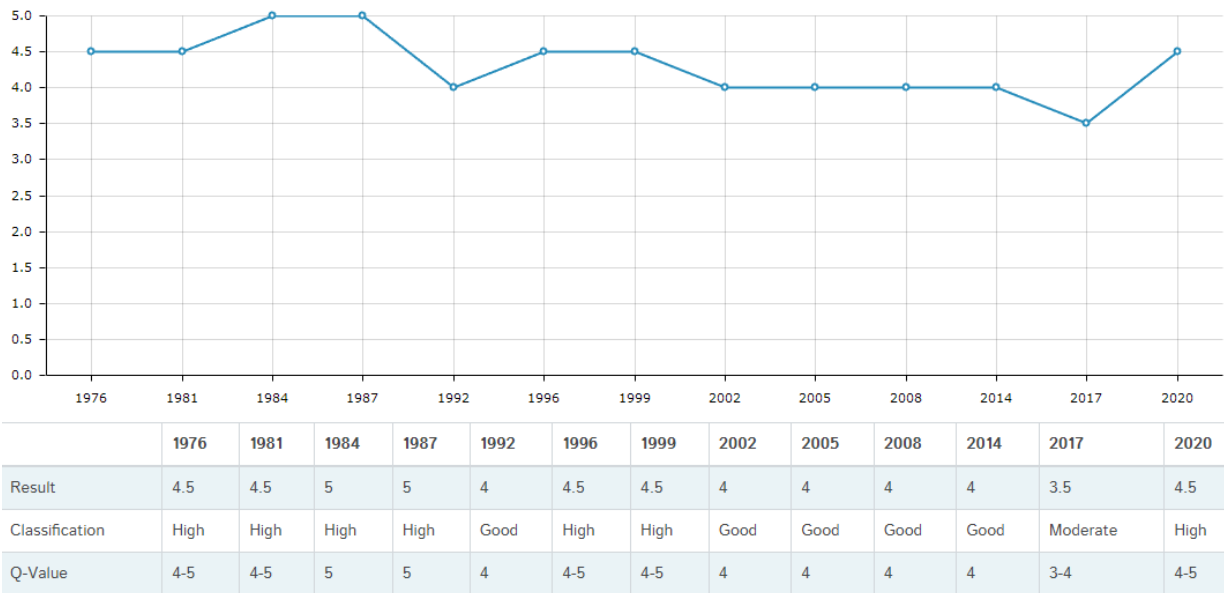
Figure 15 Q value trend for the Owennayle_020 at Br d/s Owennayle Br (RS26O050100).

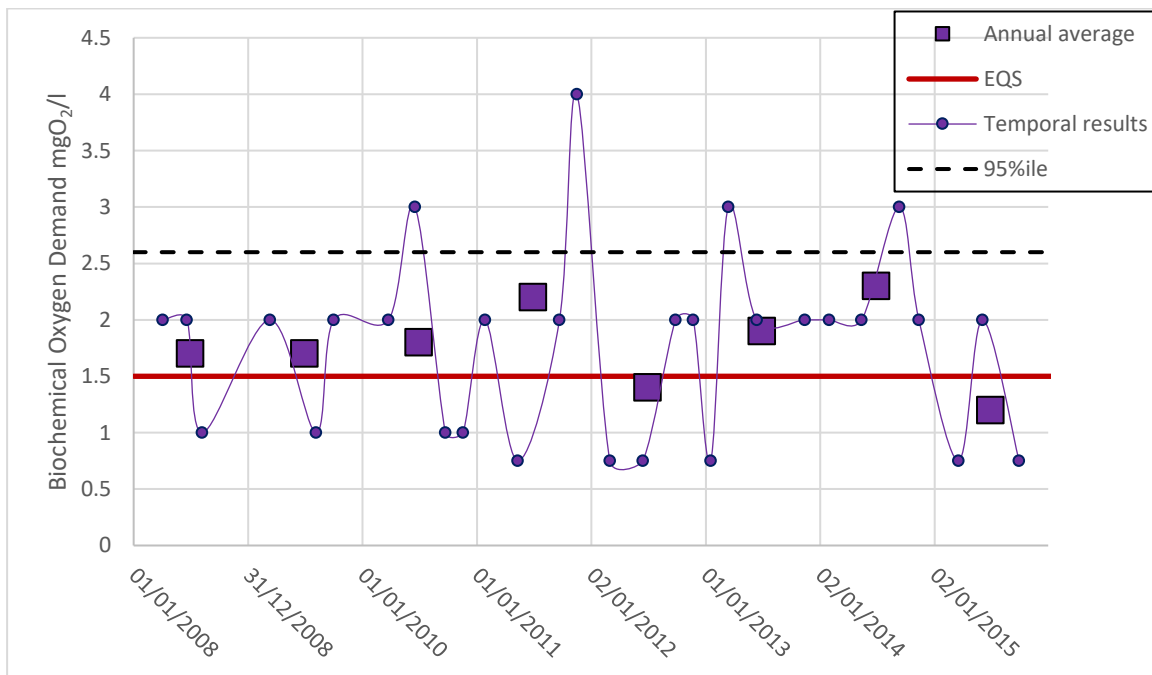
Figure 16 2008-2015 BOD data for monitoring station Br d/s Owennayle Br (RS26O050100) on the Owennayle_020.

- Supporting chemistry data is available from 2008-2015 and from 2021-2022. Ortho-phosphate, ammonia and TON annual average results are below their respective EQS/ecological threshold, however, BOD annual averages breach the EQS from 2008-2011 and from 2013-2014 (Fig. 16). Chemistry results from upstream in the Owenayle_010, available from 2007-2015, also show BOD temporal results either matched the result downstream in Owenayle_020 or are lower (Fig. 17), suggesting BOD issues were being carried downstream from Owenayle_010, but there is also an additional source in the Owenayle_020, otherwise BOD concentrations would be expected to be diminished at the Owenayle_020 monitoring point, approx. 5.5km downstream from the Owenayle_010 monitoring point, due to dilution from tributaries and oxygenation of the stream waters from the atmosphere.

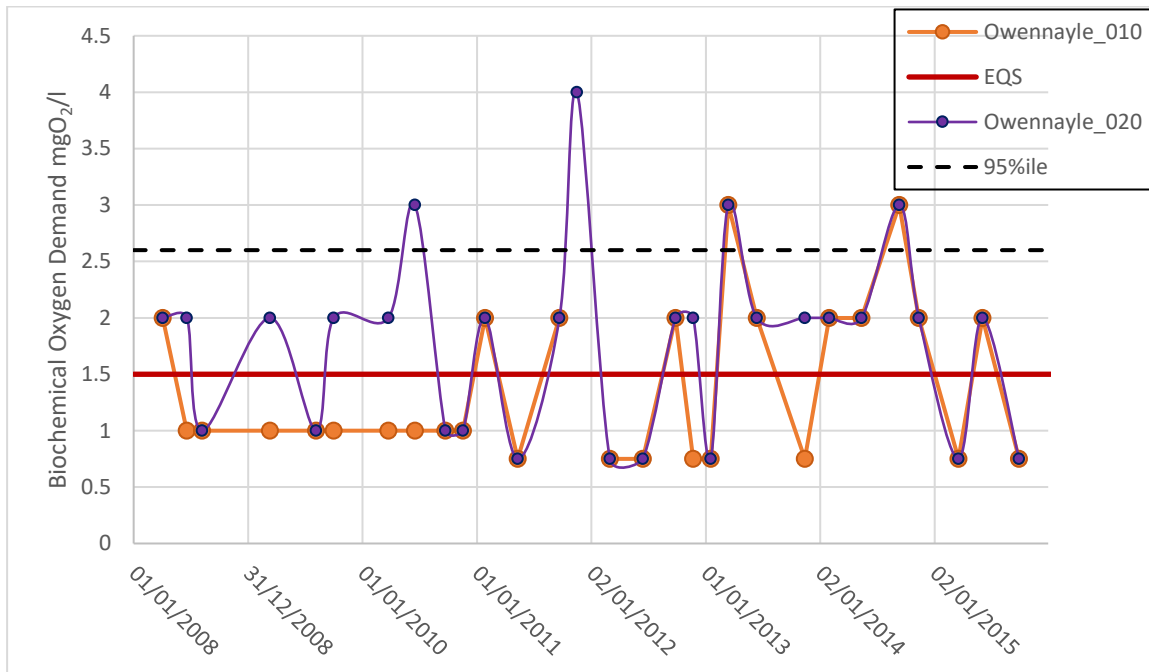
Figure 17 Comparison of temporal BOD data from the Owennayle_010 and the Owennayle_020.

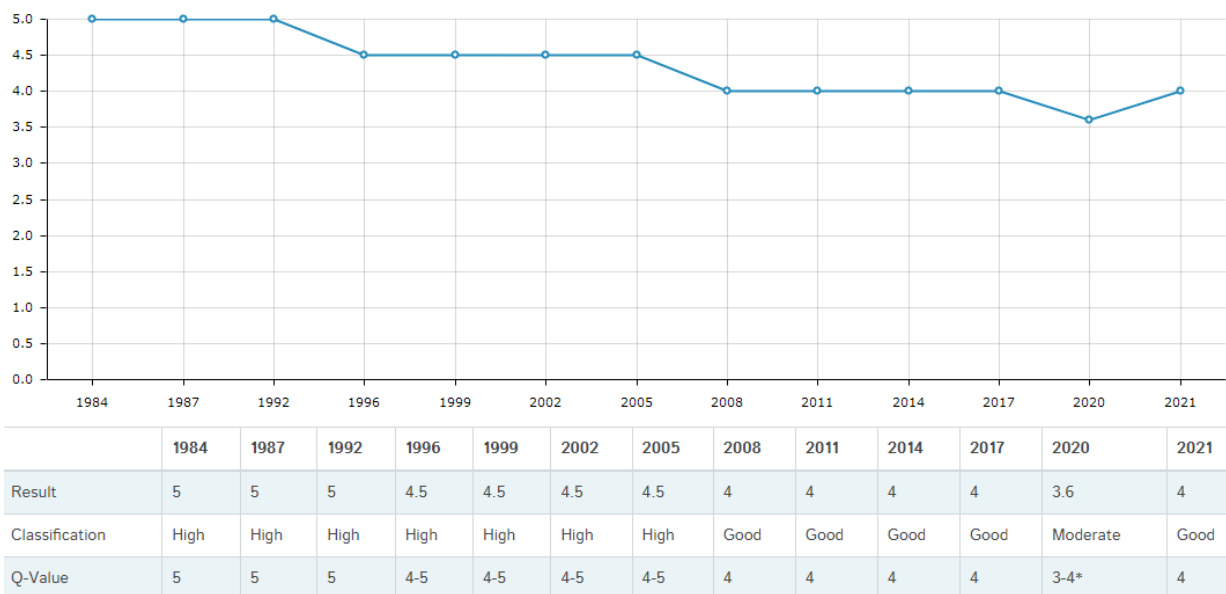
Figure 19 Q value trend for the Diffagher_010 at *Cloonemeone Bridge* (RS26D020200).

- The three Operational Monitoring Stations in the Diffagher_010 are on the Operational Monitoring Programme 2019-2021 for Q assessment alone. 2021 Q assessment at the downstream station, *Cloonemeone Bridge* (RS26D020200), showed an improvement to High Status. This station is located along the channel affected by the landslide in 2020, after which a 2020 Q assessment recorded deteriorated moderate conditions with sediment noted (Fig. 19).
- The Owengar (Leitrim)_020 Operational Monitoring Station, *Br at Annaghgerry* (RS26O020200), is located upstream of the confluence with the *Diffagher River* channel, it is therefore not along the pathway of channel affected by the June 28th, 2020, landslide which initiated in the Diffagher_010 watershed. The most recent Q assessment in 2020 recorded high invertebrate status.

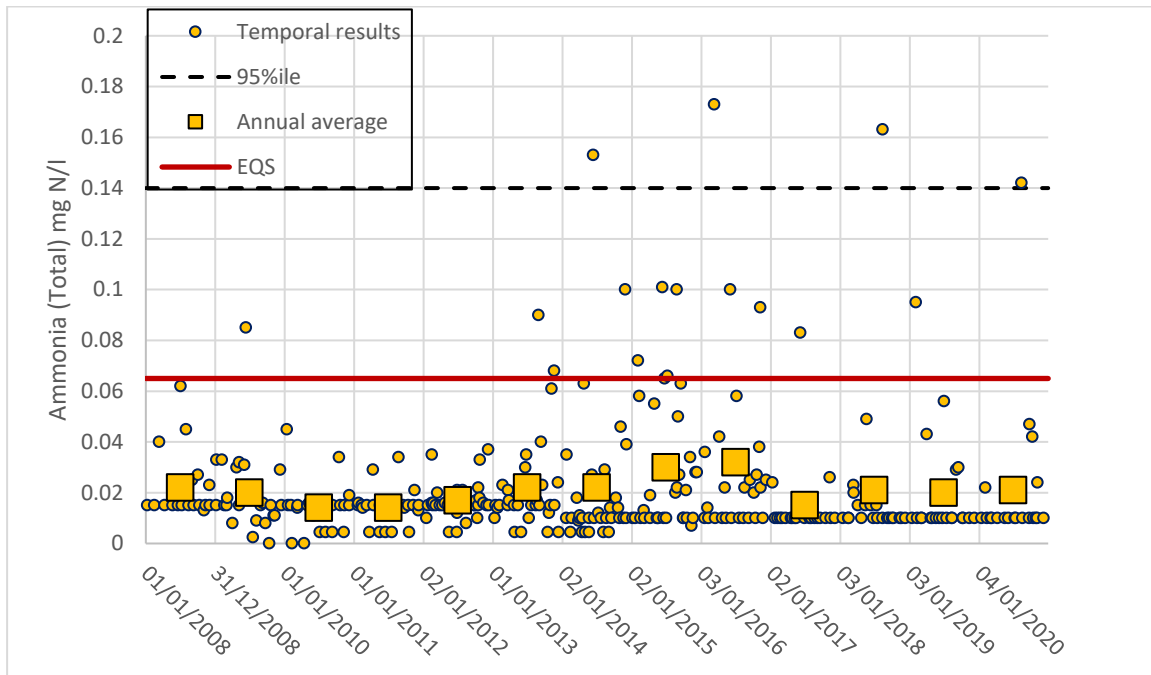
Figure 23 Ammonia data for Shannon (Upper)_040 at Battle Br (RS26S020500).

- Chemistry data available from 2008-2022 show ortho-phosphate, ammonia, TON and BOD annual average results are below their respective EQS/ecological threshold, however, there have been elevated temporal ammonia concentrations above the 95%ile value of 0.14mgN/l as recently as 2020, shown below in Figure 23. The 2016-2021 status details on the WFD App list a Chemical Surface Water Status Fail due to levels of benzo(a)pyrene above the EQS set out in Table 12, Priority Hazardous Substances, of the European Union Environmental Objectives (Surface Waters) (Amendment) Regulations 2019¹¹. Benzo(a)pyrene is a carcinogenic polycyclic aromatic hydrocarbon (PAH) found in oil, coal and tar. Exceedances in surface waters may suggest pollution from carbon-based fossil fuels or tar from activities such as road-tarring or burning of oil-based fuels¹².

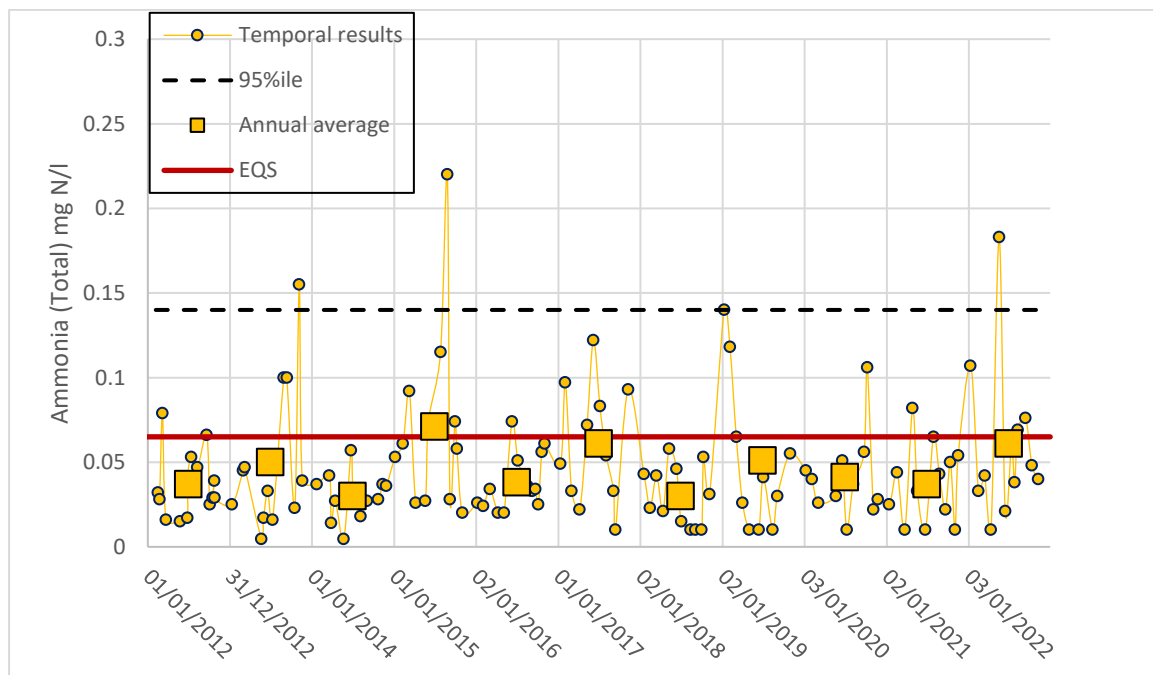
Figure 26 Ammonia data for monitoring station U/S Drumshanbo WW (RS26M800930) on the Drumshanbo Stream_010.

- There seems to be a CSA upstream of this station which causes occasional spikes of ammonia loss to the river and BOD issues, perhaps due to nitrification of this ammonia to nitrate and/or the breakdown of “carbonaceous” organic material from the same source or a separate one.

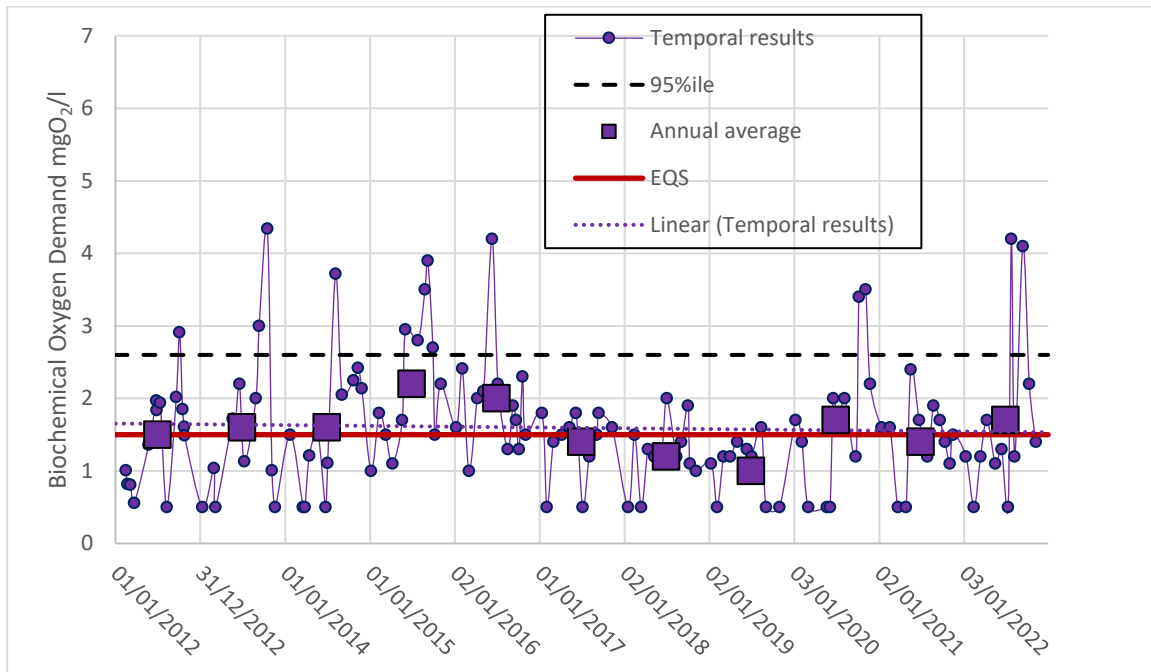
Figure 27 BOD data and trend for monitoring station U/S Drumshanbo WW (RS26M800930) on the Drumshanbo Stream_010.

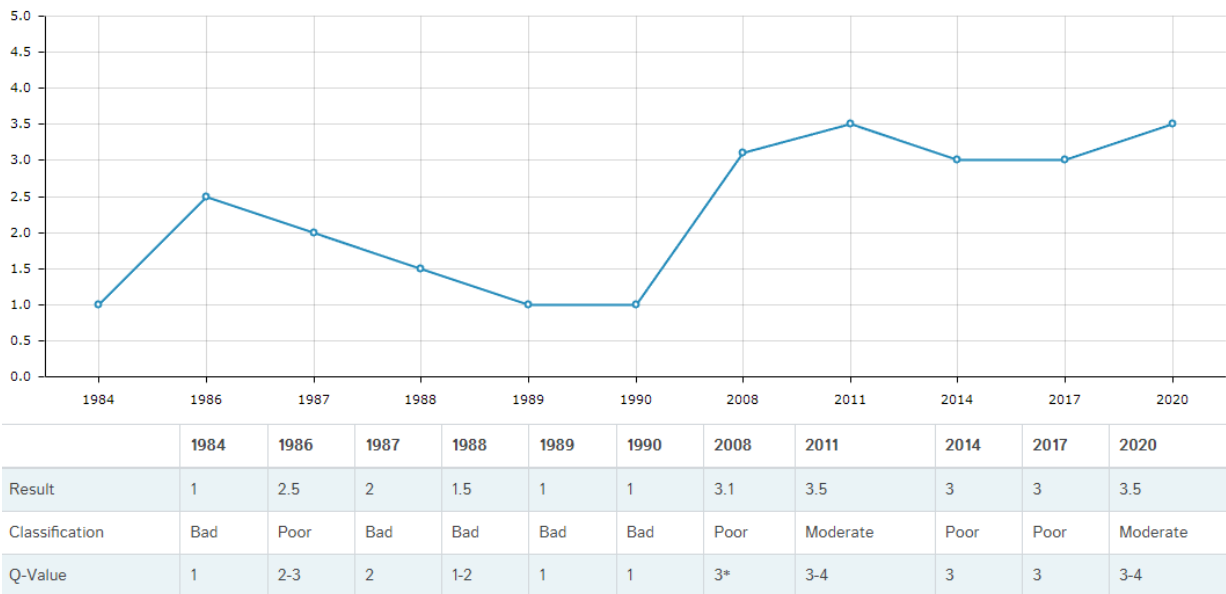
Figure 28 Q Value trend for the Drumshanbo Stream_010 at Monitoring Station 150m d/s STW outfall (RS26D050300).

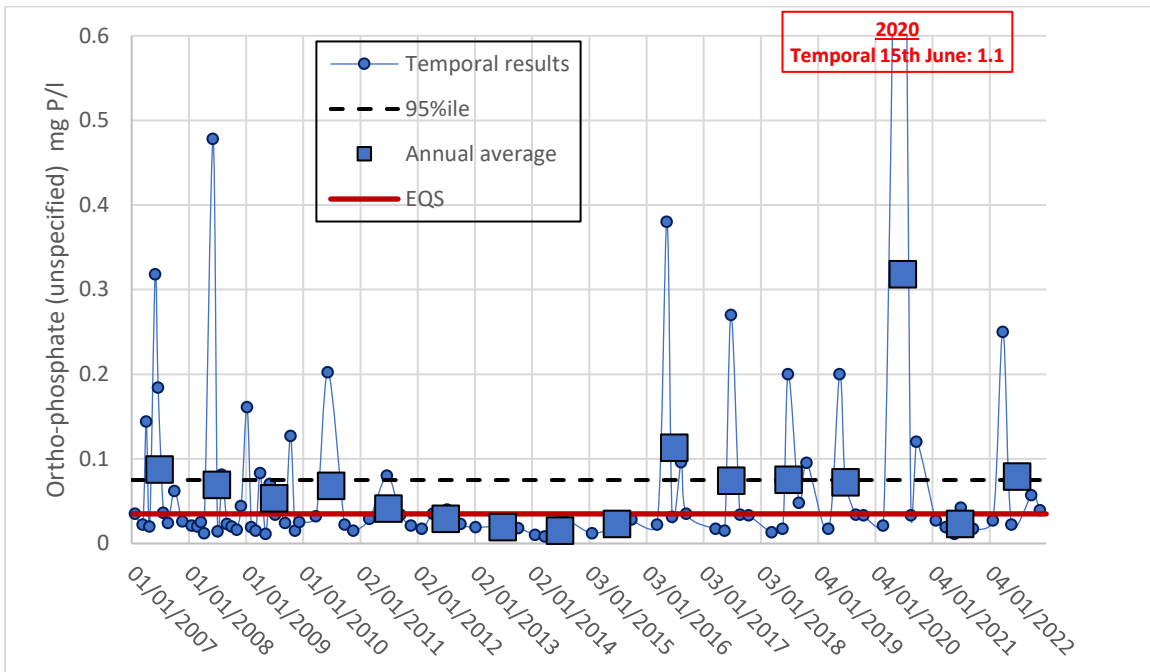
Figure 29 Ortho-phosphate data for the monitoring station 150m d/s STW outfall (RS26D050300) on the Drumshanbo Stream_010 (off chart concentrations in red text box).

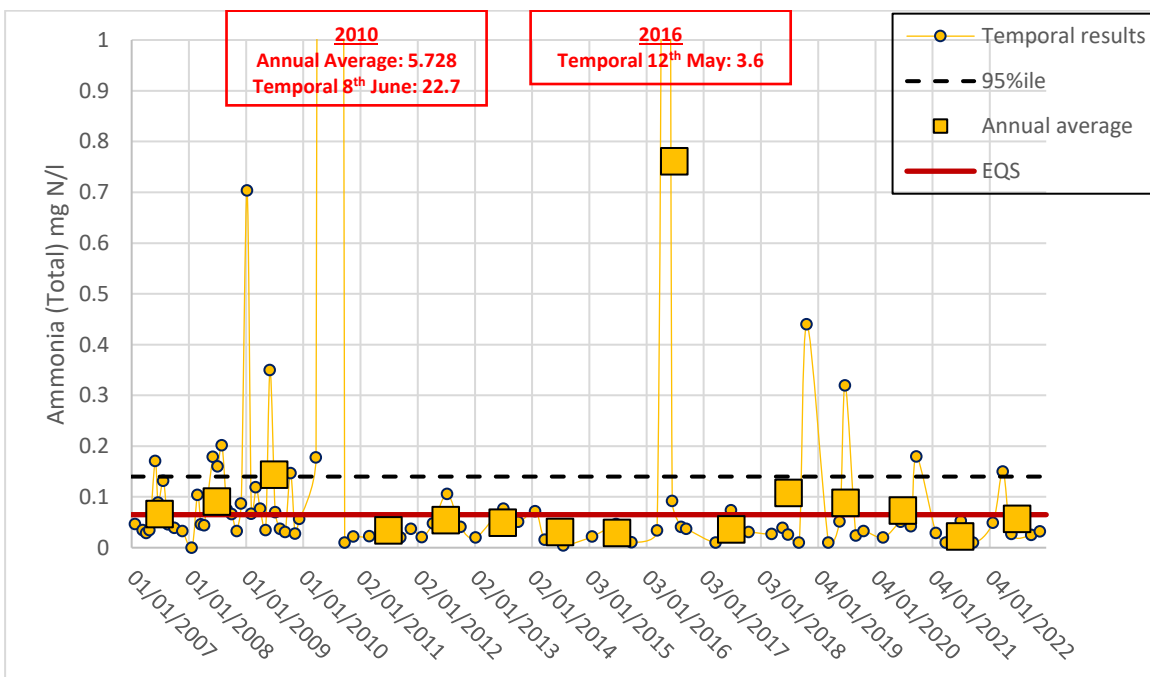
Figure 30 Ammonia data for the monitoring station 150m d/s STW outfall (RS26D050300) on the Drumshanbo Stream_010 (off chart concentrations in red text box).

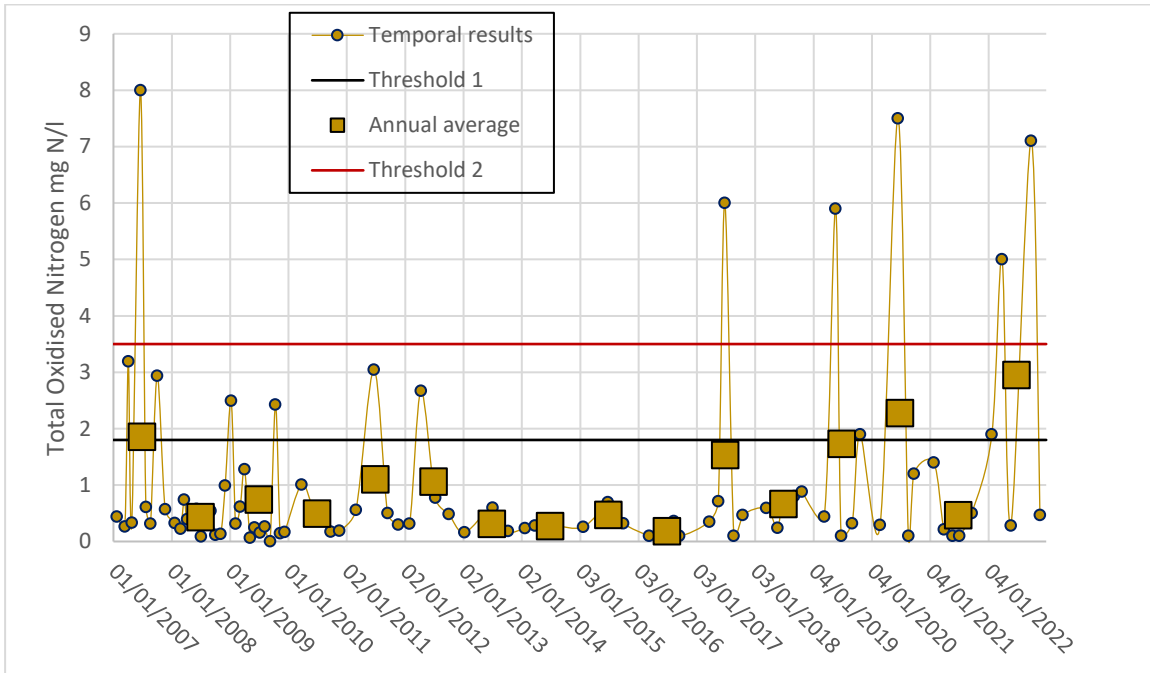
Figure 31 TON data for the monitoring station 150m d/s STW outfall (RS26D050300) on the Drumshanbo Stream_010.

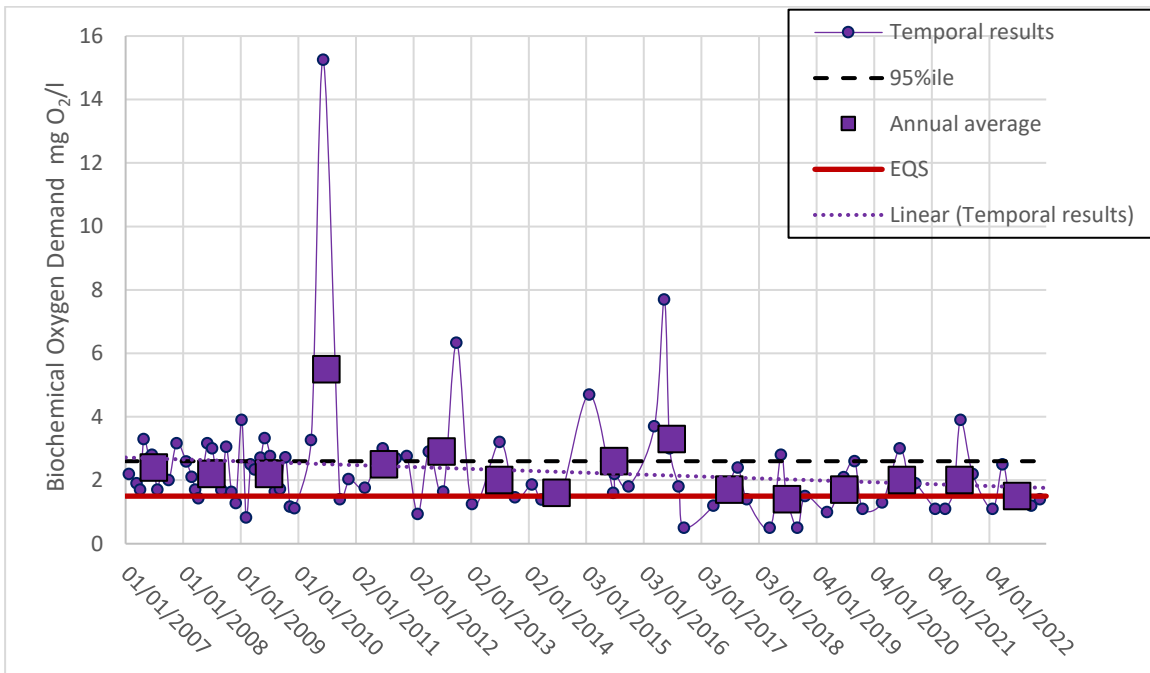
Figure 32 BOD data and trend for the monitoring station 150m d/s STW outfall (RS26D050300) on the Drumshanbo Stream_010.

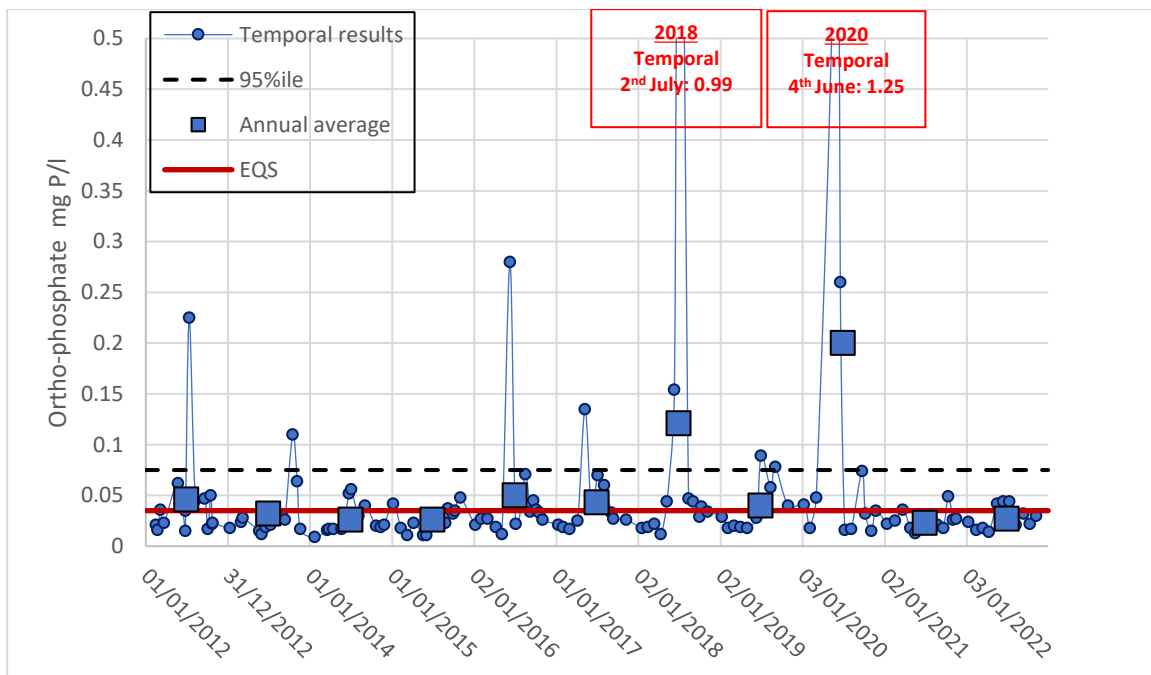
Figure 33 Ortho-phosphate (filtered 2012-2015, unspecified 2016-2022) data for 300 m d/s Sewage Trtmt Works (RS26D050400) on the Drumshanbo Stream_010 (off chart concentration in red text box).

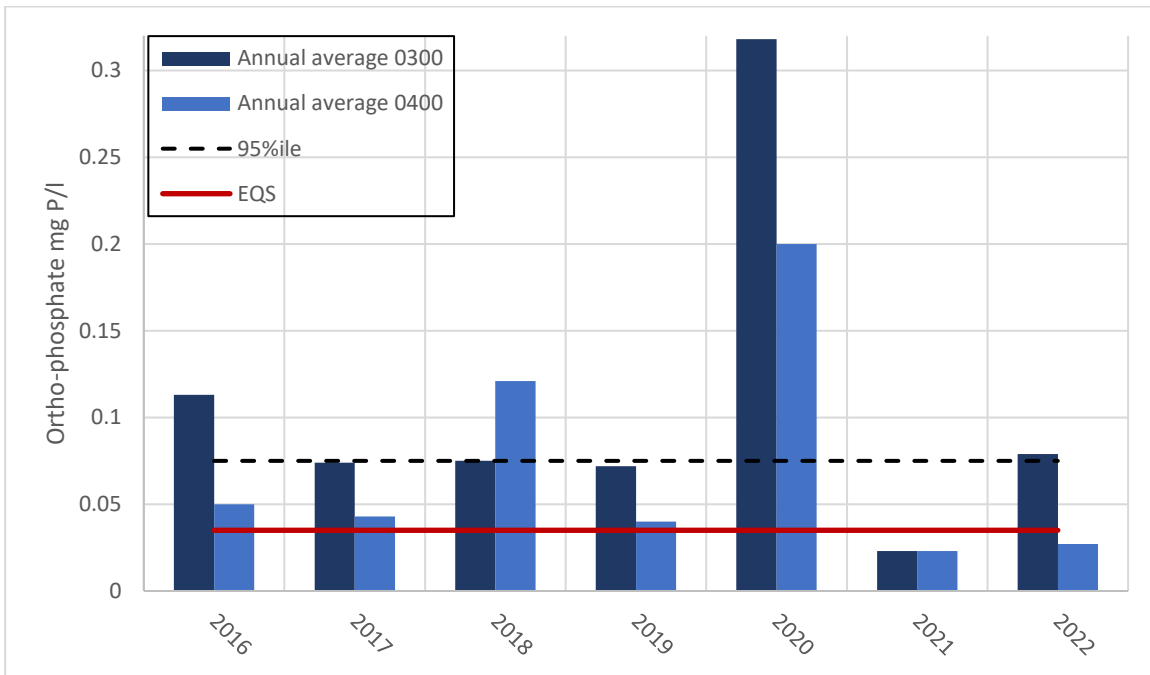
Figure 34 Comparison of Ortho-phosphate (unspecified 2016-2022) annual averages for the 0300 and 0400 monitoring points.

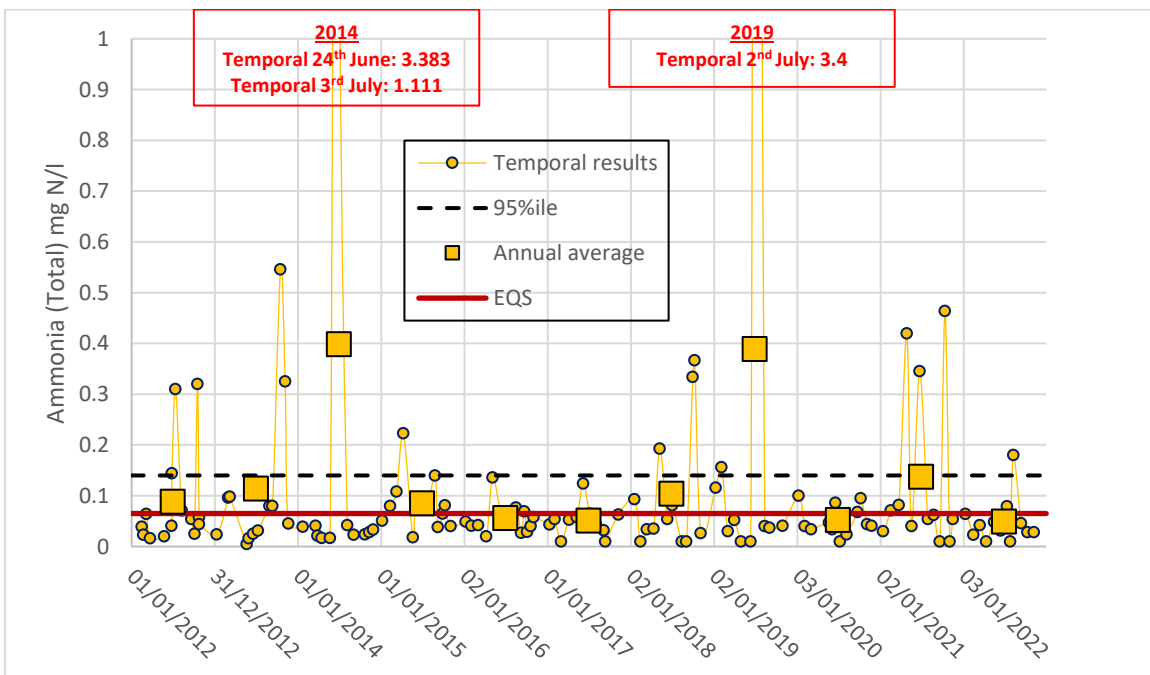
Figure 35 Ammonia data for 300 m d/s Sewage Trtmt Works (RS26D050400) on the Drumshanbo Stream_010 (off chart concentrations in red text box).

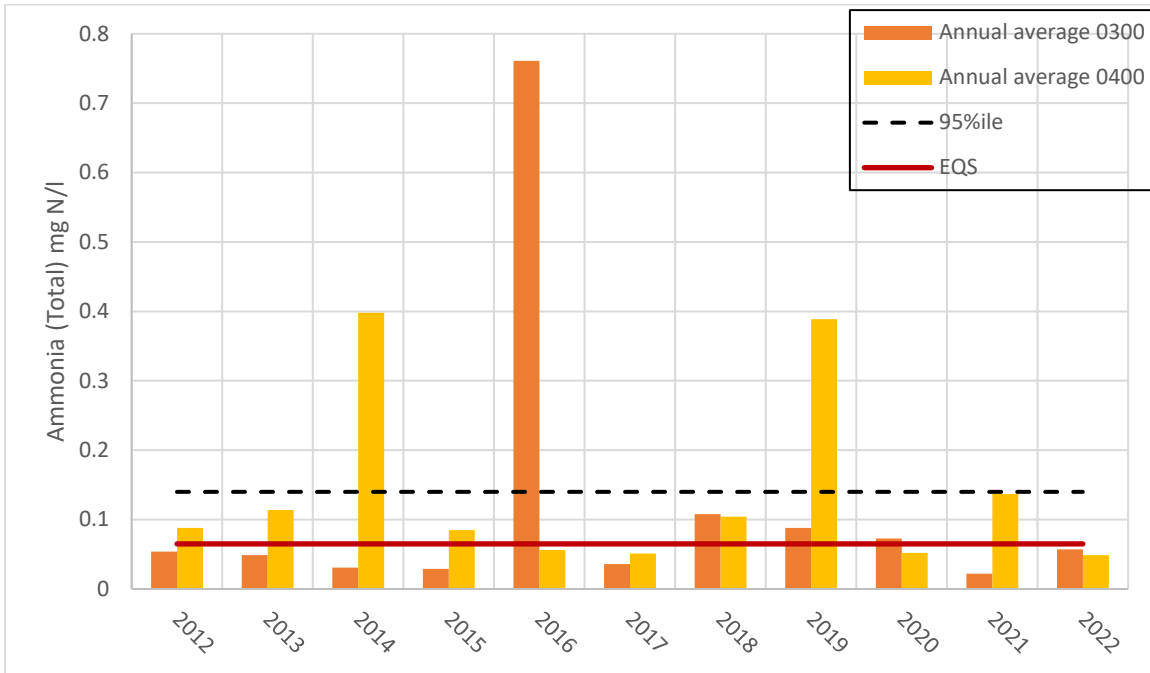
Figure 36 Comparison of ammonia annual averages for the 0300 and 0400 monitoring points.

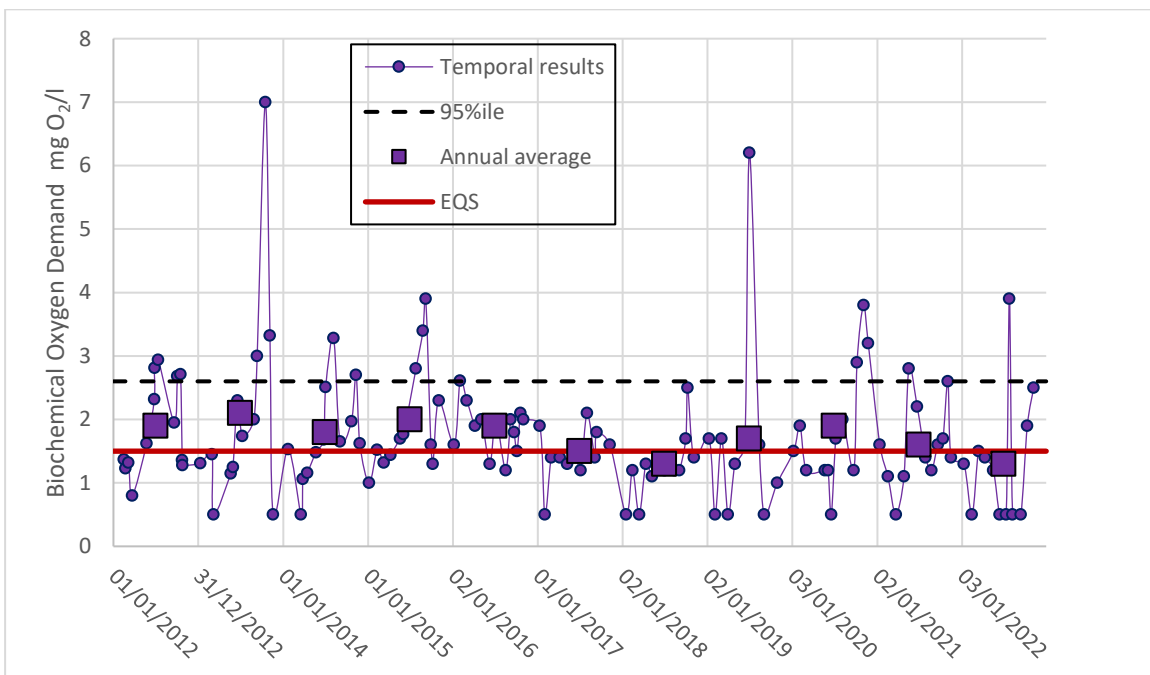
Figure 37 BOD data for 300 m d/s Sewage Trtmt Works (RS26D050400) on the Drumshanbo Stream_010.
