Lough Allen Priority Area for Action Desk Study

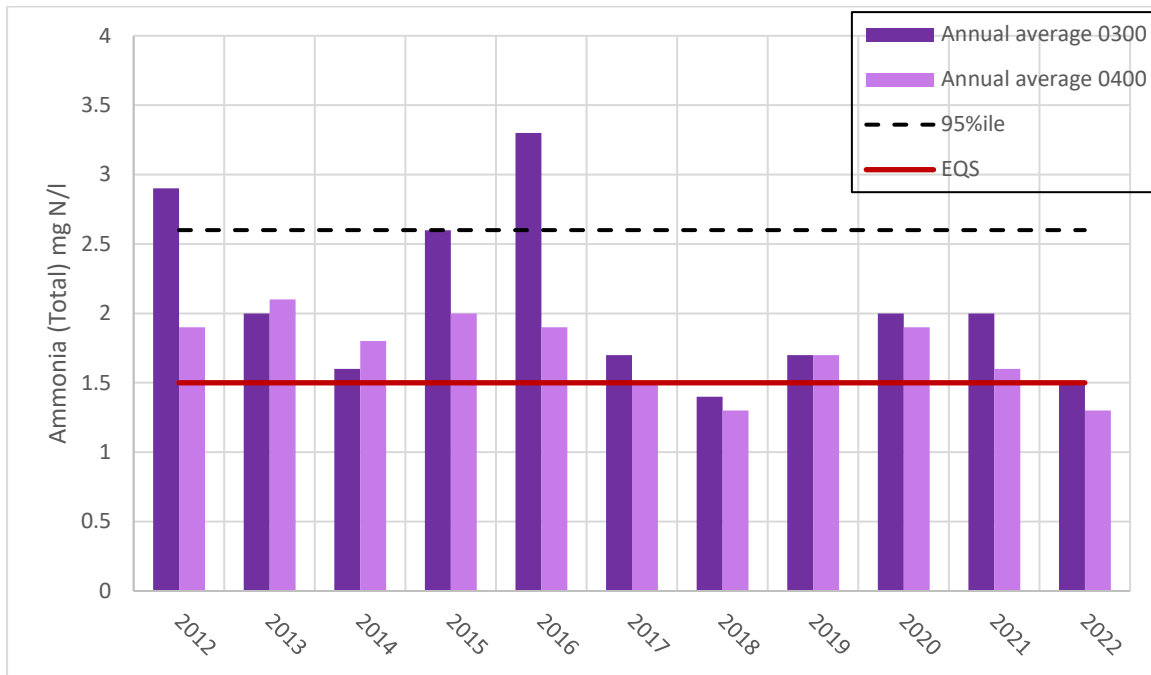
Figure 38 Comparison of BOD annual averages for the 0300 and 0400 monitoring points.

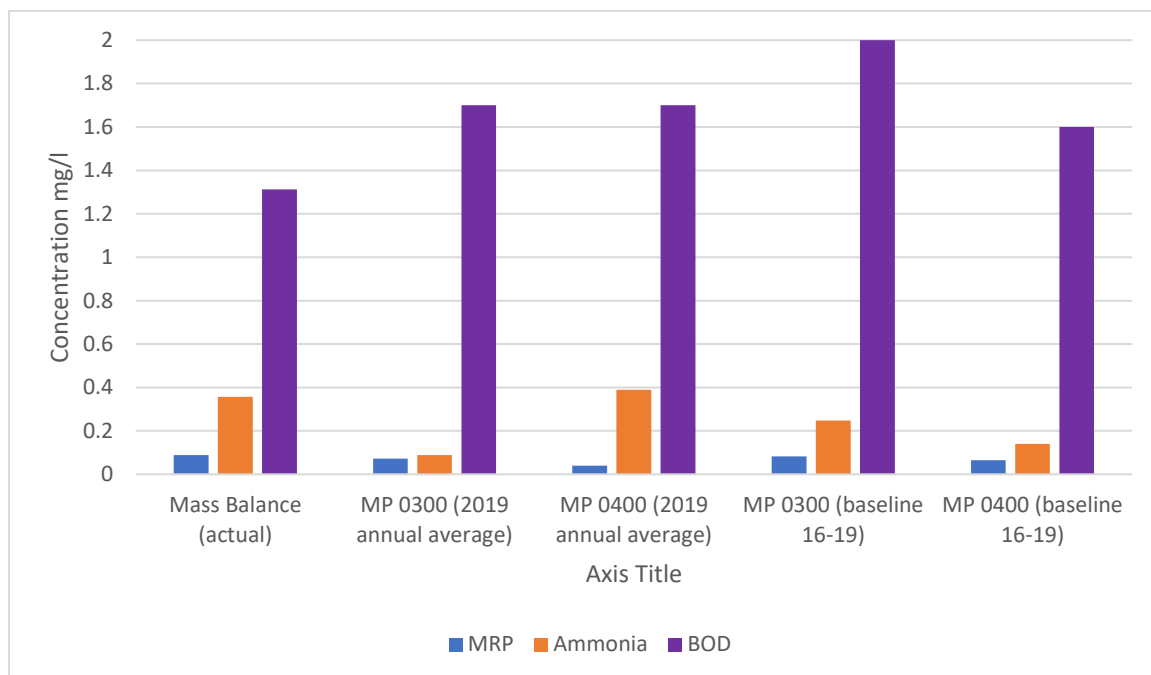
Figure 41 Comparison of the nutrient and BOD concentrations of the mass balance estimation with the actual results at the two d/s monitoring points.

- Background concentrations were the 2019 annual average concentrations at the RS26M800930 investigative monitoring point (u/s ambient MP for WWDA).
- These calculations indicate that predicted resultant concentration downstream of the discharge from Drumshanbo WWTW for ammonia-N is $0.357mg/l$ N, this is in excess of the 95%ile standard of $0.14mg/l$ N and it is noted that this discharge will use an estimated 344% of the ammonia headroom at the downstream WFD monitoring station. The predicted resultant concentration downstream of the discharge for molybdate reactive phosphate (MRP) is $0.088mg/l$ P, this is also in excess of the 95%ile standard of $0.075mg/l$ P and will use an estimated 123% of the MRP headroom at the downstream WFD monitoring station.

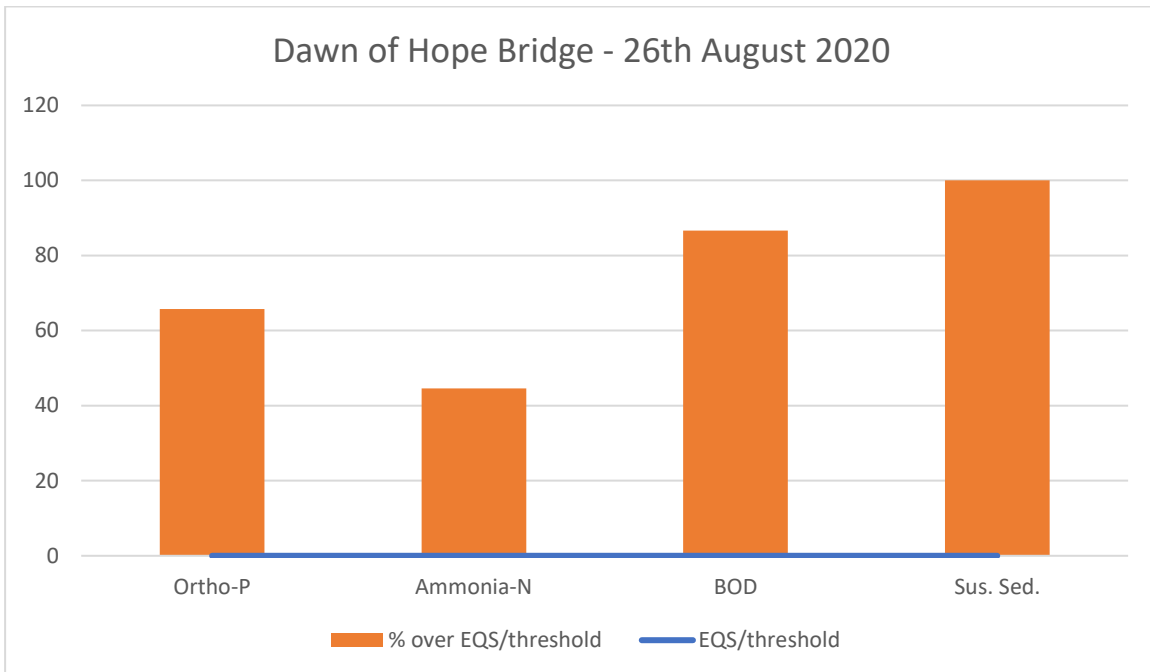
Figure 50 Showing the levels of nutrients, SS and BOD as percentage above the EQS/threshold at the Dawn of Hope Bridge on the 26/08/2020 (data from Leitrim Co. Co.).

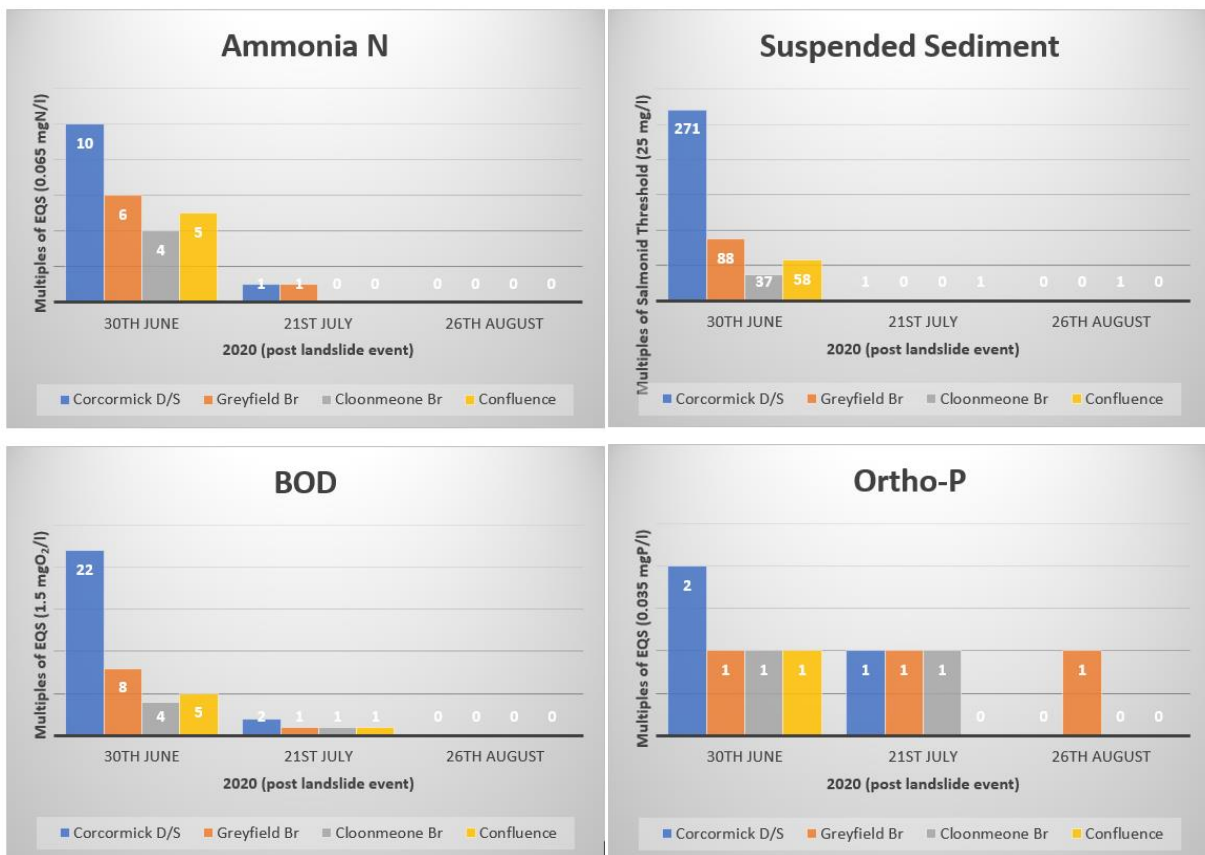
Figure 51 Showing the levels of nutrients, SS and BOD as multiples of the EQS/salmonid threshold at four progressively downstream locations between the Dawn of Hope Bridge and Lough Allen, taken at three dates after the landslide (data from Leitrim CoCo).

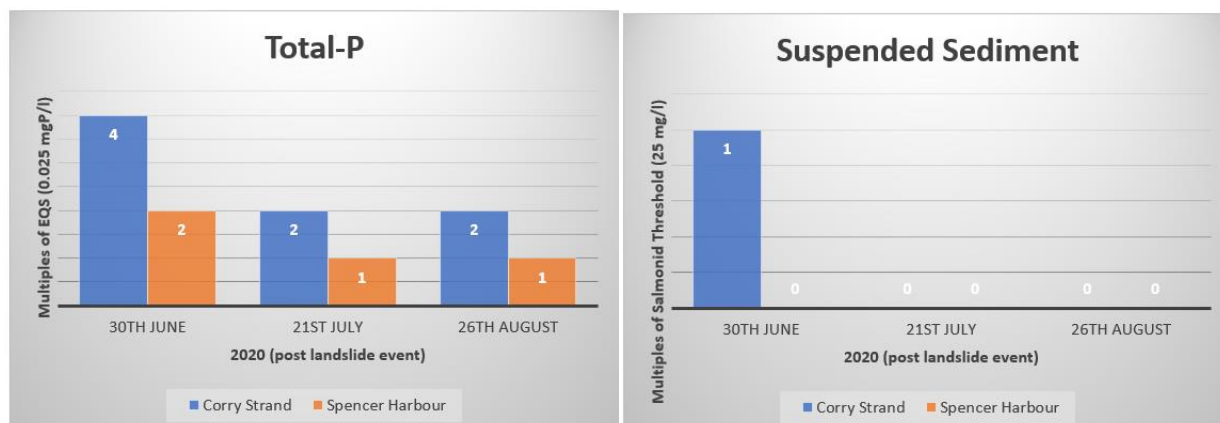
Figure 52 Showing the levels of TP and SS as multiples of the EQS/salmonid threshold at Corry Strand and Spencer Harbour in Lough Allen, taken at three dates after the landslide (data from Leitrim CoCo).

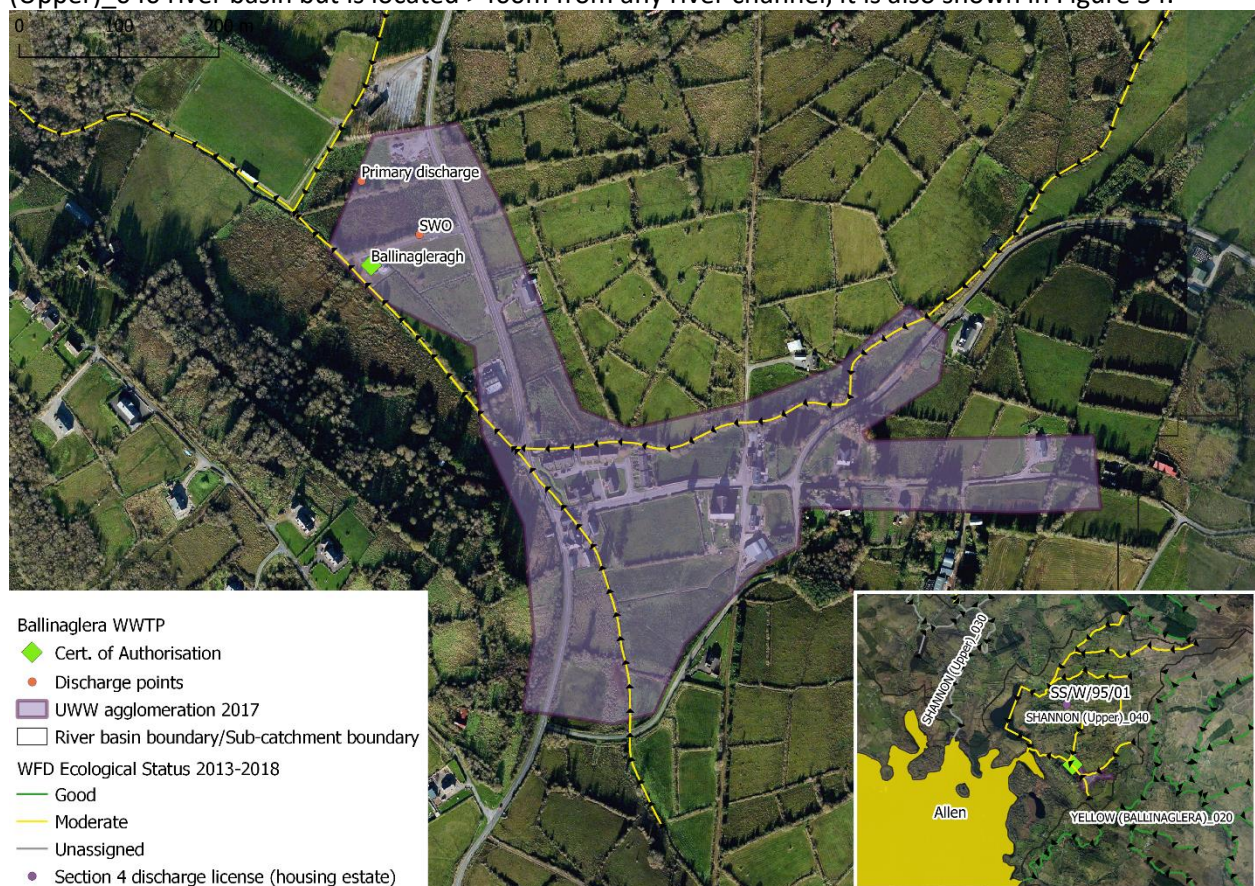
The Ballinaglera WWTP is located in the Shannon (Upper)_040 river basin and has a Certificate of Authorisation (A0469-01), it is an agglomeration with a p.e. of 64 as of 31st October 2011¹⁵, the WWTP provides secondary treatment, consisting of an activated sludge process and phosphorus removal, and has a design capacity of 100 p.e. The location of the WWTP and the associated emission points are shown in Figure 54. There are no EPA monitoring points on this section of the Shannon (Upper)_040 which flows into Lough Allen. Leitrim County Council have also granted a Section 4 discharge licence to a treatment system at Greaghnafarna housing estate (SS/W/95/01) which lies within the Shannon (Upper)_040 river basin but is located >400m from any river channel, it is also shown in Figure 54.

Figure 54 Ballinaglera WWTP and Greaghnafarna housing estate Section 4 discharge licence (SS/W/95/01) in relation to the Shannon (Upper)_040.

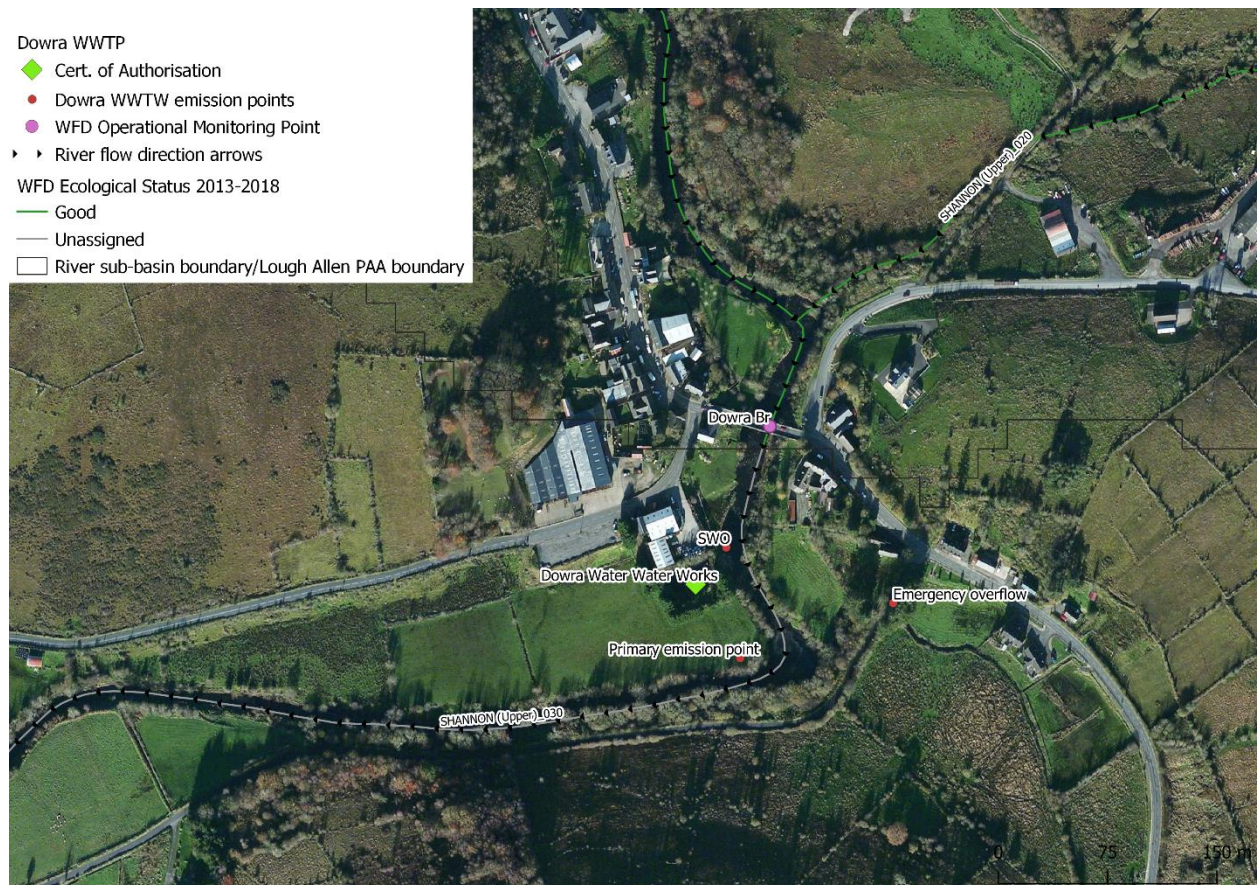
The Dowra WWTW, located in the Shannon (Upper)_030 river basin, has a Certificate of Authorisation (A0299-01). It is an agglomeration with a p.e. of 130 as of 7th April 2011¹⁶, the WWTP provides secondary treatment, consisting of an activated sludge system and phosphorous removal, and has a design capacity of 176 p.e. The location of the WWTP and the associated emission points are shown in Figure 55. The single monitoring point on the Shannon (Upper)_020, *Dowra Br* (RS26S020300), is at the downstream limit of the waterbody as it flows into the Shannon (Upper)_030, just upstream of the Dowra Wastewater Works, but there is no available chemistry data after 2015, the available 2008-2015 data show no breaches of EQS/ecological threshold for ortho-phosphate, ammonia or TON, the BOD EQS is breached in 2010 and 2013-2014. There is no available data for any point on the Shannon (Upper)_030 downstream of the WWTW, the impact of which will be assessed as part of the LCA.

Figure 55 Dowra WWTW in relation to the Shannon (Upper)_030.

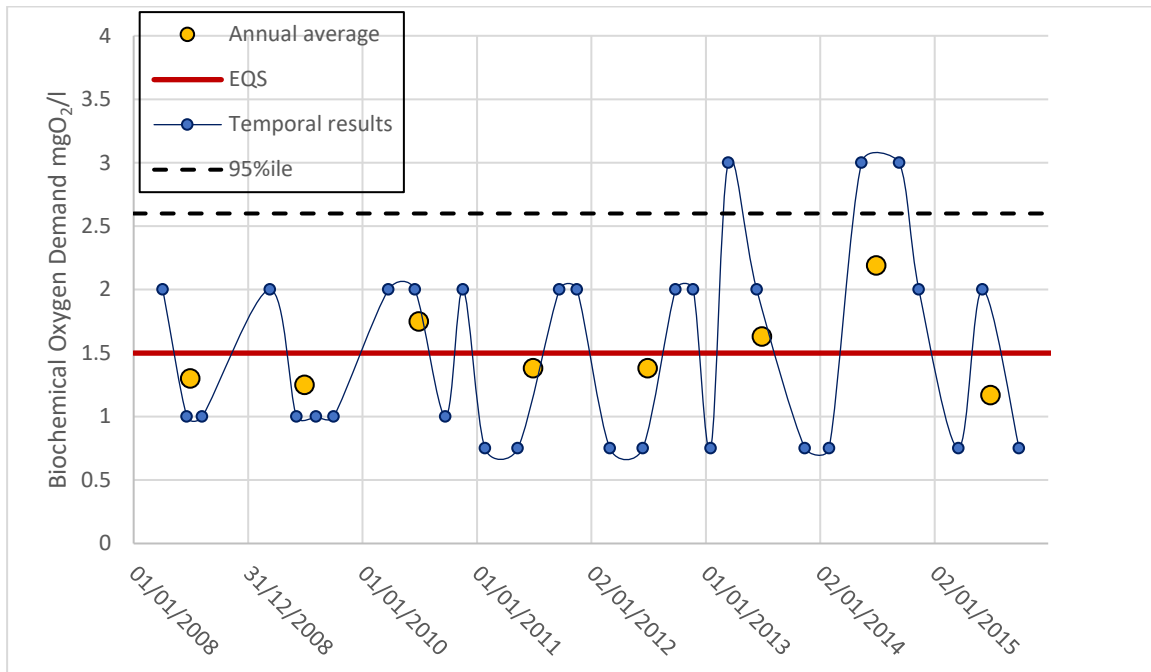
Figure 56 BOD data¹⁷ for monitoring station *Dowra Br* (RS26S020300) on the Shannon (Upper)_020, upstream of Dowra Wastewater Works.

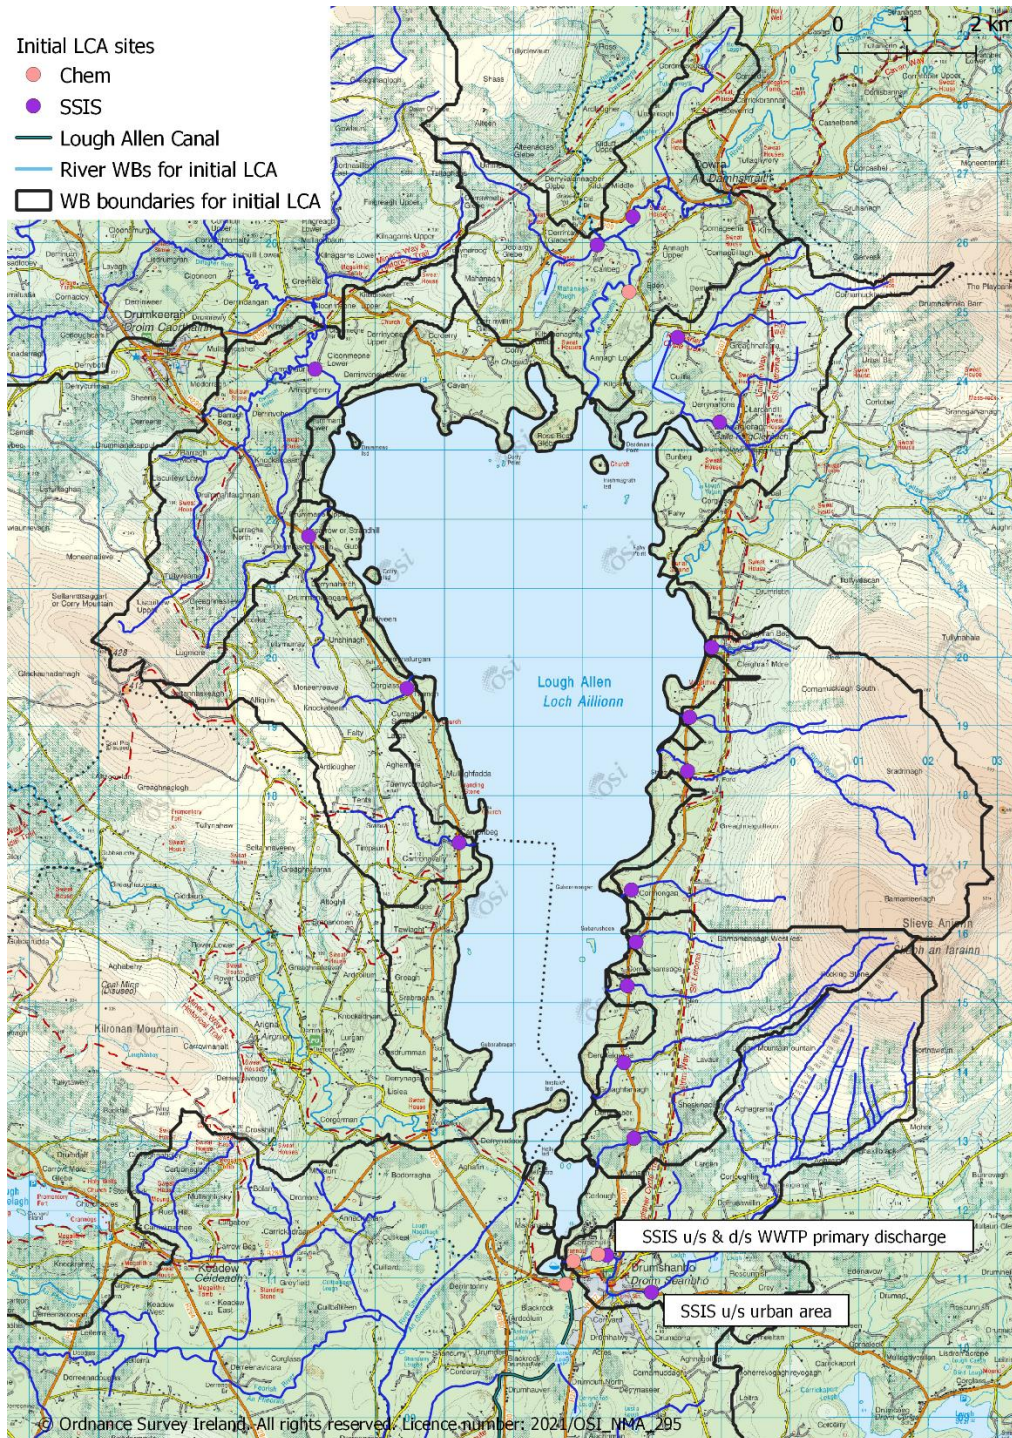
Figure 68 Initial LCA assessment locations for the Lough Allen PAA.
