Desk Study

Duiske Priority Area for Action

The Duiske Prioritised Area for Action (PAA) is located in Kilkenny on the Kilkenny/Carlow border in the vicinity of Graiguenamanagh. There are two waterbodies in the PAA, the Powerstown_010 and the Duiske_020. Both waterbodies are tributaries of the Barrow River. A summary of the ecological status and pressures for these waterbodies can be seen in **Table 1**.

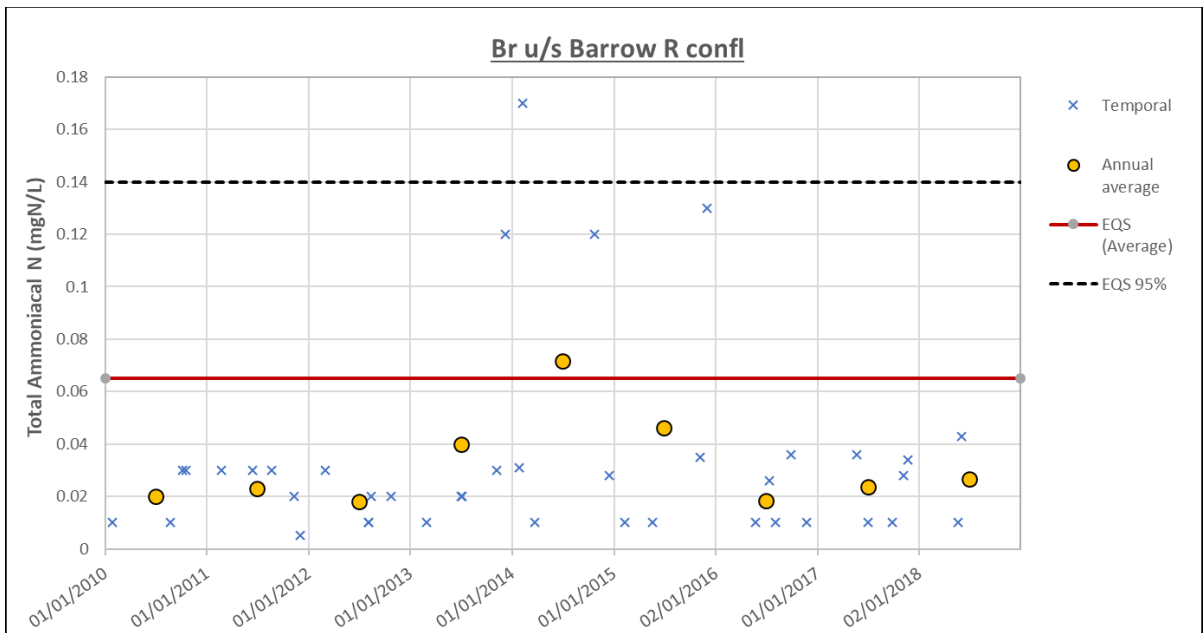
Figure 3. Ammonia concentrations at Bridge Upstream Barrow River Confluence on Powerstown_010.

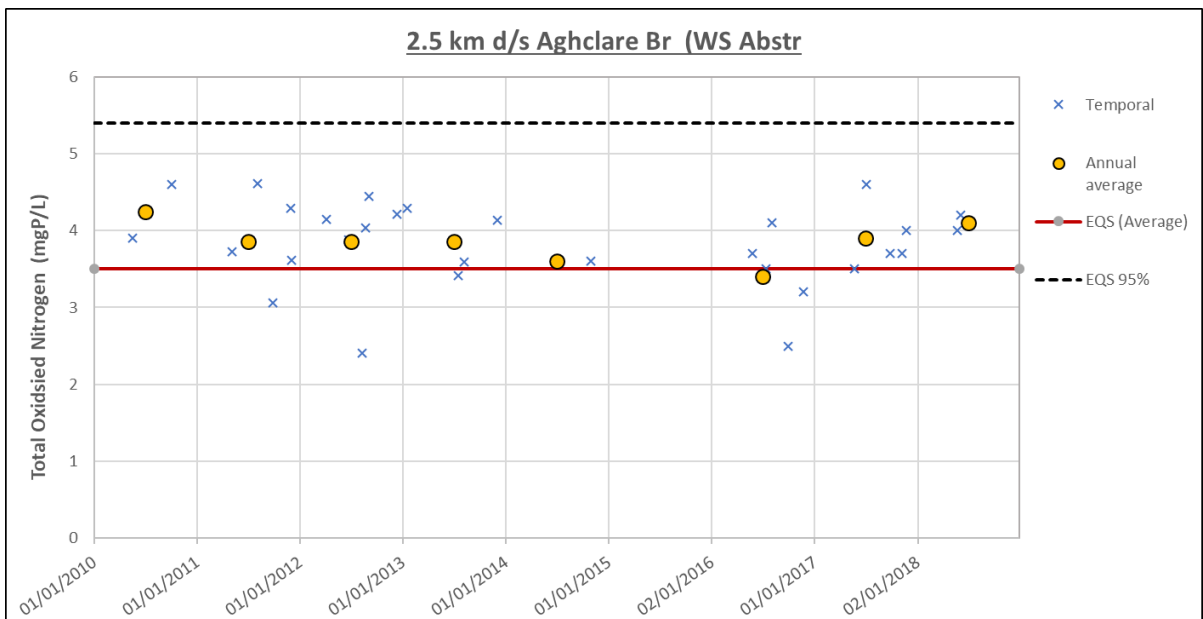
Figure 10. TON concentrations at 2.5km downstream of Aghclare Bridge on Duiske_020.

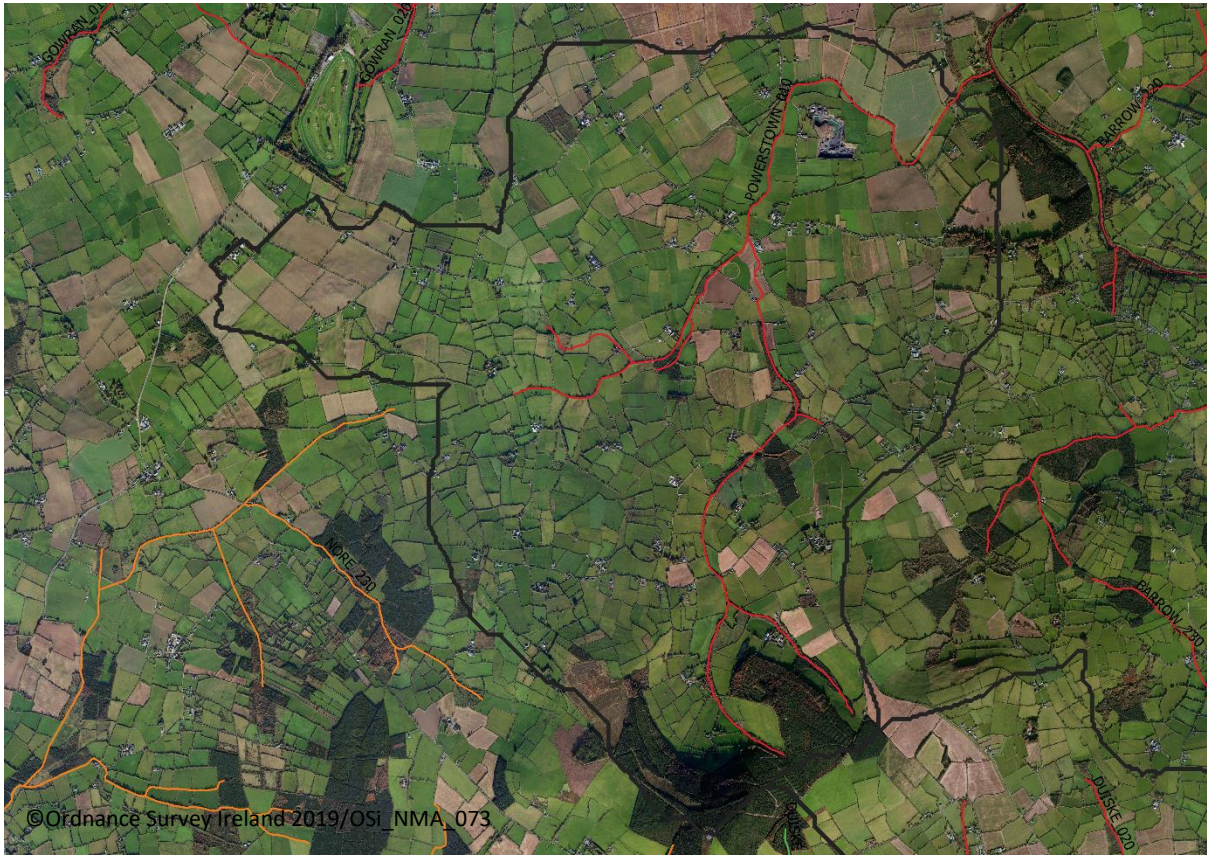
Figure 16. Aerial photograph of Powerstown_010 showing forestry and quarry locations.

- The quarry is located in compartment 2. Soils in this area are well drained so any sediment losses are likely to be direct via drains from the quarry to the stream rather than via overland flow.

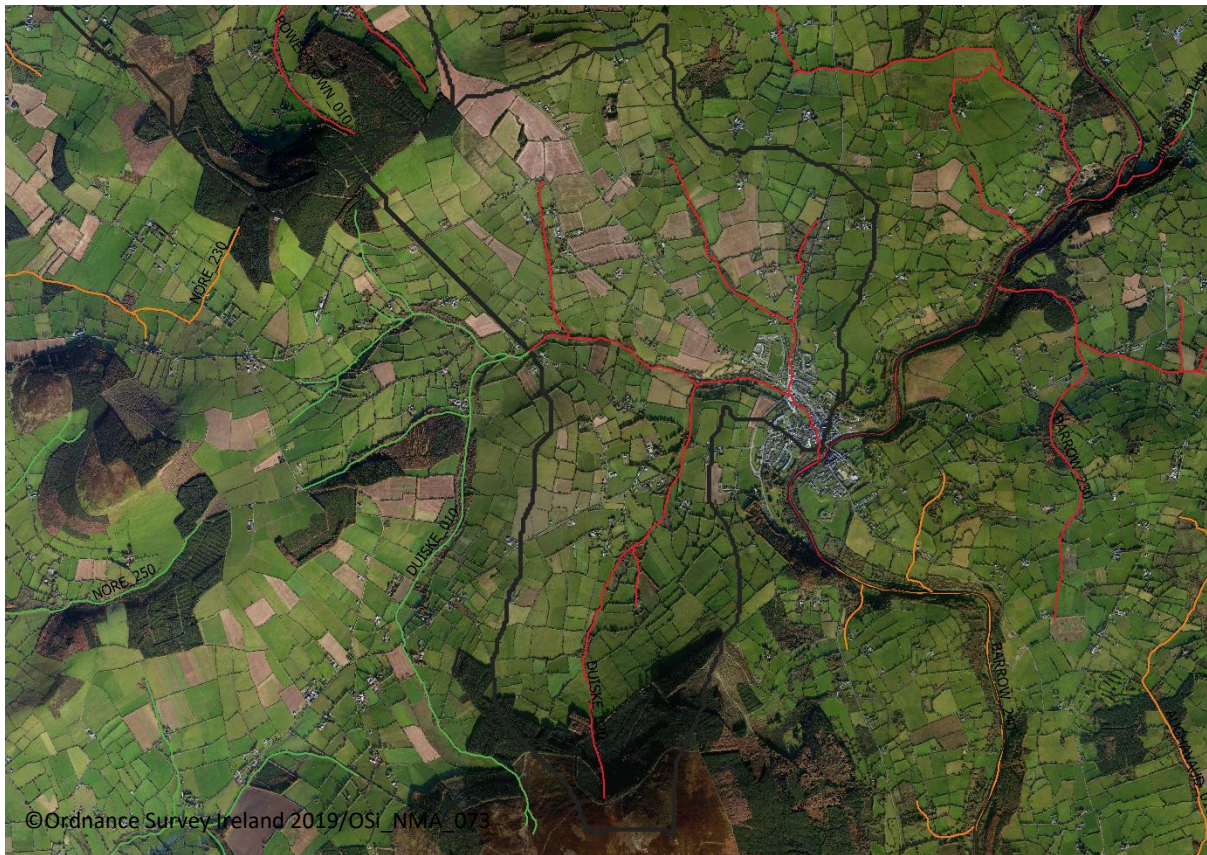
Figure 17. Aerial photograph of Duiske_020 showing location of forestry.
