Urrin Priority Area for Action (AFA0184) Desk Study Report South East Region

Urrin PAA

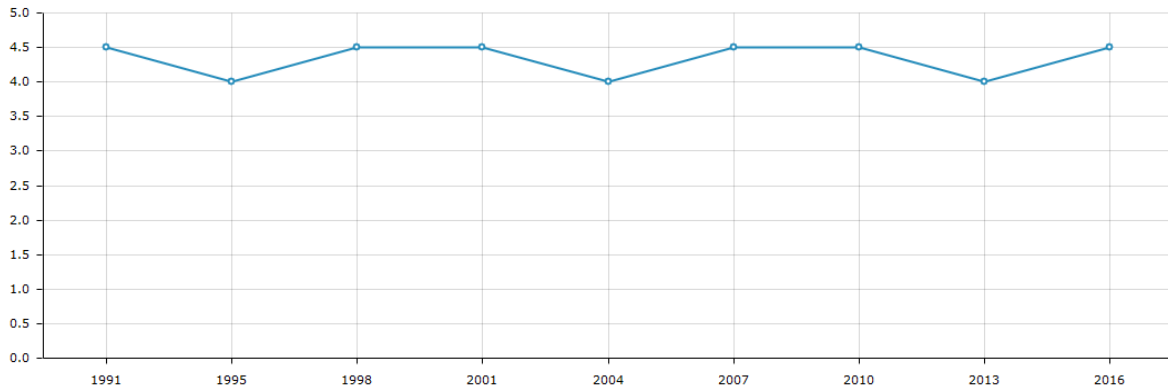
1991	1995	1998	2001	2004	2007	2010	2013	2016
Result	4.5	4	4.5	4.5	4	4.5	4.5	4	4.5
Classification	High	Good	High	High	Good	High	High	Good	High
Q-Value	4-5	4	4-5	4-5	4	4-5	4-5	4	4-5

Figure 3 Q-Values recorded at the Askinvillar Br Monitoring Station

- The Askinvillar Stream_010 is situated in the headwaters of the river and is upstream of the Urrin_020 (currently at Moderate Status). The river waterbody has one operational monitoring station located at Askinvillar Br (RS12A030200) as illustrated in **Figure 2**. **Table 2** summarises the receptor information for the river waterbody and details the biological status.
- Significant issue(s) cannot be determined at this stage due to the absence of hydrochemistry data.

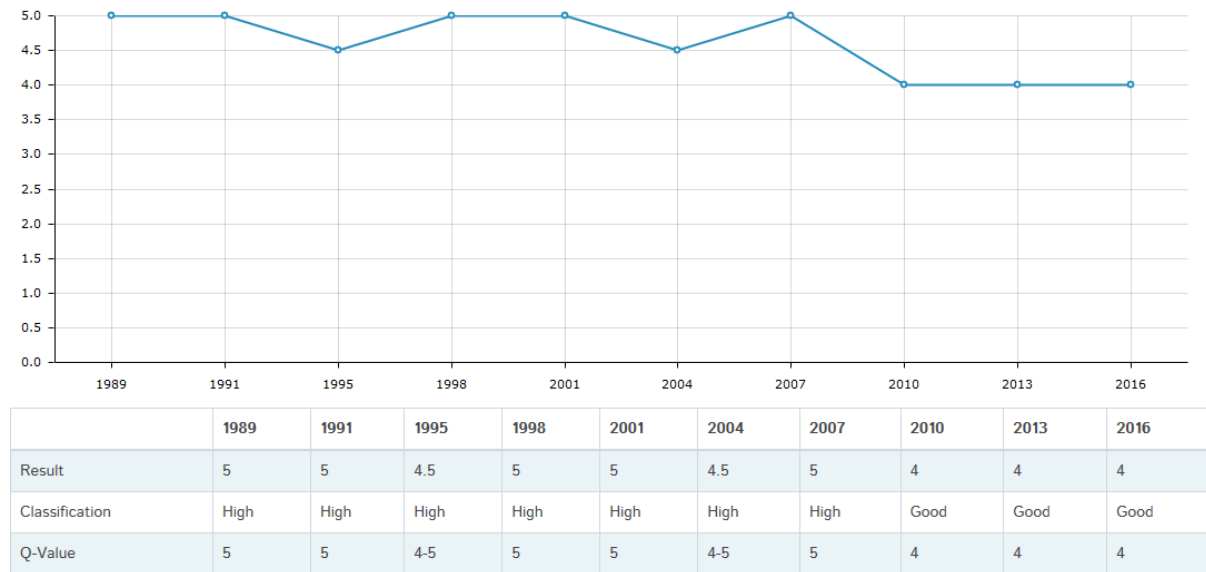
Figure 4 Q-Values recorded at the Ballycrystal Br Monitoring Station

- The Urrin_010 is situated in the headwaters of the river and is upstream of Urrin_020 (currently at Moderate Status). The river waterbody has one operational monitoring station located at Ballycrystal Br (RS12U010050) as illustrated in **Figure 2**. **Table 3** summarises the receptor information for the river waterbody and details the biological status.
- Significant issue(s) cannot be determined at this stage due to the absence of hydrochemistry data.

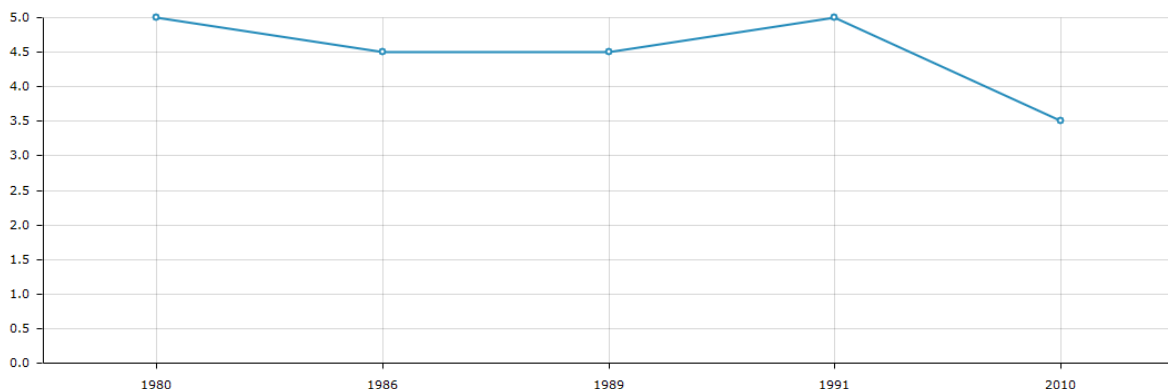
1980	1986	1989	1991	2010
Result	5	4.5	4.5	5	3.5
Classification	High	High	High	High	Moderate
Q-Value	5	4-5	4-5	5	3-4

Figure 5 Q-Values recorded at the Urrin - Mocurry Br Monitoring Station

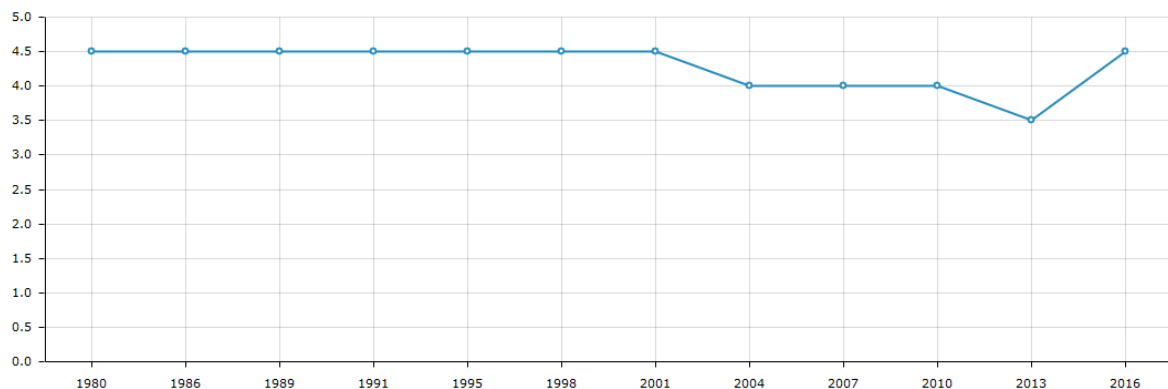
1980	1986	1989	1991	1995	1998	2001	2004	2007	2010	2013	2016
Result	4.5	4.5	4.5	4.5	4.5	4.5	4.5	4	4	4	3.5	4.5
Classification	High	High	High	High	High	High	High	Good	Good	Good	Moderate	High
Q-Value	4-5	4-5	4-5	4-5	4-5	4-5	4-5	4	4	4	3-4	4-5

Figure 6 Q-Values recorded at the Buck's Br Monitoring Station

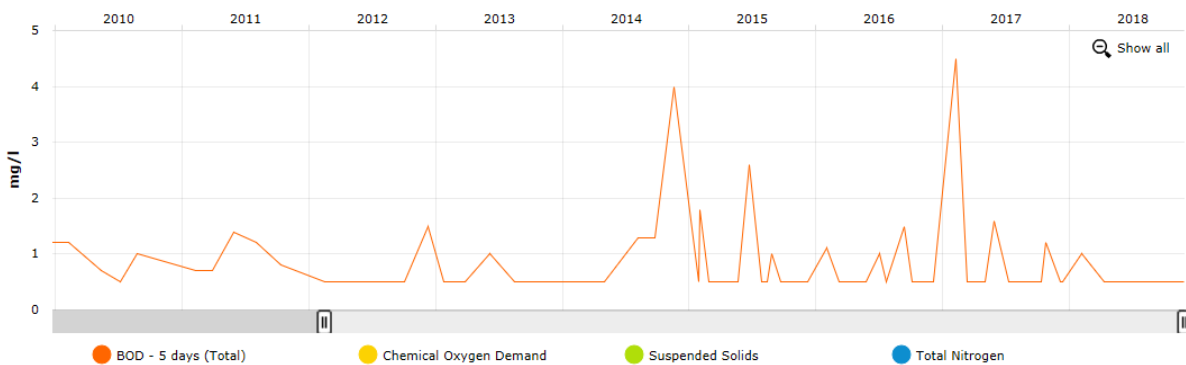
Figure 7 Chemistry data recorded at the Buck's Br Monitoring Station

- Ortho-phosphate, Ammonia and Total Oxidised Nitrogen concentrations have been on a downward trend at the Buck's Br monitoring station since 2010. Recent data for 2018 shows that annual average concentrations for Ortho-phosphate and Ammonia are below the relevant EQS and levels of Total Oxidised Nitrogen are below the Action Threshold.

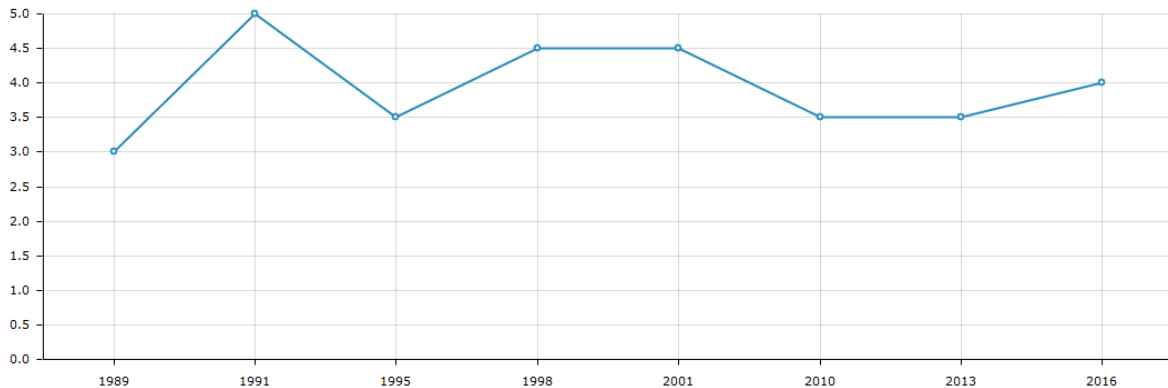
1989	1991	1995	1998	2001	2010	2013	2016
Result	3	5	3.5	4.5	4.5	3.5	3.5	4
Classification	Poor	High	Moderate	High	High	Moderate	Moderate	Good
Q-Value	3	5	3-4	4-5	4-5	3-4	3-4	4

Figure 8 Q-Values recorded at the URRIN - Verona Br Monitoring Station

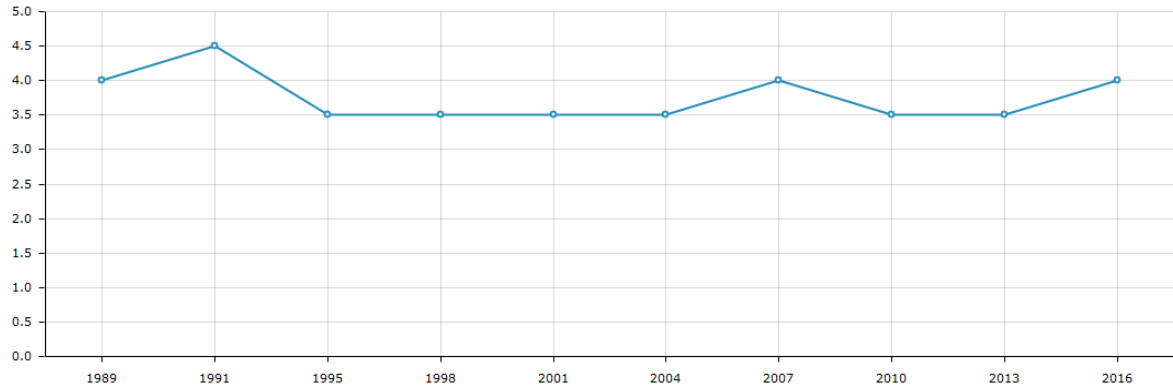
1989	1991	1995	1998	2001	2004	2007	2010	2013	2016
Result	4	4.5	3.5	3.5	3.5	3.5	4	3.5	3.5	4
Classification	Good	High	Moderate	Moderate	Moderate	Moderate	Good	Moderate	Moderate	Good
Q-Value	4	4-5	3-4	3-4	3-4	3-4	4	3-4	3-4	4

Figure 9 Q-Values recorded at the John's Br Monitoring Station

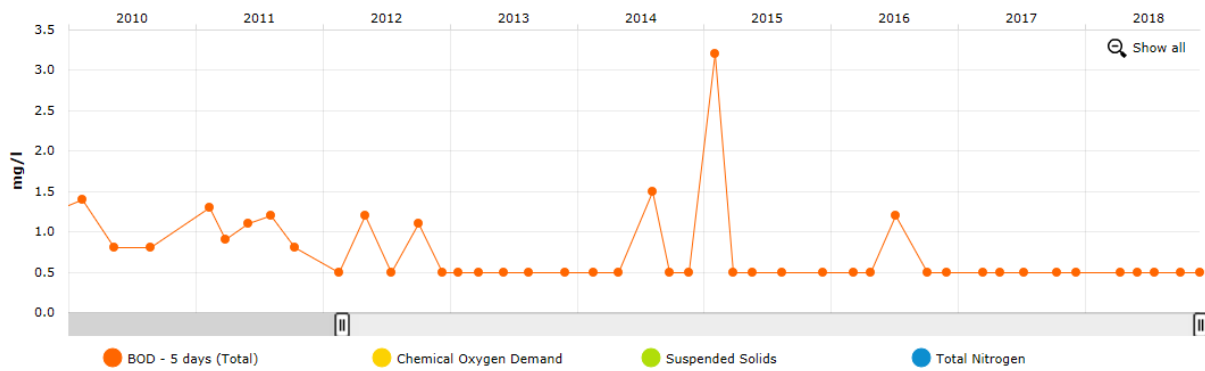
Figure 10 Chemistry data recorded at the John's Br Monitoring Station

- Ortho-phosphate, Ammonia and Total Oxidised Nitrogen concentrations have been on a downward trend at the John's Br monitoring station since 2010. Recent data for 2018 shows that annual average concentrations for Ortho-phosphate and Ammonia are below the relevant EQS. However, annual average concentrations of TON remain high and data for 2018 show an average concentration of 4.58 mg/l which is above the Action Threshold of 3.5 mg/l.

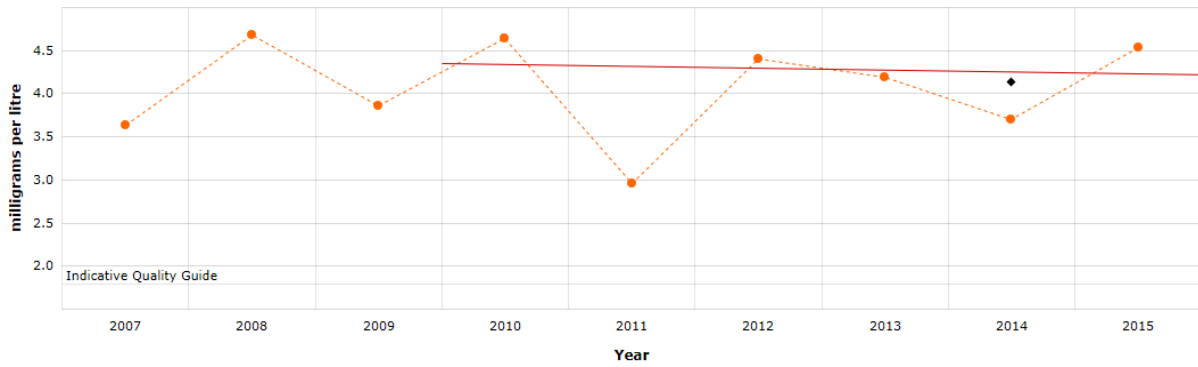
Figure 11 Average Total Oxidised Nitrogen concentrations recorded at the John's Br Monitoring Station

- Nitrate is the significant issue identified for the Urrin_050. The Q value classification at John’s Br monitoring station returned to Good in 2016. However, concentrations of Total Oxidised Nitrogen are consistently above the Action Threshold level of 3.5 mg/l (**Figures 11 & 12**).

- Nitrate is the significant issue affecting water quality in the Urrin_050.
- Concentrations of TON at the John's Br monitoring station are consistently greater than the Action Threshold of 3.5 mg/l (**Figures 11 and 12**).

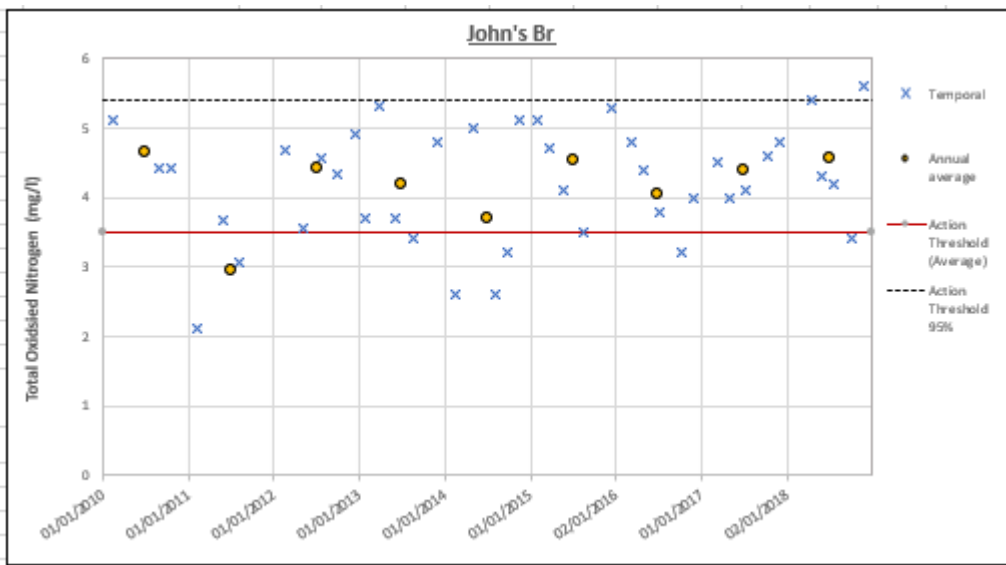
Figure 12 Total Oxidised Nitrogen concentrations recorded at the John's Br Monitoring Station

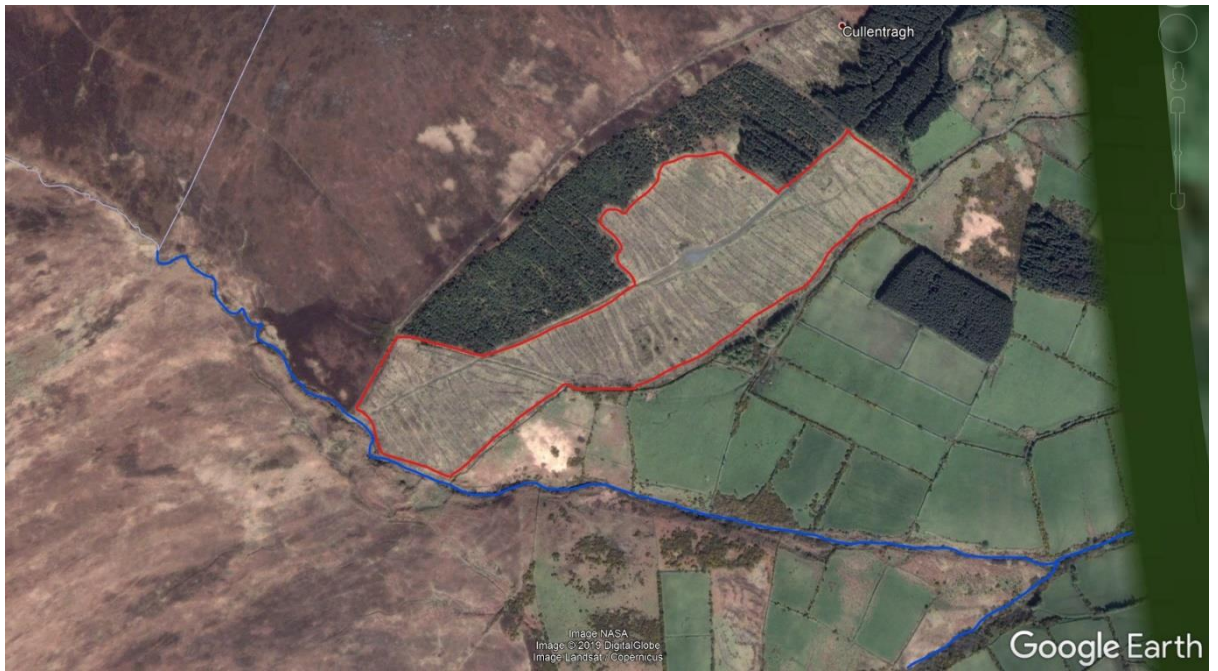
Figure 14 Forestry Cover in the Askinvillar Stream_010 catchment (Stream in blue, clearfelled area in red)

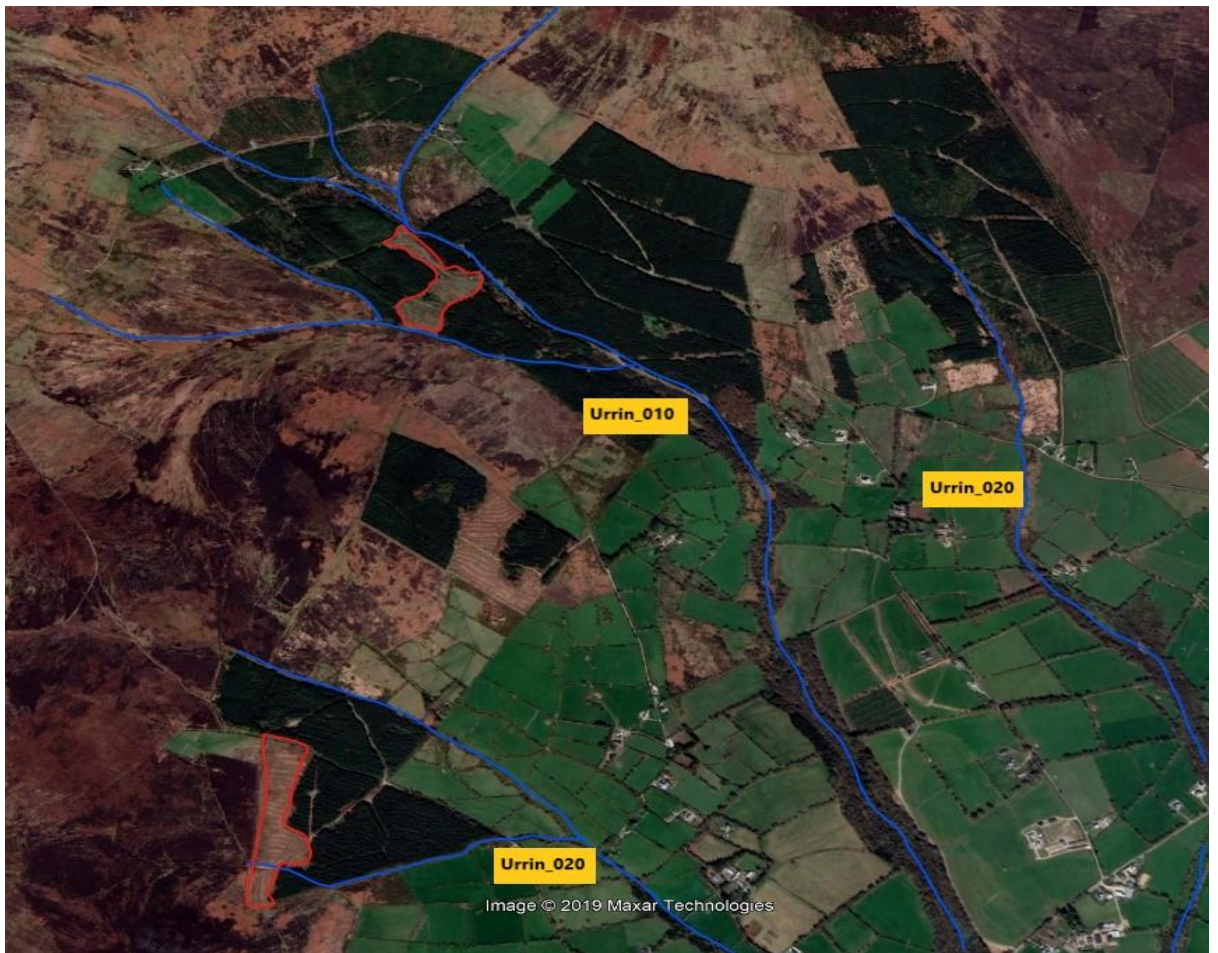
Figure 15 Forestry Cover in the Urrin_010 and Urrin_020 catchments (Clearfelled areas in red)

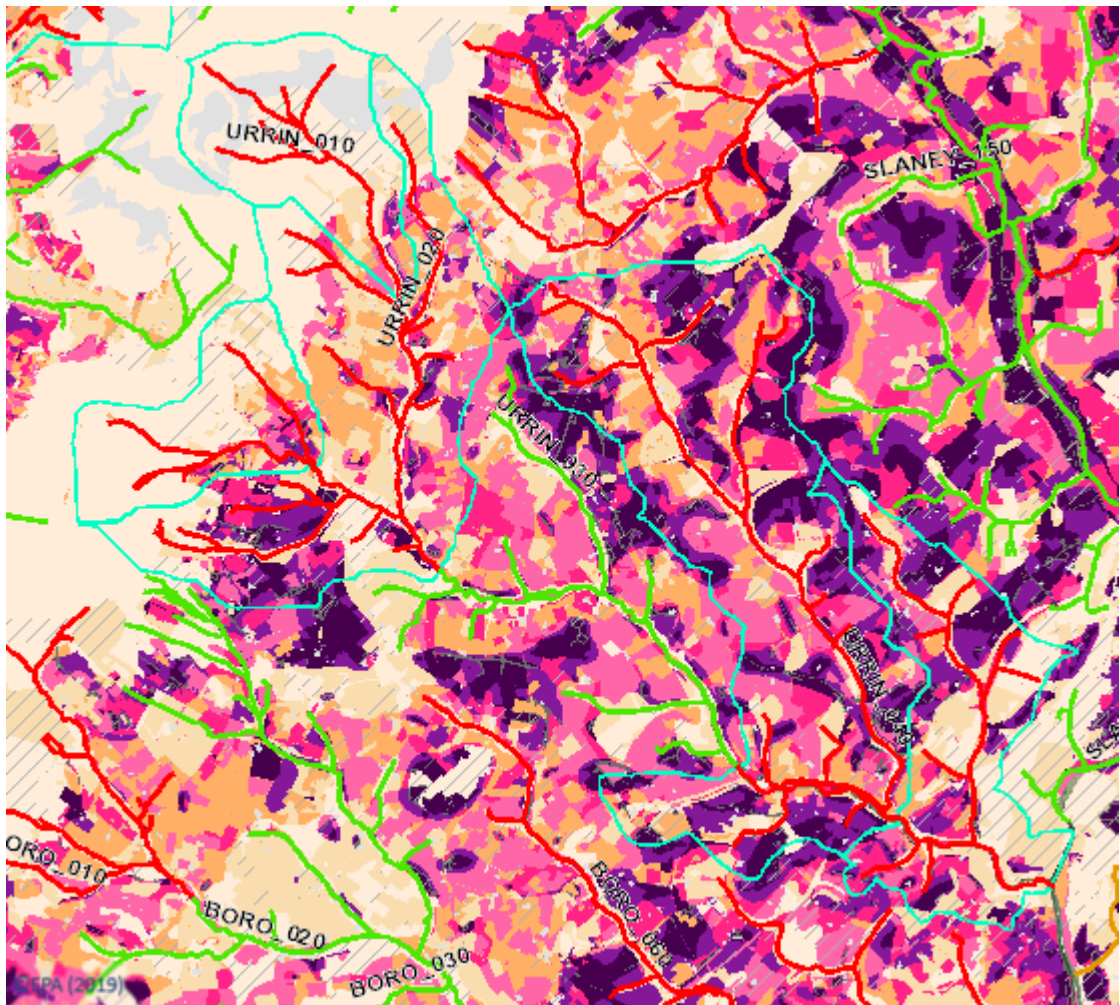
Figure 16 Surface water nitrate PIP map

The significant pressures identified by EPA for the Urrin PAA through the initial characterisation process are presented in **Table 8**. The Pollution Impact Potential (PIP) map for Nitrate is illustrated in **Figure 16**.

- Agriculture may be contributing to elevated levels of nitrate in the waterbody and high risk PIP ranking areas for NO₃ can be seen throughout the sub basin for the Urrin_050 (**Figure 16**).

- The critical source areas (CSA) for nitrate are likely to be in areas of free draining soils with high risk PIP rankings (**Figure 16**). These can be found throughout both compartments but in particular the middle and upper parts of the sub-basin.

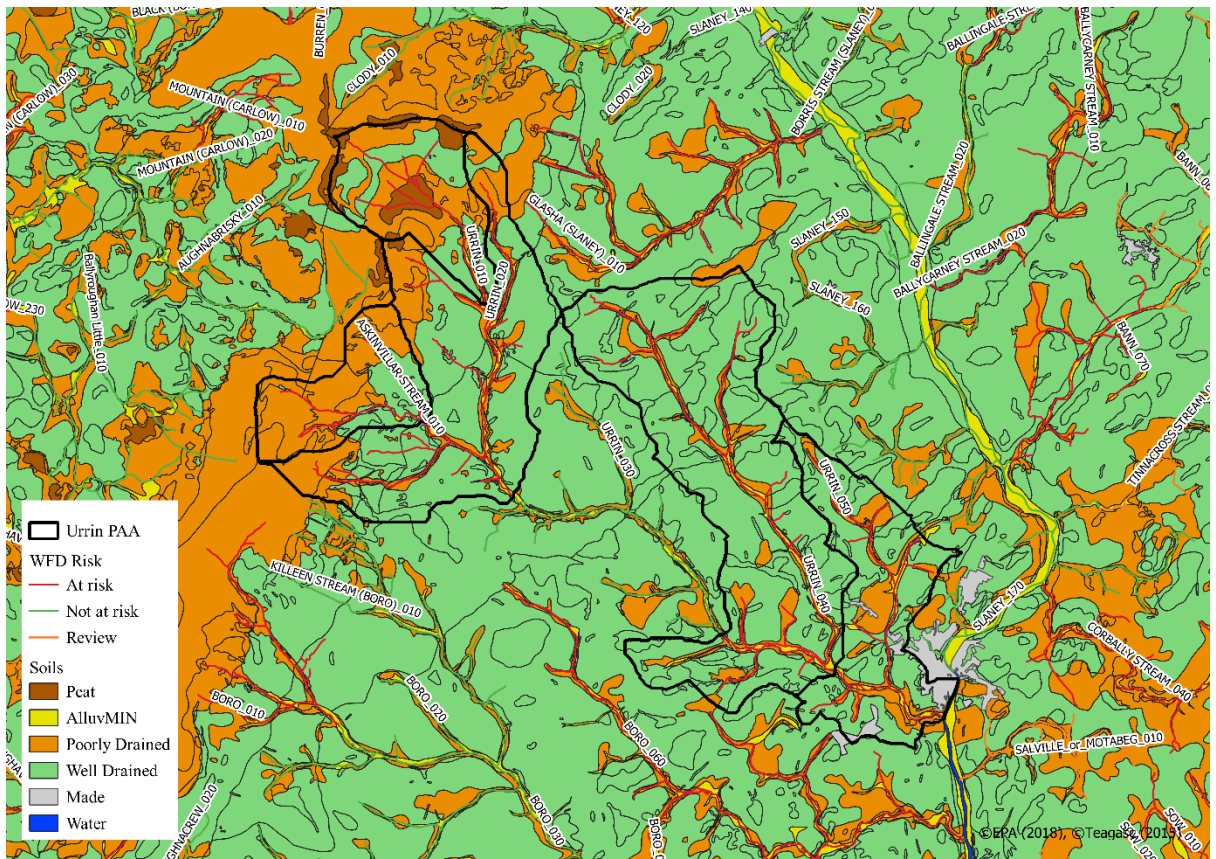
Figure 18 Soils map for the Urrin PAA

The only identifiable significant issue in this catchment is Nitrate in the Urrin_050 waterbody. Two main pathway compartments have been identified for the significant issue and they are described in **Table 9**. The regional pathway framework is provided by the aquifer map (**Figure 17**) and the soil type map (**Figure 18**) as follows:
