Desk Study

Mountain (Carlow) Priority Area for Action

Mountain (Carlow) PAA Desk Study

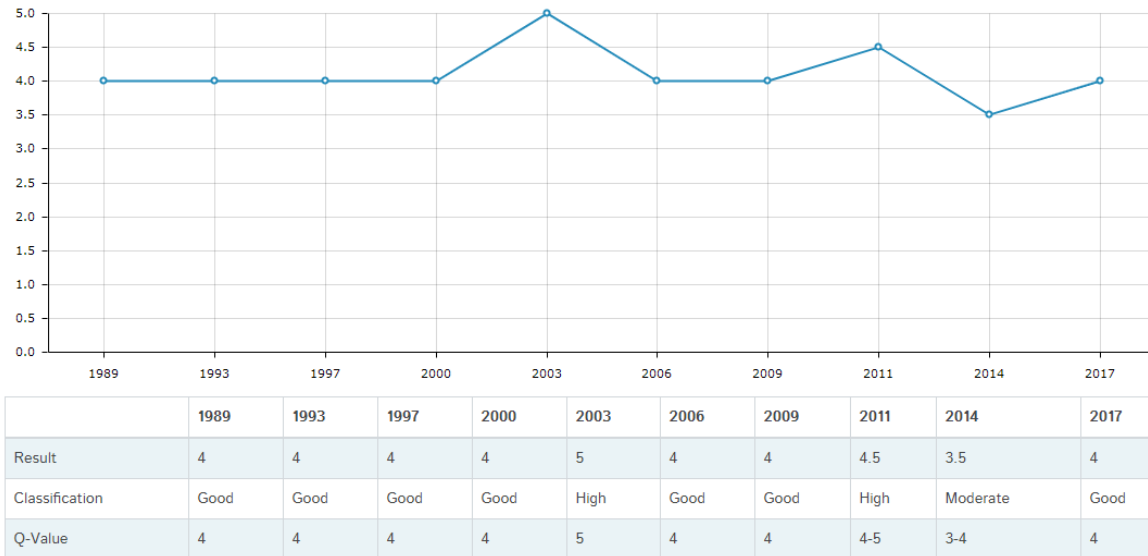
Figure 2. Q-value data at Br u/s of Killedmond Br on the Mountain (Carlow)_010.

Factor	Comment/Description
Risk Category	<i>At Risk</i>
Biological Status Monitoring Station(s) with Q-Values 2009-2015 Status Trends in Q value since 2009 2016-2018 Q value data	Br u/s of Killedmond Br Moderate Fluctuating Good
Hydrochemistry Data Monitoring Station(s) with data Existing New	None
Summary & Trends in PO₄, NH₃ and NO₃ In App All available data Other water quality data Baseline Concentration (mg/l) Other relevant values Distance to threshold	N/A N/A N/A N/A N/A
Supporting Conditions Chemical Conditions Oxygenation Conditions Acidification Conditions	N/A N/A N/A
Hydromorphology RHAT Score Evidence of arterial drainage	High None
Ecological Status 2017	Good
Protected Areas	Blackstairs Mountains SAC; FWPM Protected Area
WFD Objective	Good
EPA biologist notes (if any)	After a decline from High to Moderate ecological quality in 2014, Station 0020 showed sign of recovery with a welcome improvement to Good quality in 2017. Further downstream Station 0070 declined from its previous High ecological quality to Good in 2017.

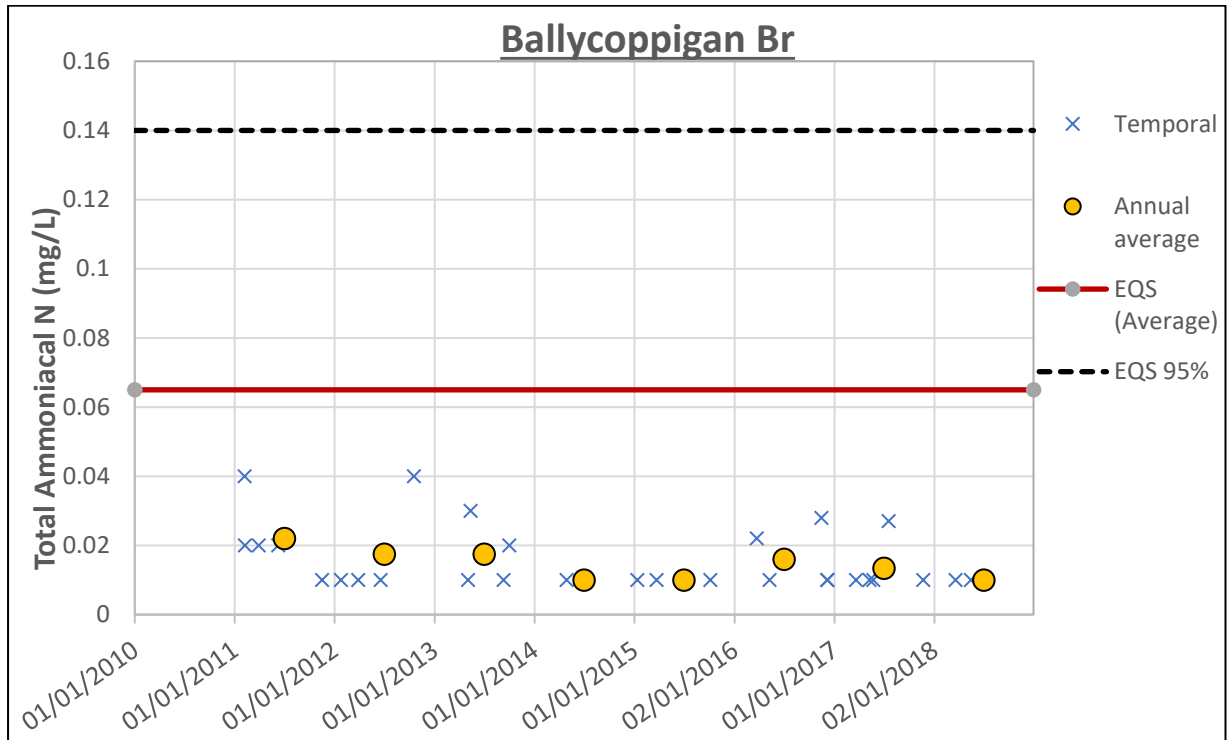
Figure 3. Ammonia concentrations at Ballycoppigan Bridge on Mountain (Carlow)_030.

- The current status of the Mountain (Carlow)_030 is unknown as it has not been monitored since 1993.
- The chemistry monitoring results show that ammonia, ortho-phosphate and TON are generally below the EQS at the Ballycoppigan Br monitoring point.
- Borris UWWTP which discharges below Ballycoppigan Bridge failed it's ELV for ammonia in 2017 and there have been a number of spikes in ammonia, ortho-phosphate and COD recorded downstream of the UWWTP. The discharge is located at the outlet of the catchment and should be investigated.

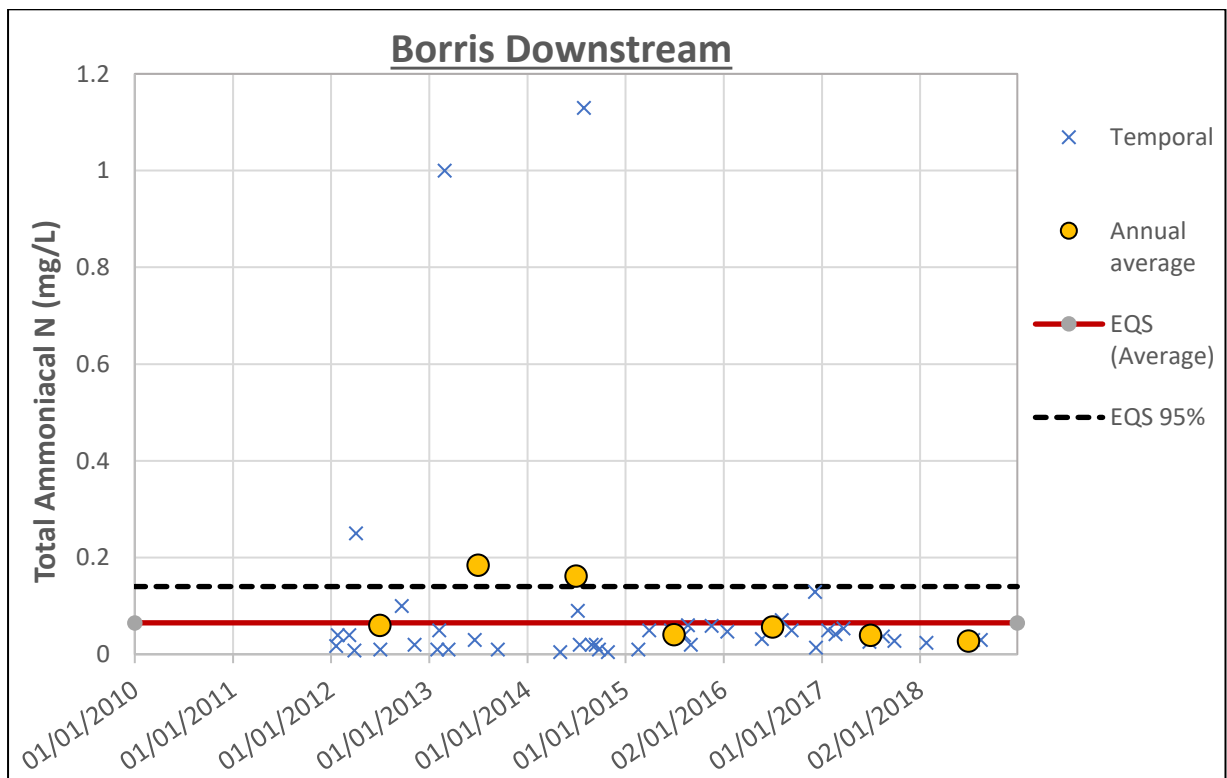
Figure 4. Ammonia concentrations at Borris Downstream on Mountain (Carlow)_030.

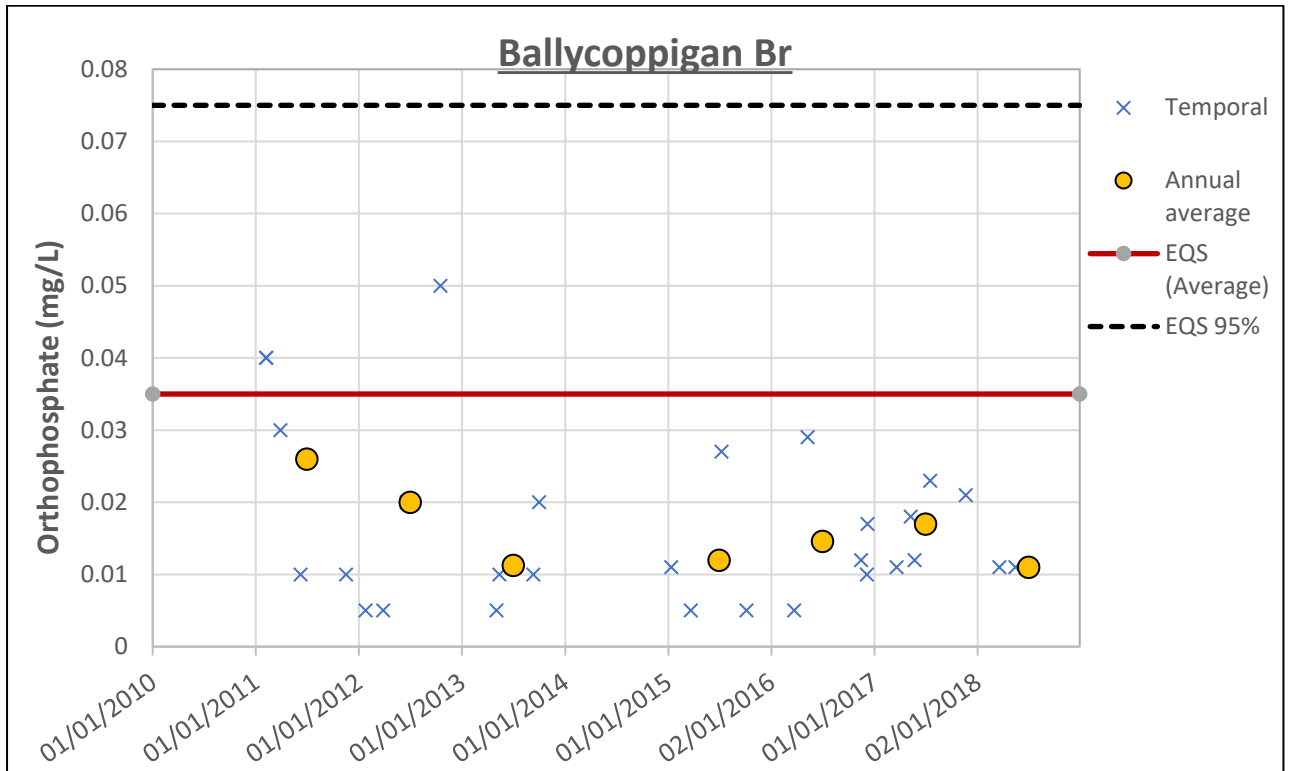
Figure 6. Ortho-phosphate concentrations at Ballycoppigan Br on Mountain (Carlow)_030.

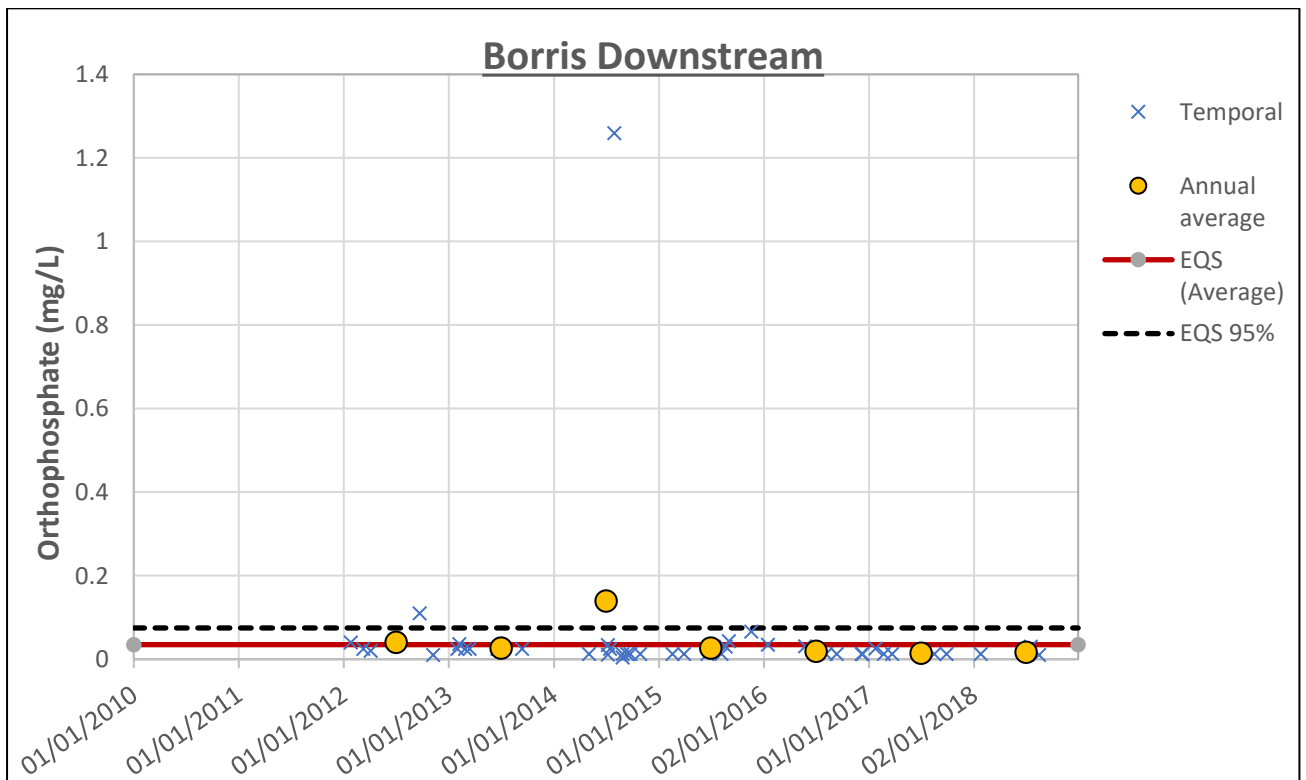
Figure 7. Ortho-phosphate concentrations at Borris Downstream on Mountain (Carlow)_030.

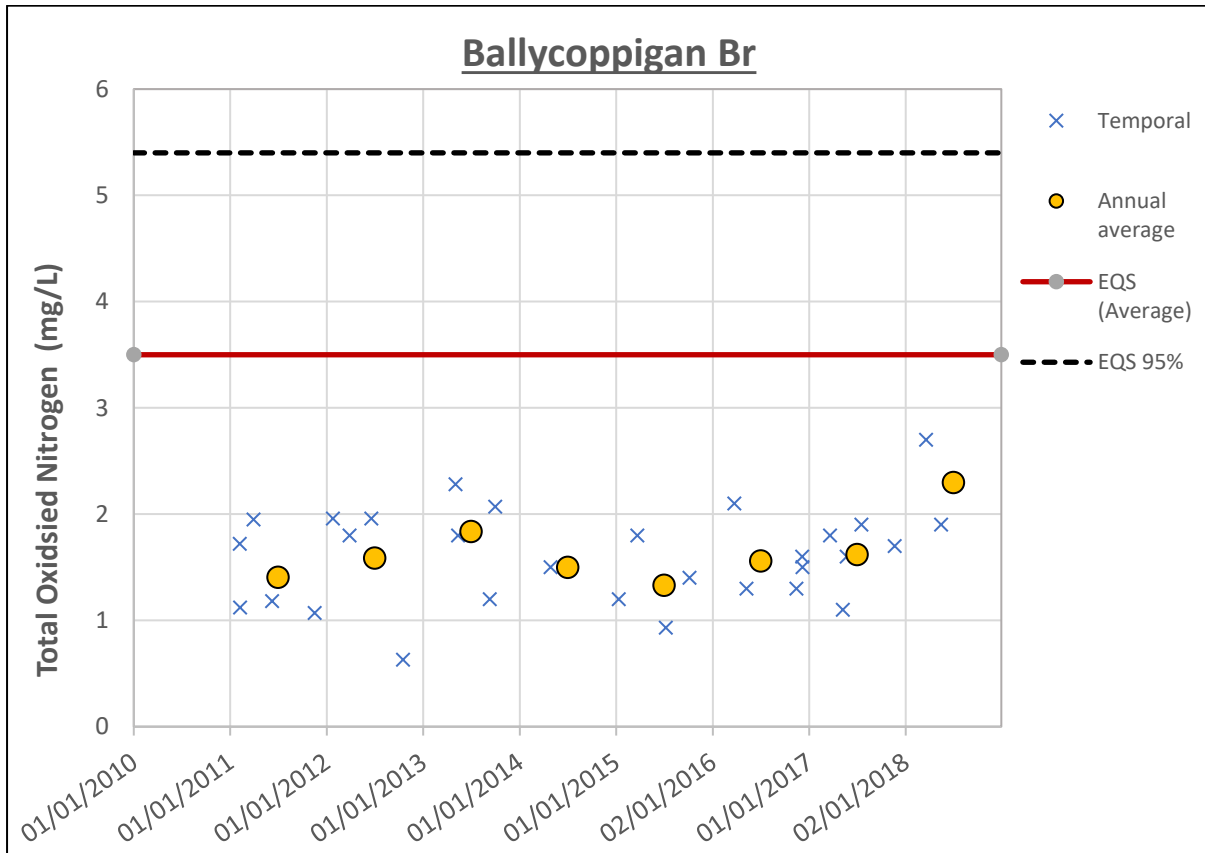
Figure 9. TON concentrations at Ballycoppigan Bridge on Mountain (Carlow)_030.

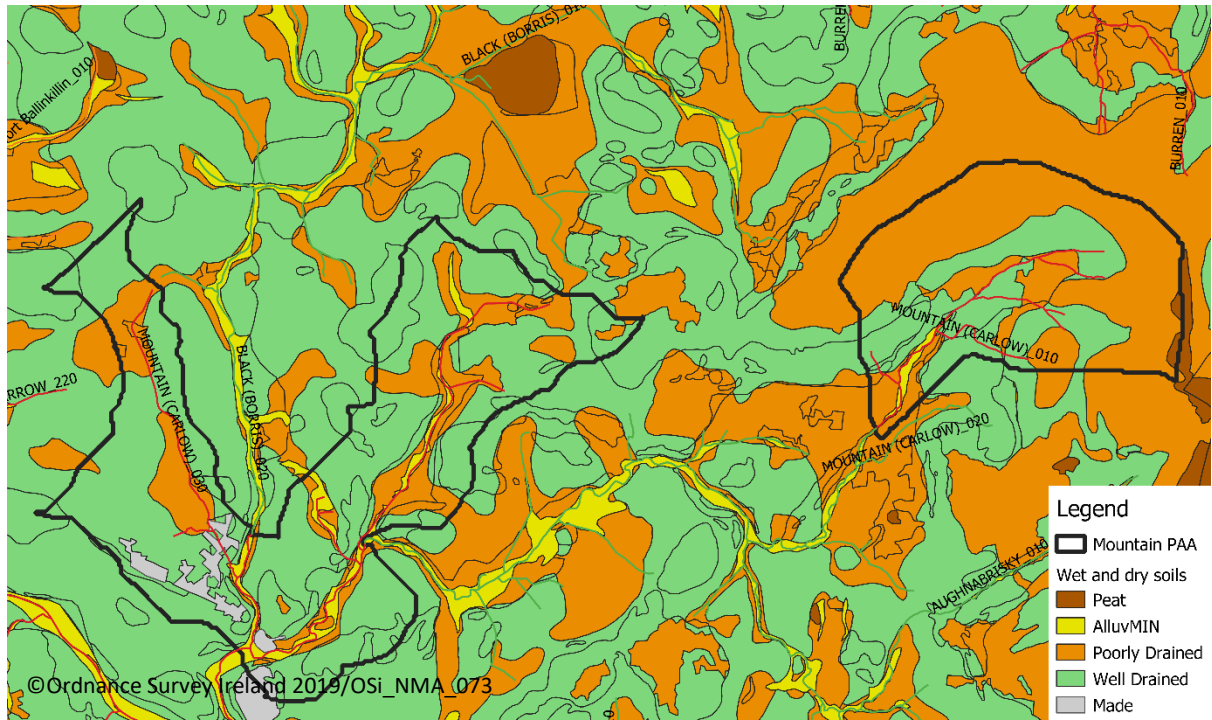
Figure 10. Wet and dry soils map.

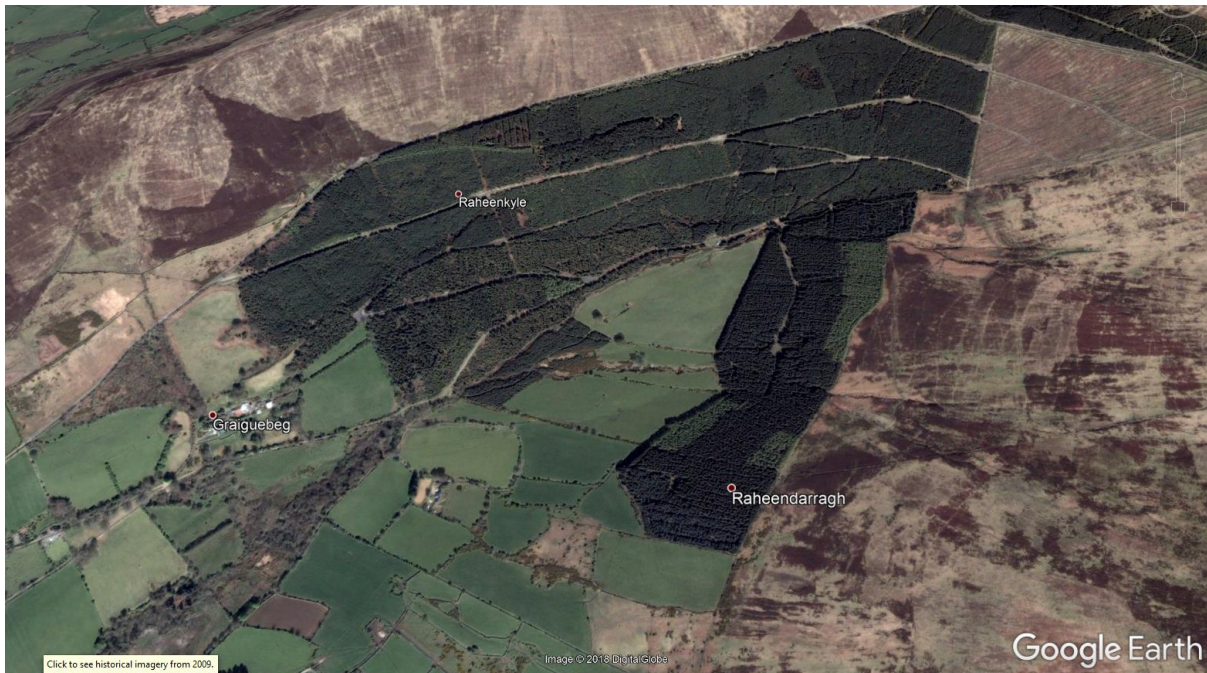
Figure 11. Aerial photograph from 2009 showing extent of forestry in Mountain (Carlow)_010 catchment.

- The Mountain (Carlow)_010 is classified as *At Risk*.
- The waterbody improved to good status in 2017 having been moderate status in 2014.
- There is no hydrochemistry data available for this waterbody.
- Therefore, significant issues, if any, cannot be determined.
- If there are any significant pressures in this catchment they are most likely resulting from the large area of forestry at the top of the catchment.
- The decline in status in 2014 was likely due to an impact from a large area of forestry which had been felled (see **Fig. 11** and **Fig. 12**). This was a once-off pressure and water quality has since returned to good status in 2017.

The desk study identified no significant issues which are likely to be affecting the overall status of the Mountain (Carlow)_010 or Mountain (Carlow)_030 waterbodies. The Mountain (Carlow)_010 has recently returned to good status. One possible explanation for the drop to moderate status in 2014 could be the large area of tree felling in the upper reaches of the waterbody (**Fig. 11** and **Fig. 12**) that took place after 2009 (exact date currently unknown). Borris UWWTP should be investigated due to breaches of ELVs which could be affecting water quality in the lower section of the Mountain (Carlow)_030.

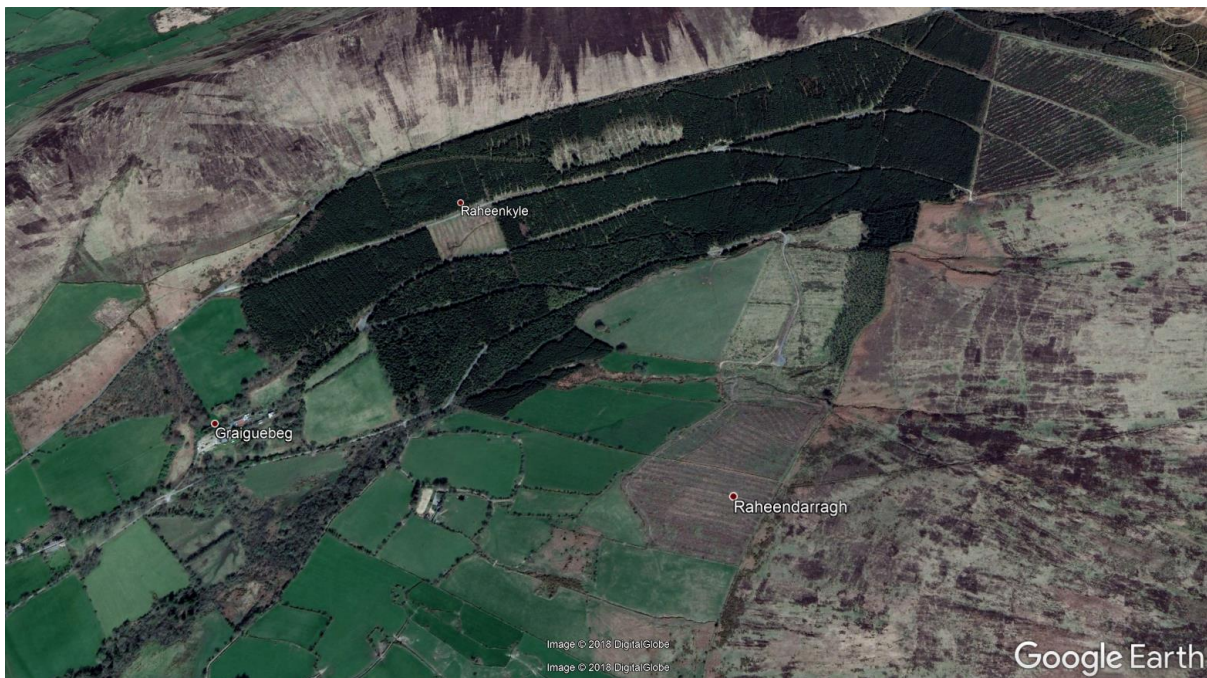
Figure 12. Aerial photograph from April 2018 showing current extent of forestry in Mountain (Carlow)_010 catchment.
