Tay

Priority Area for Action Desk Study (AFA0171)

LA Waters Programme Office	Clonmel
Document Title	Tay Priority Area for Action Desk Study
Document No.	South East Rp AFA0171_F01

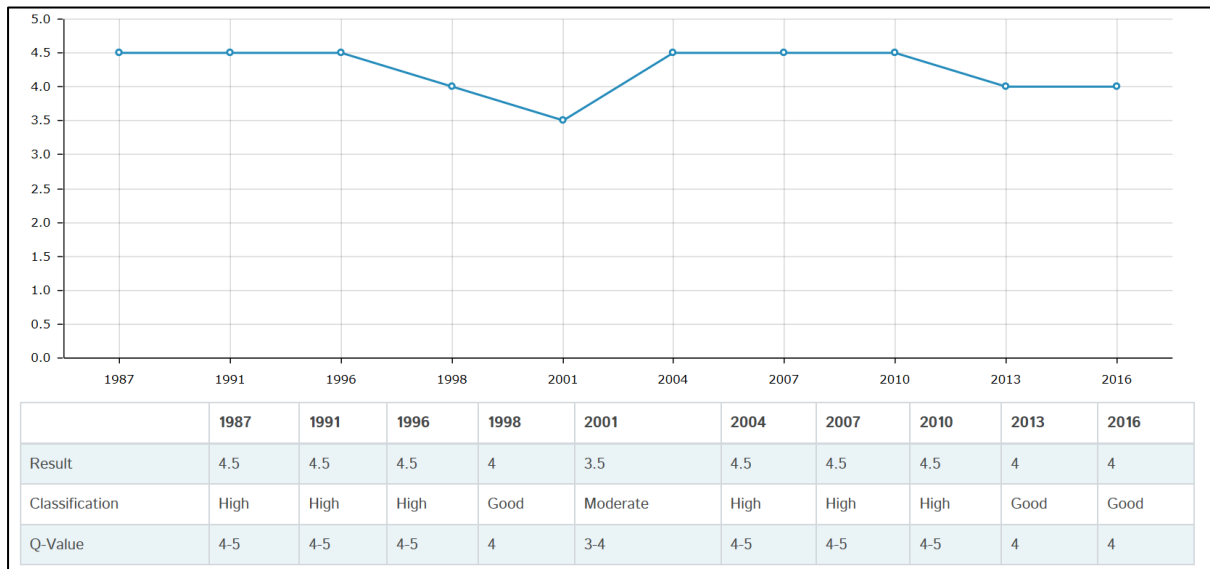
Figure 2-3 Q-Value graph for Aughnacurra Br monitoring point – Tay_010

- Results for Biological Oxygen Demand (BOD) are shown in Figure 2-7.
- The Tay_010 is monitored at the Aughnacurra Br monitoring point. Ecological status is Good (Figure 2-3) and is classified as *At Risk* because the environmental objective for this water body is High Status.

- It has one receiving surface waterbody the river Tay_020 which is *Not at Risk*.
- The Q-value was High (4-5) in 2010, Good (4) in 2013 and Good (4) in 2016 (Figure 2-3).

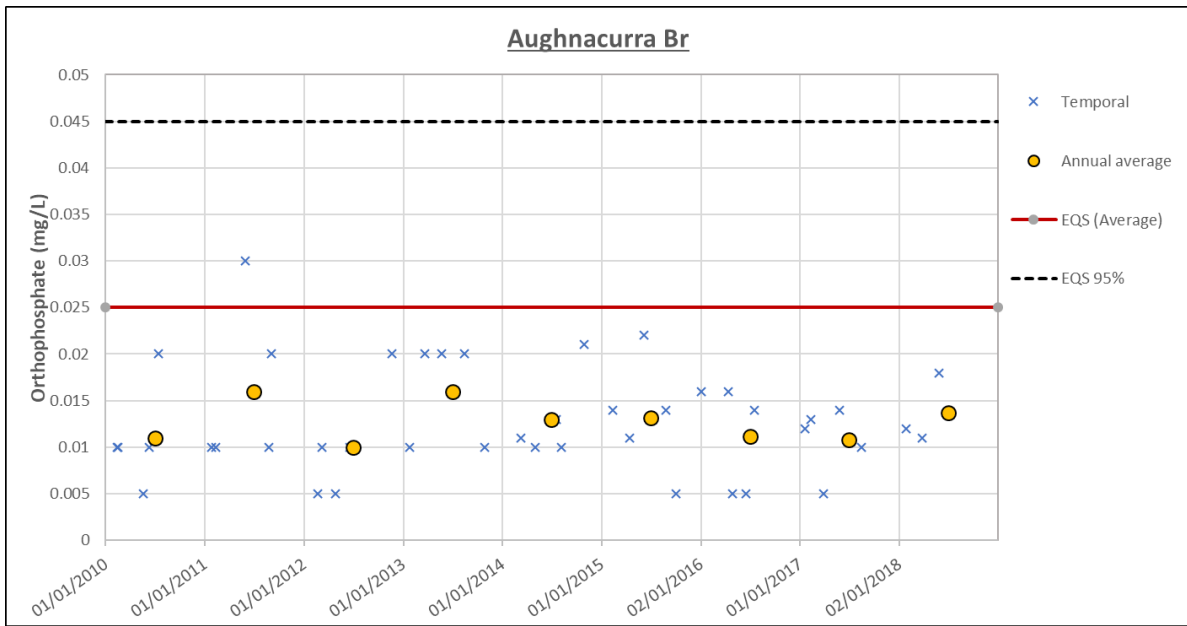
Figure 2-4 -Phosphate data for Aughnacurra Br monitoring point – Tay_010

- Phosphate levels for the Tay (0.014 mg/l, baseline 2014) are below the High status Environmental Quality Standard (EQS) threshold (0.025mg/l) (Figure 2-4).

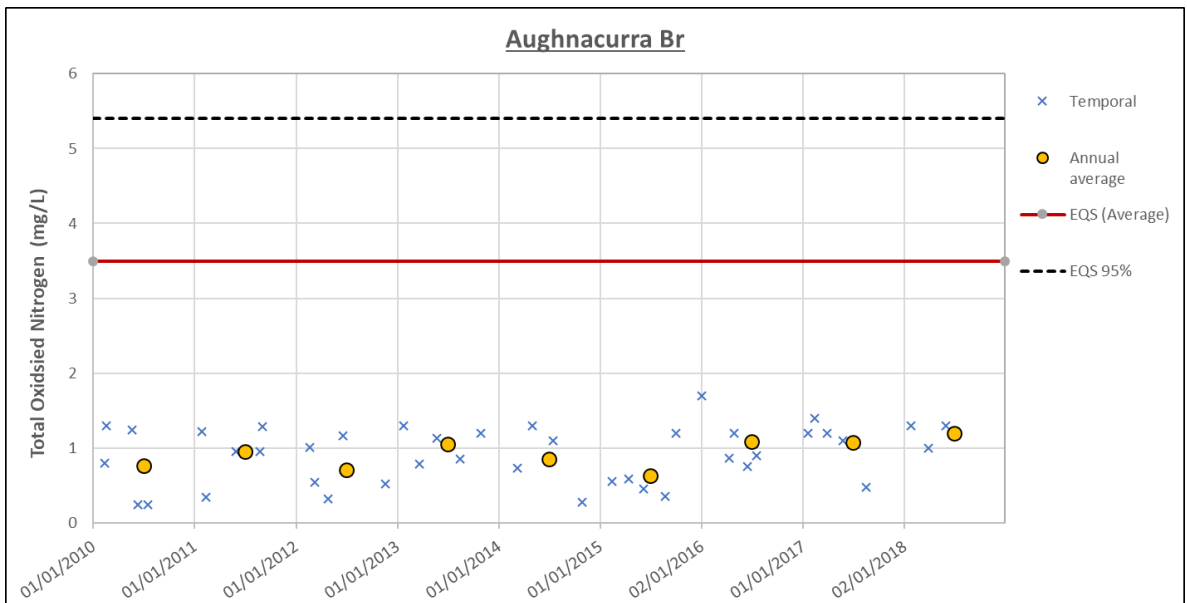
Figure 2-5 - Nitrate data for Aughnacurra Br monitoring point – Tay_010

- Nitrate levels (0.848 mg/l baseline 2014) are below the High status EQS threshold (1.8mg/l) (Figure 2-5).
- Ammonia levels (0.020 mg/l baseline 2014) are below the High status EQS threshold (0.040 mg/l) (Figure 2-6).

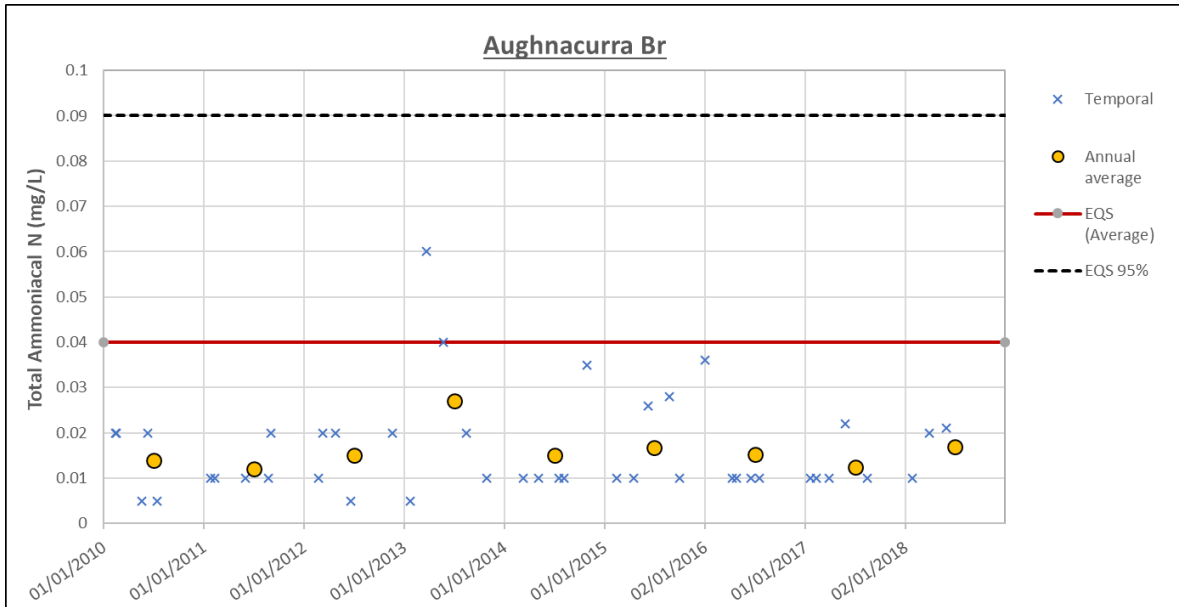
Figure 2-6 - Ammonia data for Aughnacurra Br monitoring point – Tay_010

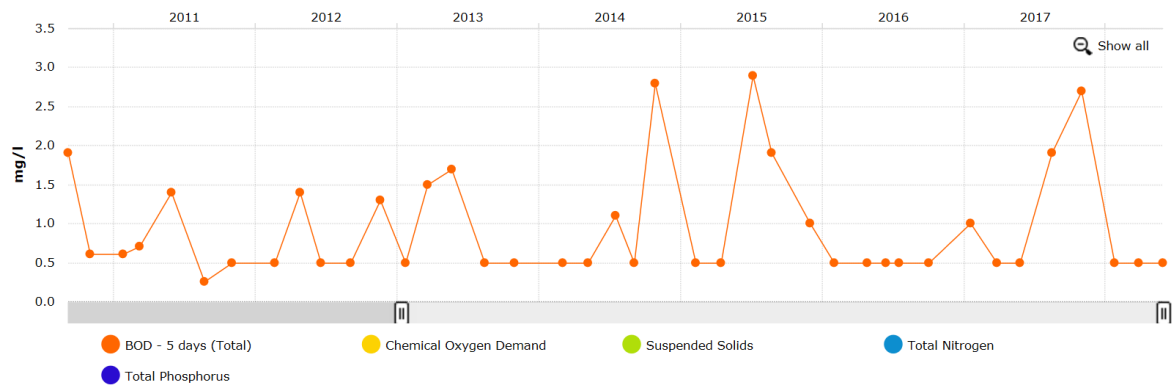
Figure 2-7 - Biological Oxygen Demand (BOD) for Aughnacurra Br monitoring point – Tay_010

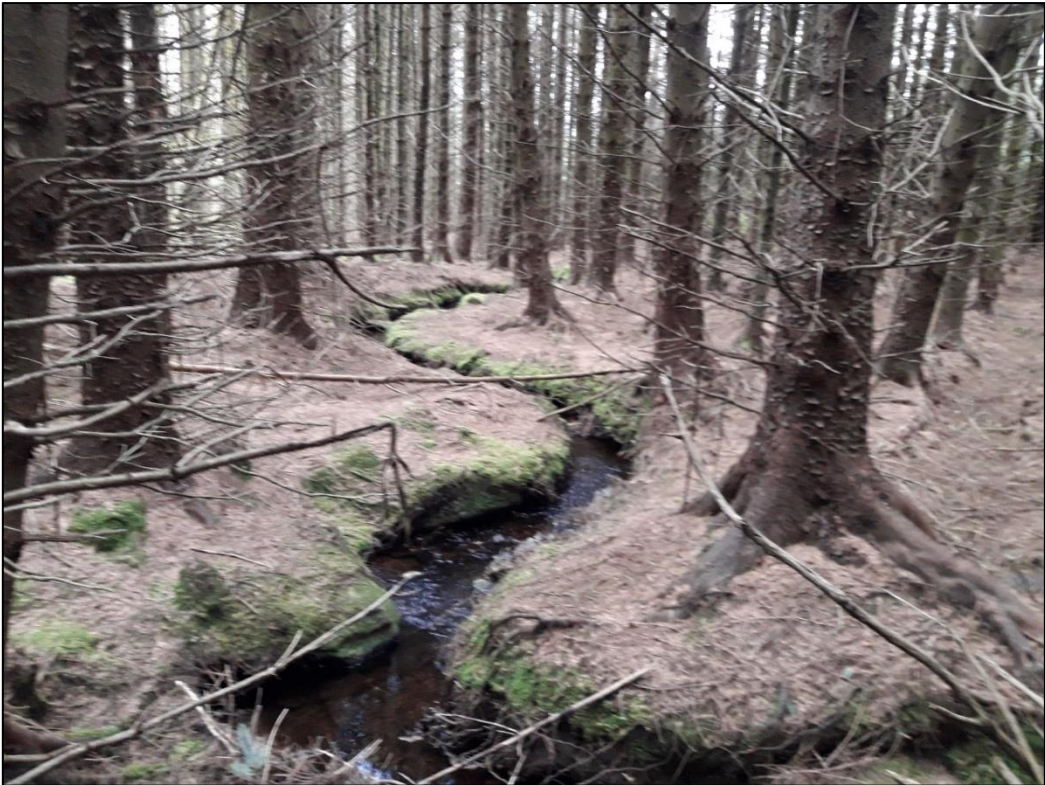
Figure 3-2 - Picture Provided by Inland Fisheries Ireland: Showing One of a number of streams which represents the headwaters of the Tay River in a Coillte site, on peat soils, which are “tunnelled” because no riparian buffer zone was incorporated.

- For forestry pressure & altered habitat:
 - Inland Fisheries Ireland provided a picture showing a lack of buffer on a forest stand in Tay_010 (Figure 3-2).

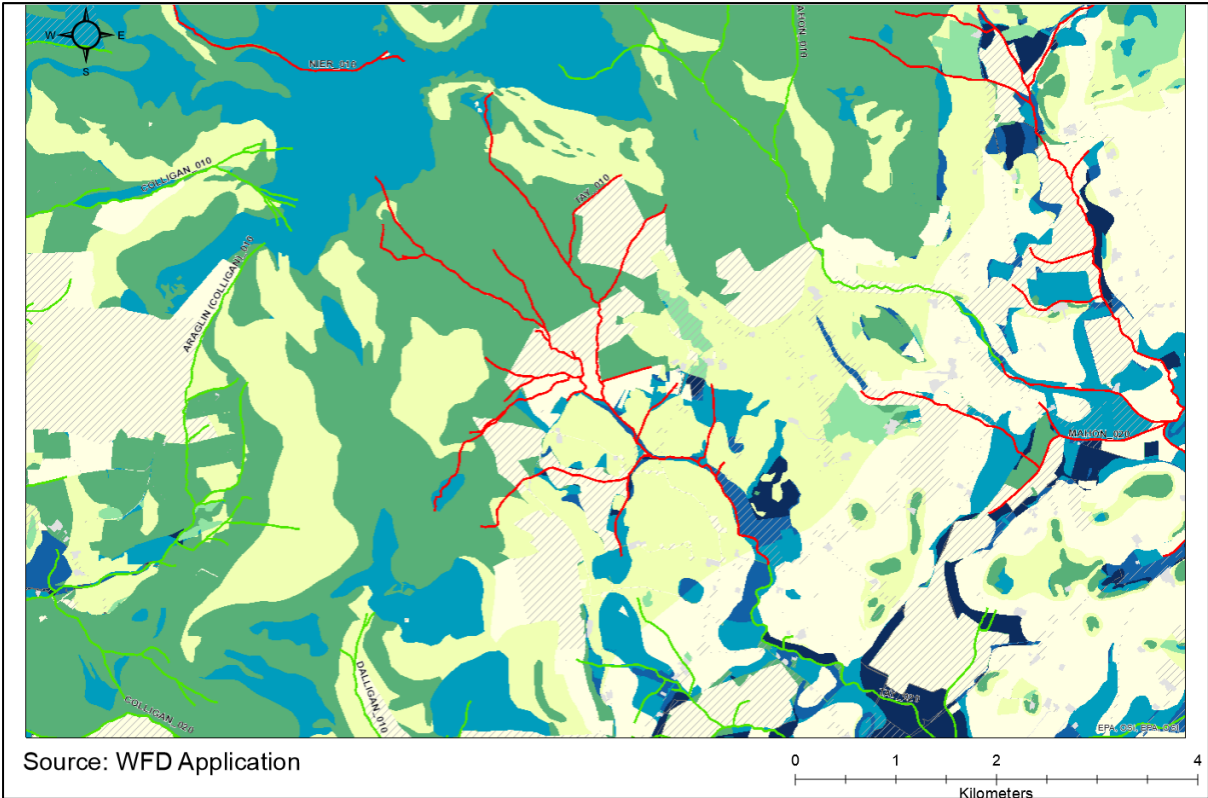
Figure 3-3 PIP maps Phosphate to surface receptor within the Tay PAA

- For farmyard pressure & organic pollution:
 - Farmyards may be identified during the catchment walks and, high PIP areas, shown in Figure 3-3 and Figure 3-4, can be used to identify areas where the risk of phosphorus loss or Nitrate loss to surface water is greatest for example.

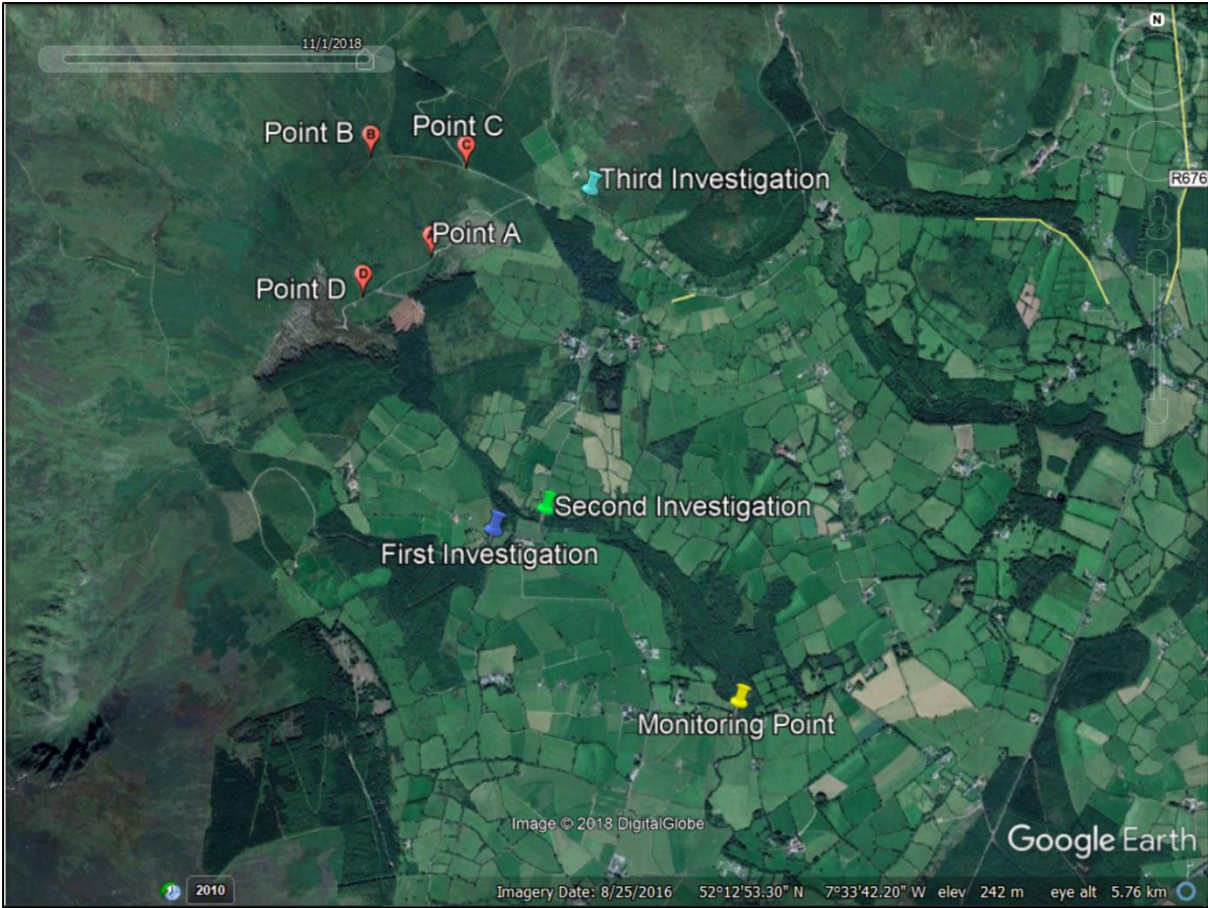
Figure 6-1 Map of suggested sampling locations given in Work Plan.

There are only two sampling points accessible from the roadways (First & Second Investigation). A third sampling point (Third Investigation) is only accessible via forestry roads which may require permission from forestry owners or agencies. Note also that the river is currently in Good Status, so the field work test results may reflect this. Sampling locations and map are shown in Table 6-1 and Figure 6-1 and factors to look out for during the LCA are shown in Table 6-2.
